FISH PASSAGE ENGINEERING PROJECT

Site Analysis Final Report

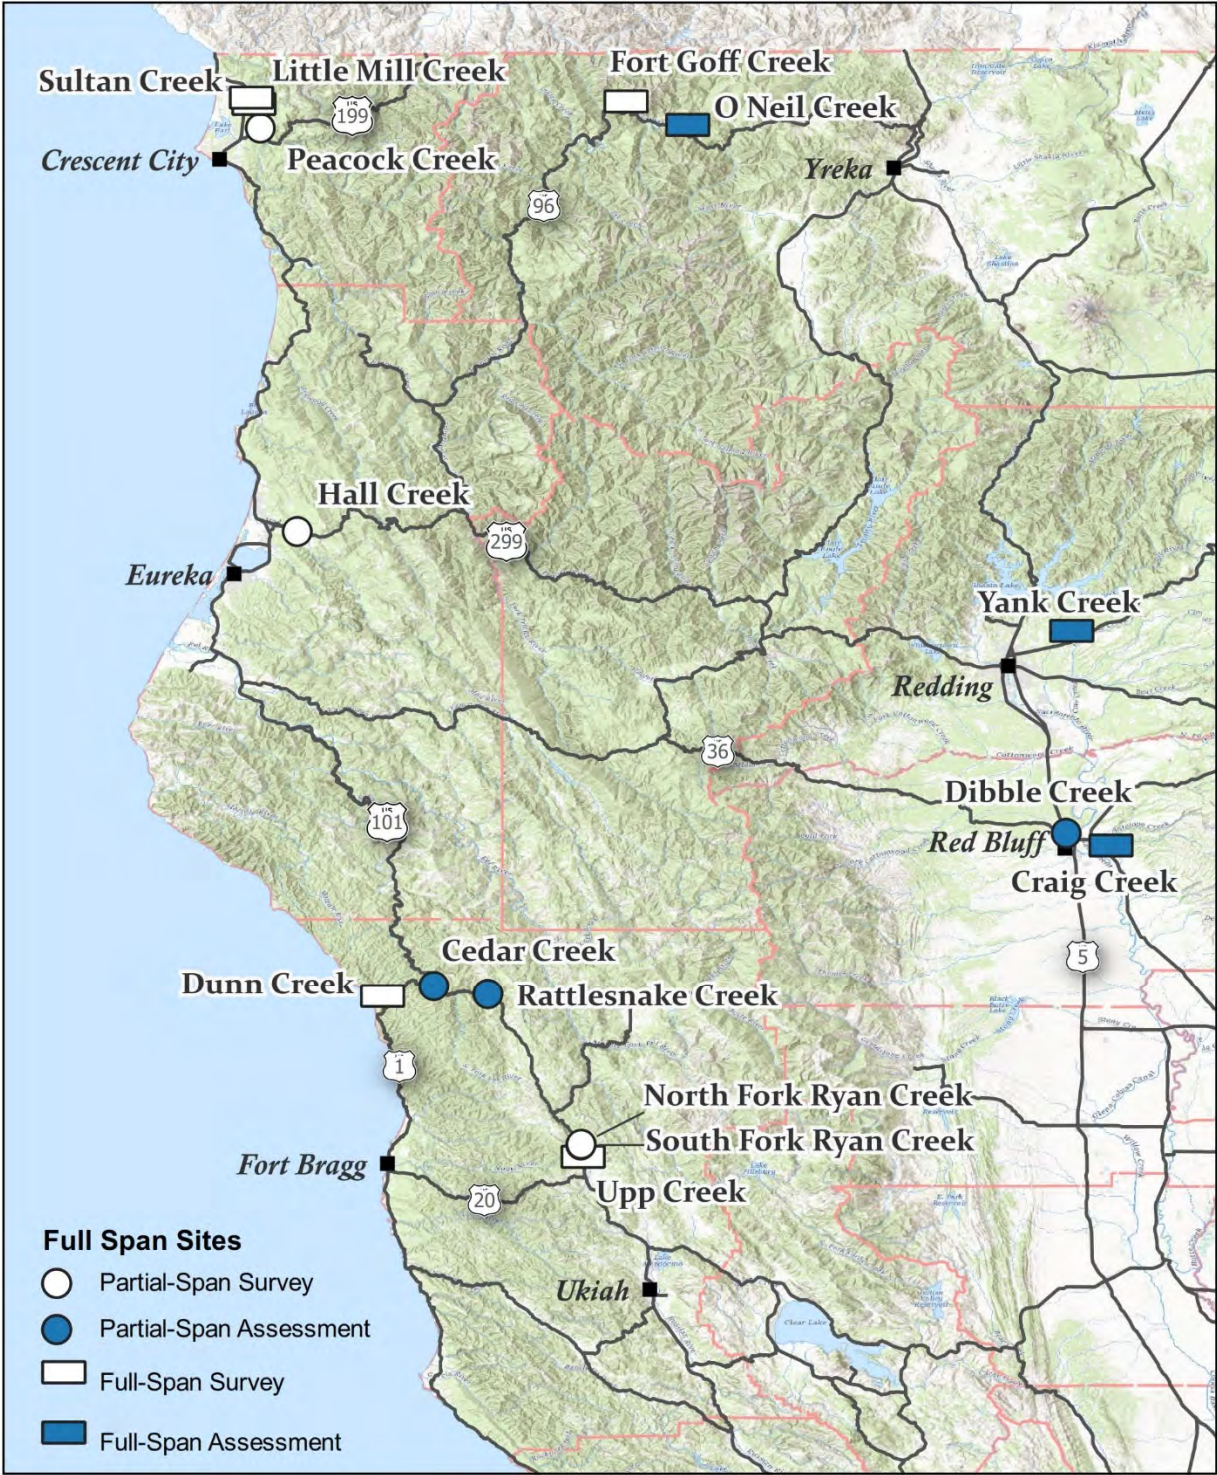
- The project monitoring plan (Appendix C) submitted and approved by the project advisory board in August 2019
- Modeling case studies comparing 1D and 2D model simulations (Appendix D), and
- A literature review summarizing relevant design documents and resources (Appendix E).

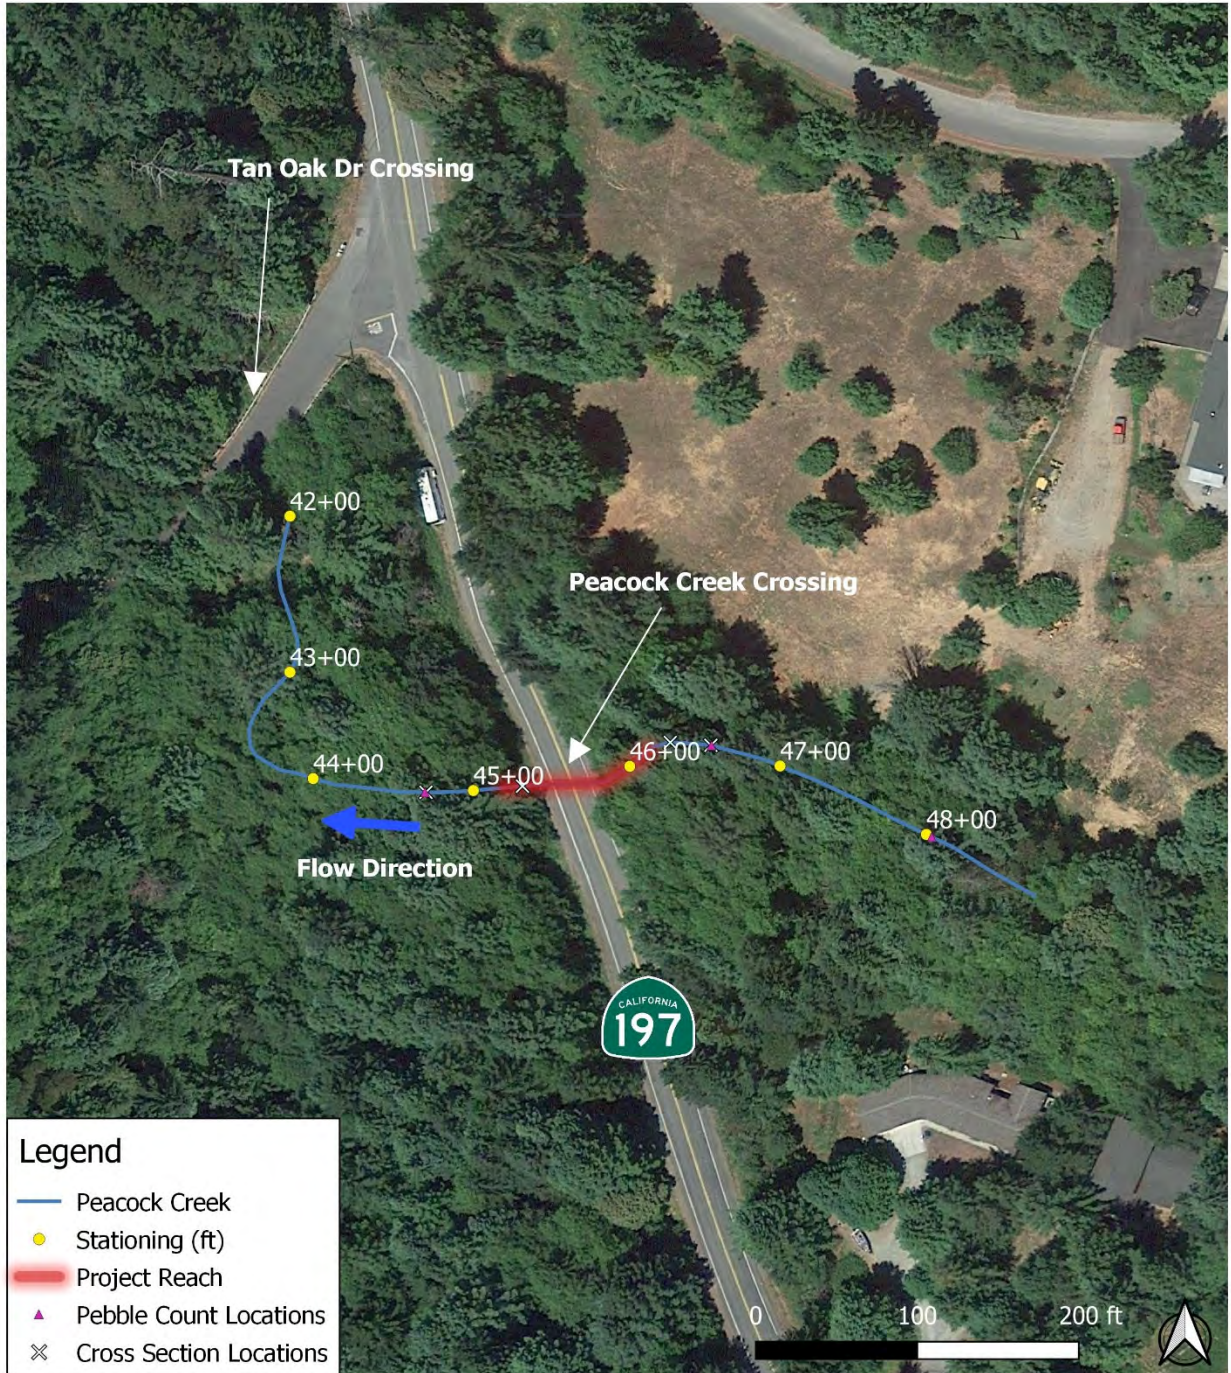
<p>Datums: Horizontal: NAD83 State Plane CA Zone 1 Vertical: NAVD88</p>	<p>Peacock Creek DN 197 PM 2.12</p> <p>Site Map and Channel Stationing</p>	<p>Caltrans Design Guidance for Full-Span Crossings Fish Passage Restoration Project</p>
<p>Image Source: Google 2021</p>		<p>HSU Sponsored Programs Foundation Fish Passage Engineering (S4085)</p>

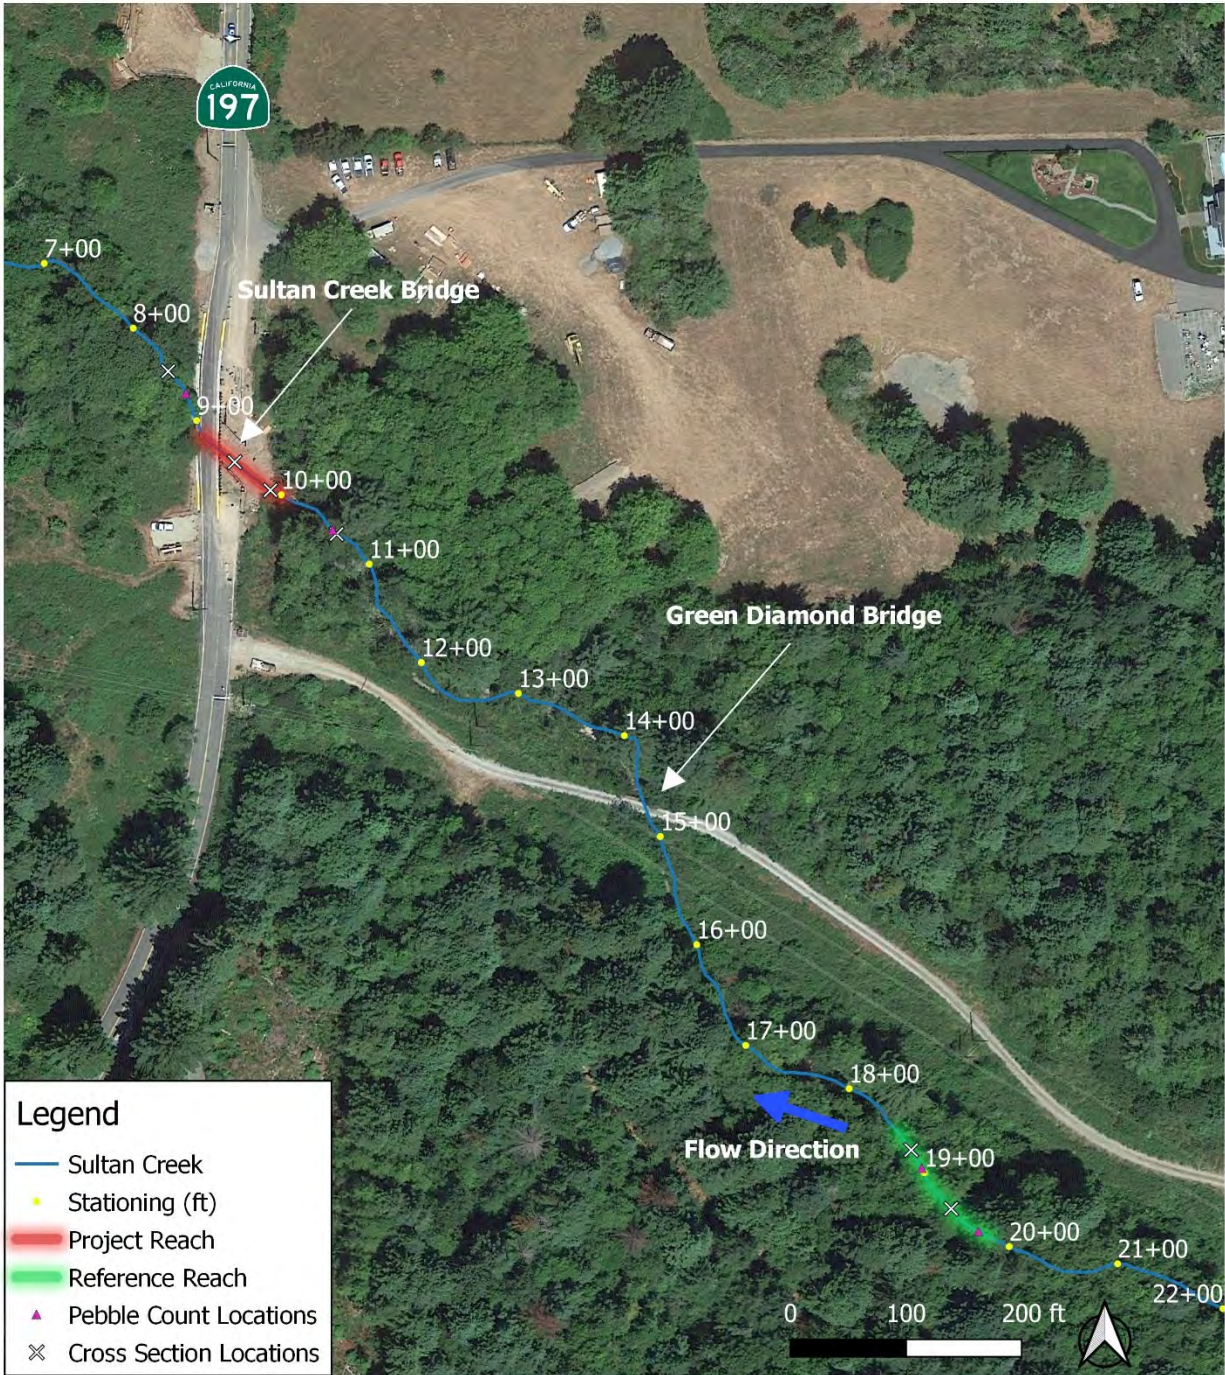
Datums:
 Horizontal: NAD83 State Plane CA Zone 1
 Vertical: NAVD88

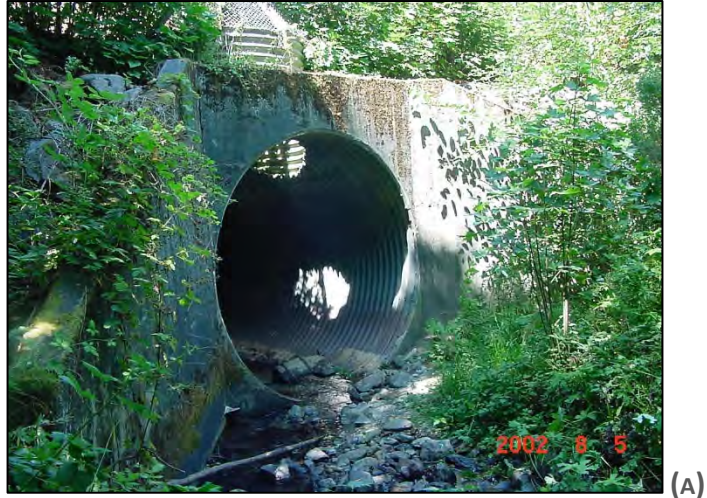
The constructed rock weirs were no longer present, and the channel bed appeared to have down-cut approximately 1 foot below its constructed grade. The streambed material in the project reach was native coarse cobble and gravel transported from upstream. Immediately upstream of the project reach, the channel bends to the right which causes flow to concentrate along the left bank under the bridge. The RSP along the left bridge abutment had been scoured and undermined, with the lower layers of rock missing (Figure 3-2e). With a portion of the RSP toe removed, the RSP slope appeared potentially unstable.

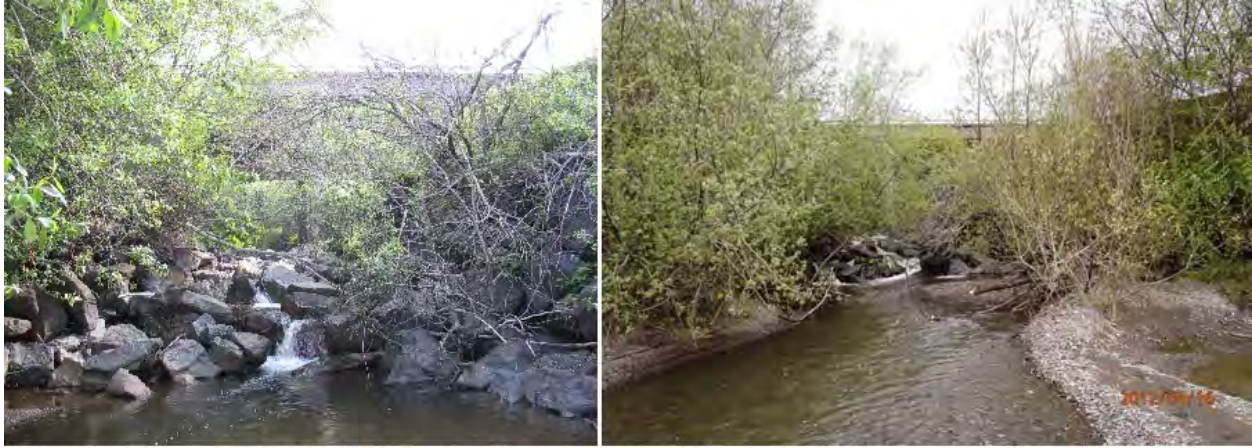
Before: Photo of downstream end of the RSP barrier looking upstream (top left) and photo of downstream end of the project near the mouth of Hall Creek, looking upstream (top right). Photos courtesy of the California Department of Transportation.

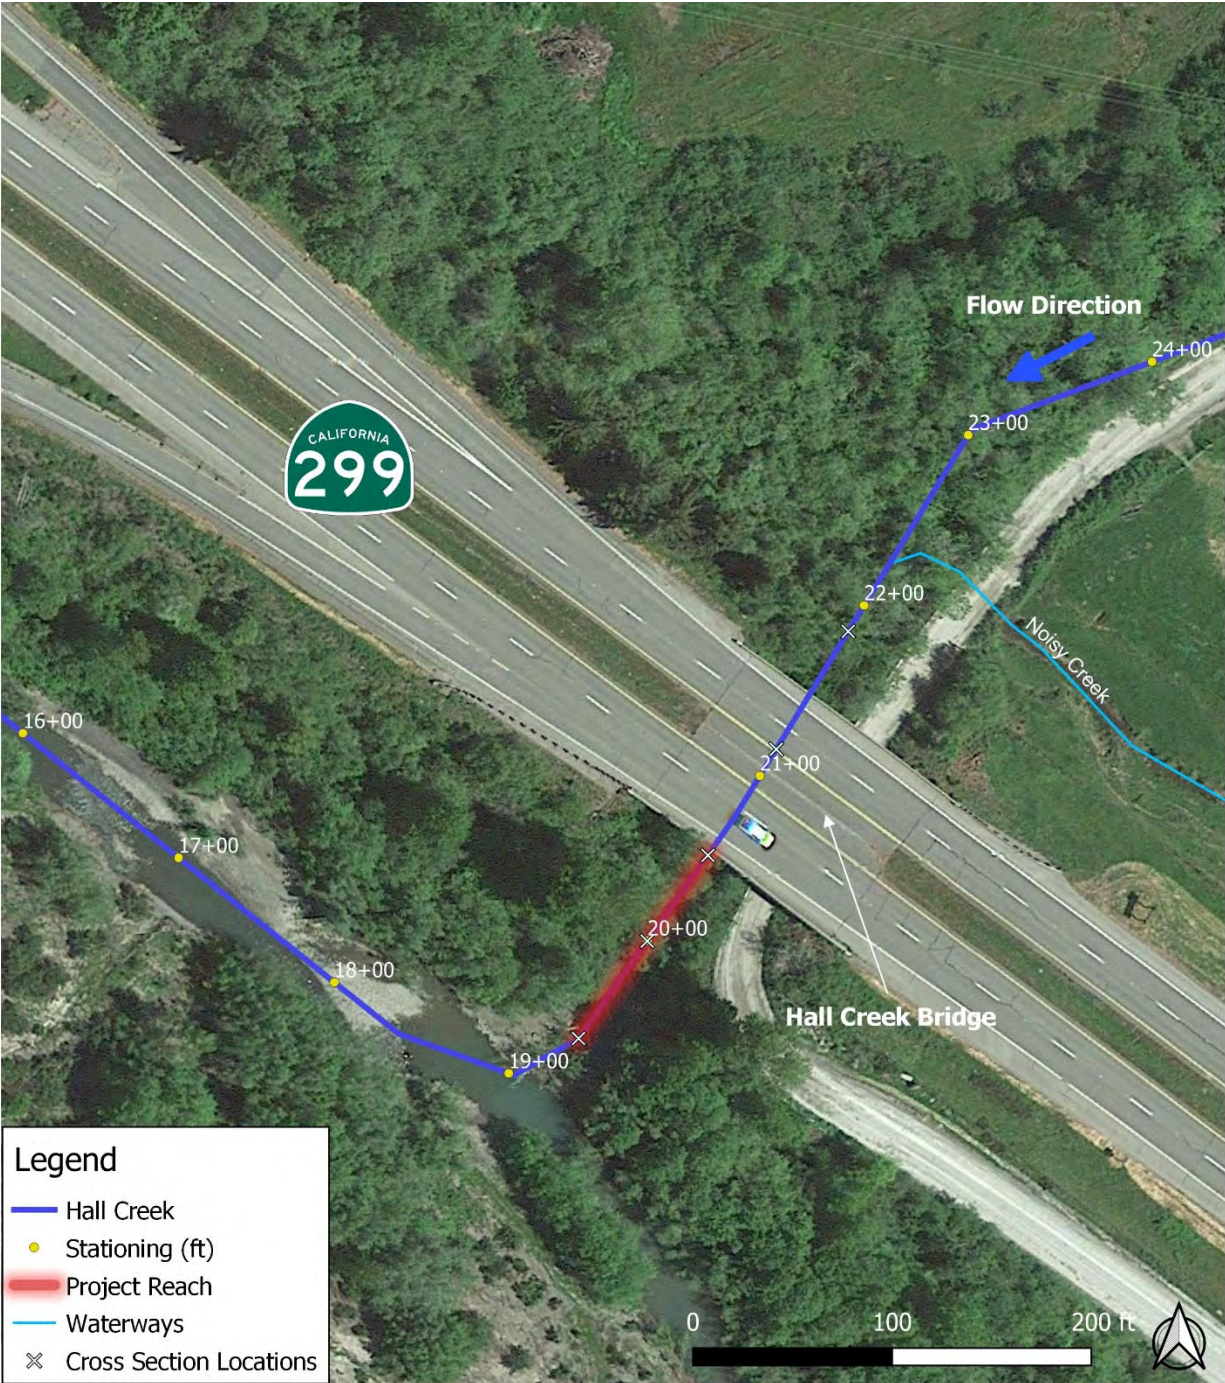
<p>Datums: Horizontal: NAD83 State Plane CA Zone 1 Vertical: NAVD88</p>	<p>Hall Creek Bridge HUM 299 PM 4.20 Site Map and Channel Stationing Project Area</p>	<p>Caltrans Design Guidance for Full-Span Crossings Fish Passage Restoration Project HSU Sponsored Programs Foundation Fish Passage Engineering (S4085)</p>
<p>Image Source: Google 2021</p>

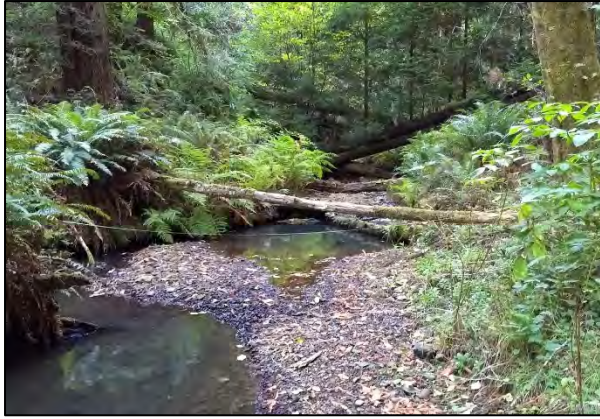
Downstream of the crossing, the channel is highly entrenched. There is some slash in the channel and a slide further downstream that has caused local aggradation. It is not clear if this channel reach is still actively incising.

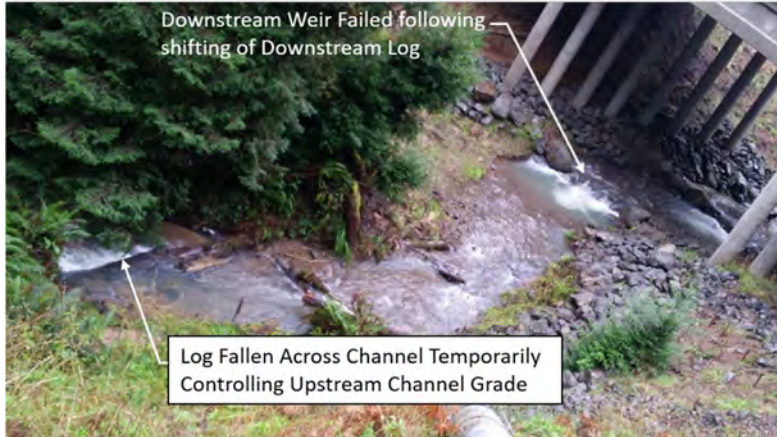
FIGURE 5-2. THE DESIGN ELEVATION AND DROP OVER THE DOWNSTREAM WEIR WAS BASED ON THE DOWNSTREAM CHANNEL BED ELEVATION CONTROLLED BY RECENTLY FALLEN LOG WITHIN THE CHANNEL BED, WHICH SUBSEQUENTLY SHIFTED, CAUSING THE BED TO DROP AND THE BOULDER WEIR TO FAIL.

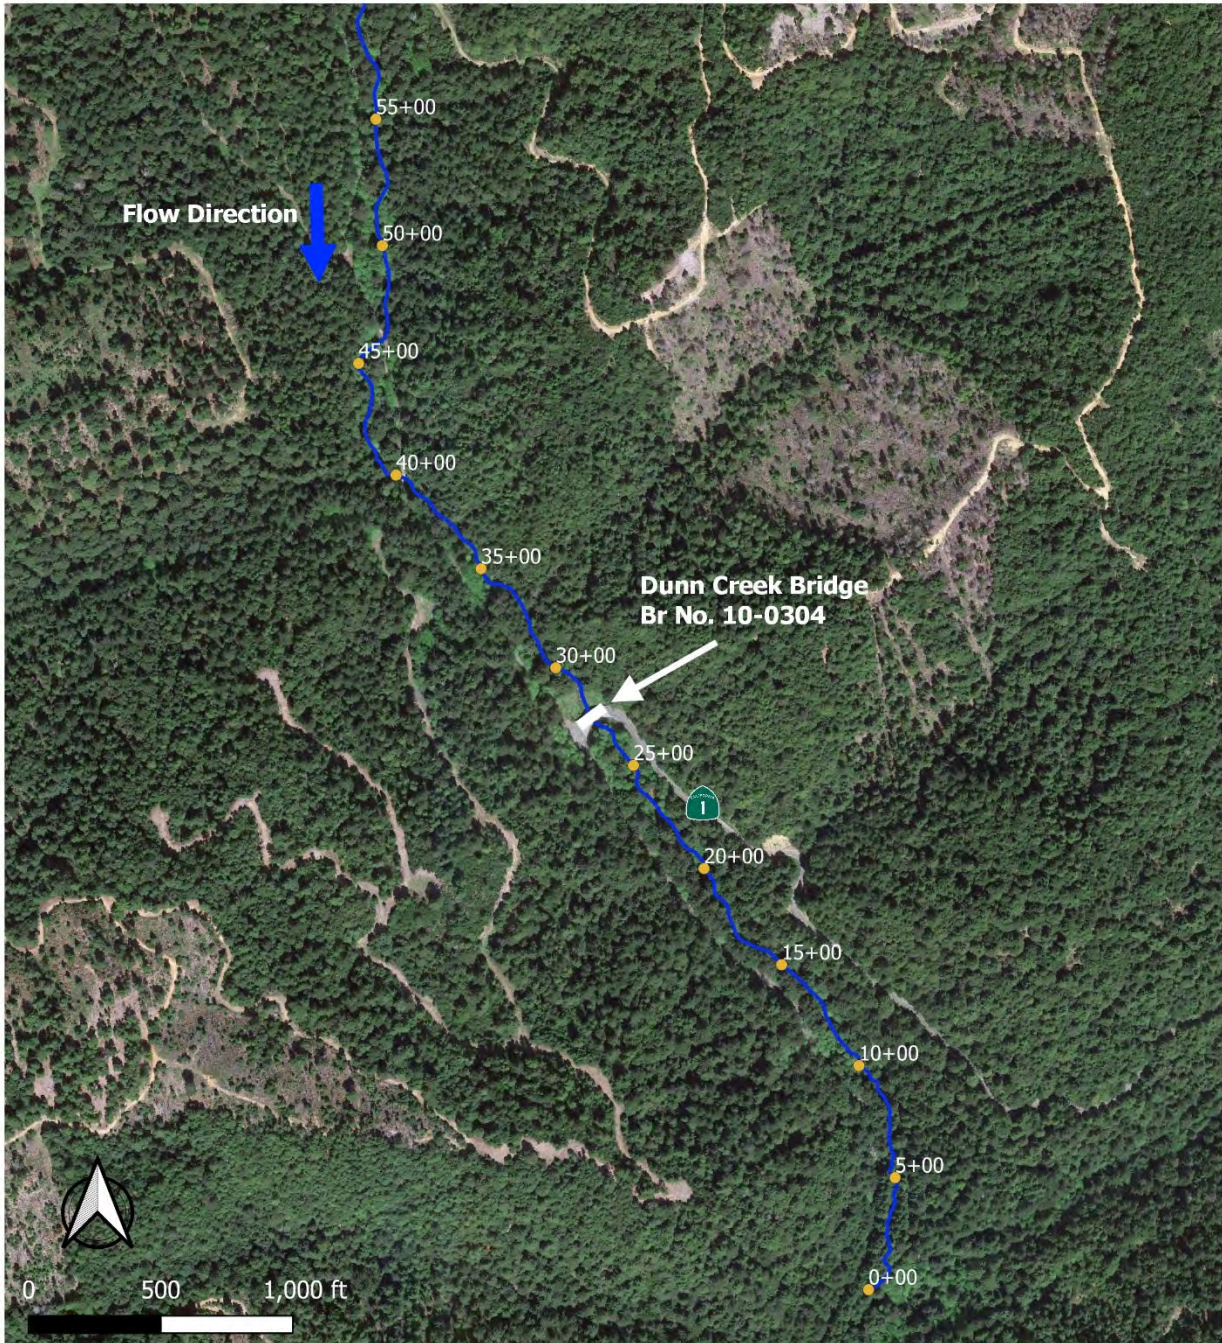
Datums:
 Horizontal: NAD83 State Plane CA Zone 1
 Vertical: NAVD88

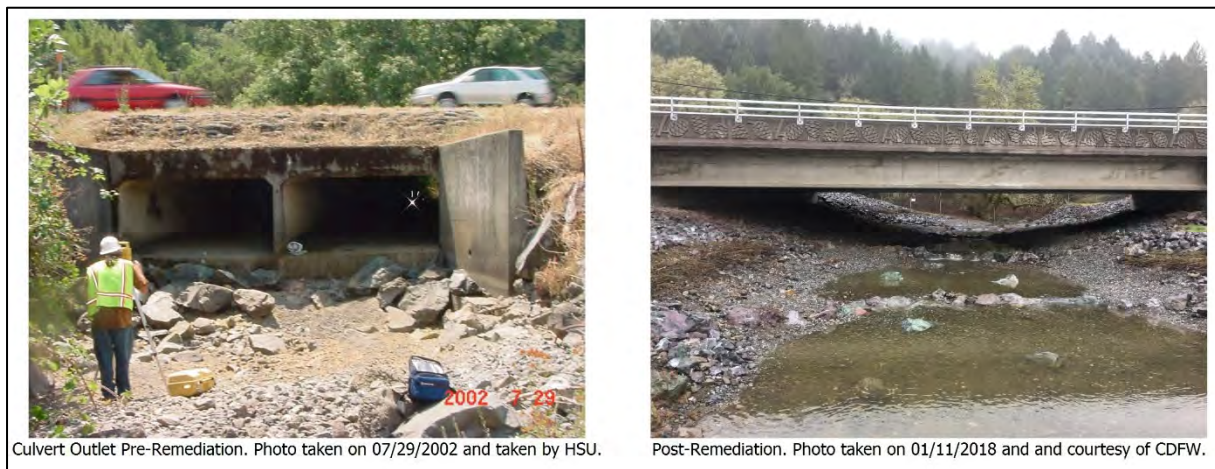
FIGURE 6-1. PRE AND POST PROJECT LOOKING UPSTREAM AT CROSSING.

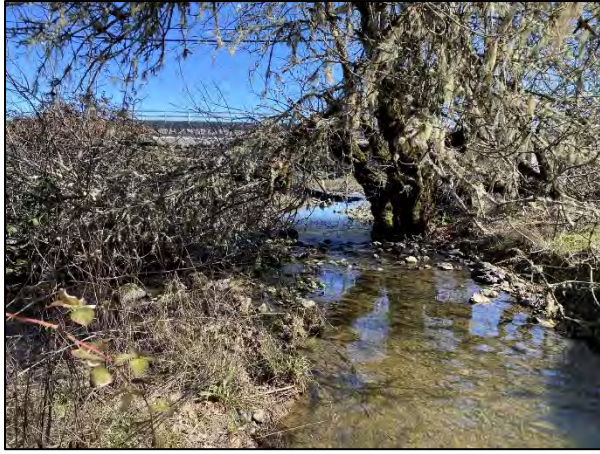
The upstream-most boulder weir had failed. It was originally constructed as a straight weir, and the mobilized rock from the weir that was deposited in the downstream channel appeared relatively small in size. Also of note was the large amount of rock used to form the streambanks downstream of the bridge crossing and the lack of successful revegetation within this bank rock (Figure 6-2d).

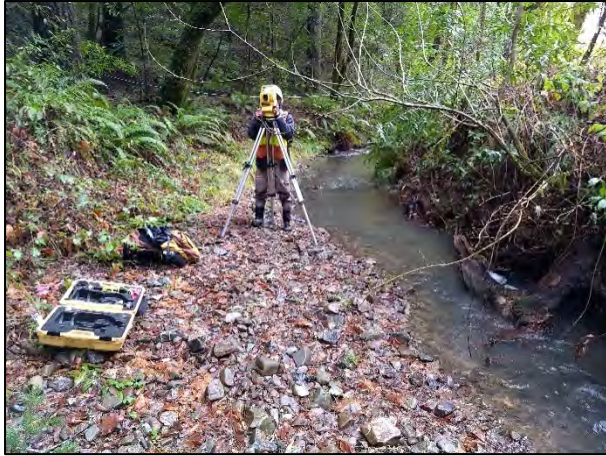
The substrate within the culvert is substantially coarser than the bed material in the upstream reference reach. This may be in-part due to the narrow width of the culvert compared to the bankfull channel width. The flow confinement in the culvert during bedload transporting flows may result in a coarser bed. The coarseness of the bed material may be the cause of the low-flow subsurface conditions found through much of the project reach. However, this could also be due to the lack of adding sufficient fines to the installed streambed material during construction.

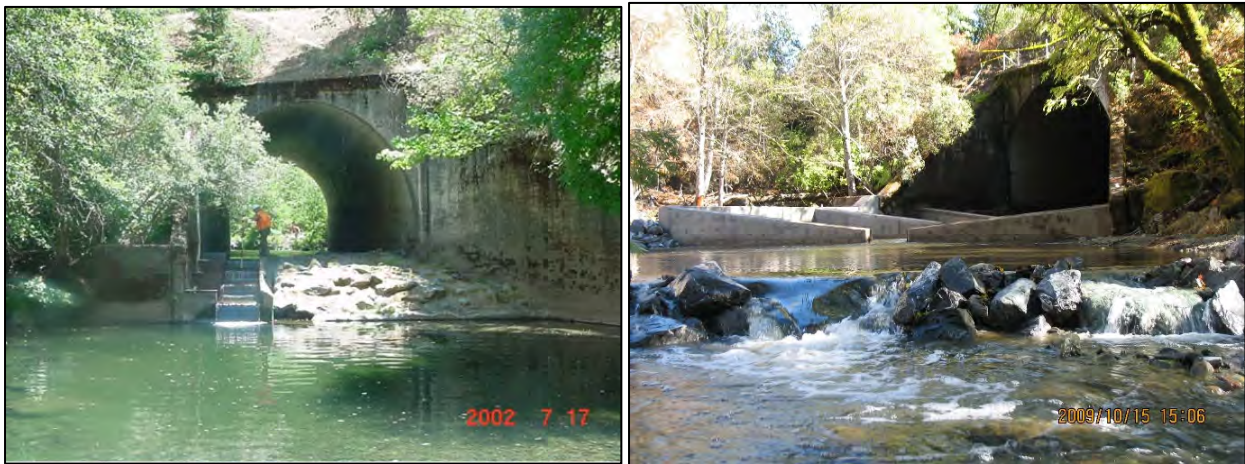
FIGURE 9-1. RATTLESNAKE CREEK CROSSING OUTLET BEFORE AND AFTER MODIFICATION. PHOTOS PROVIDED BY M. MOLNAR, CALTRANS.

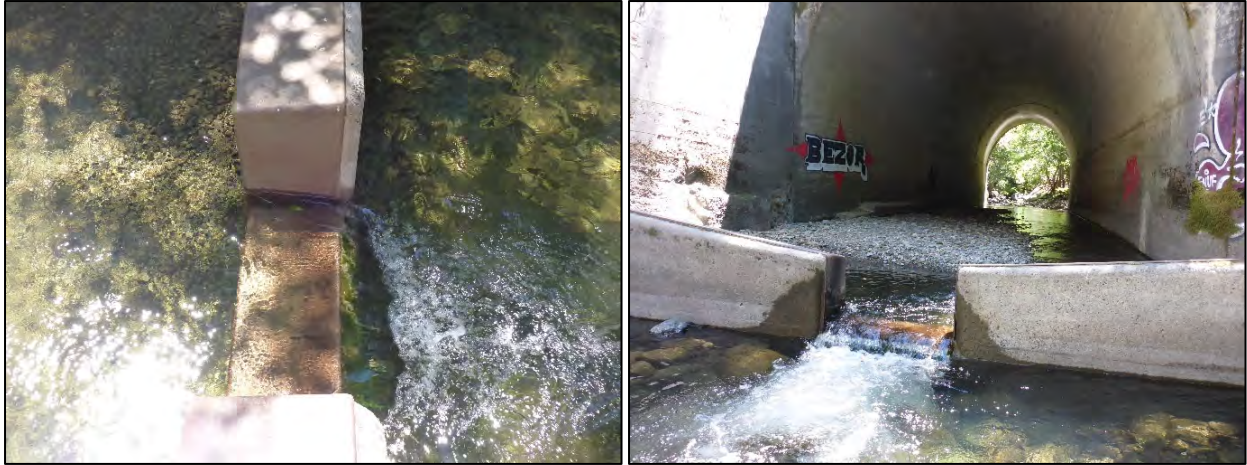
FIGURE 9-3. THE WEIR NOTCHES ON THE OUTLET FISH LADDER ARE BROAD, CREATING LOCALIZED SHALLOW, FAST FLOW. WEIR 1 SHOWN HERE HAD THE SHALLOWEST DEPTHS (0.45 FT ON THE US SIDE, 0.25 FT ON THE DS SIDE). AT SOME FLOWS THE NOTCH CONDITIONS MIGHT EXCEED FISH PASSAGE SWIMMING CRITERIA, ESPECIALLY FOR JUVENILE SALMONIDS. PHOTOS TAKEN JULY 17, 2019.

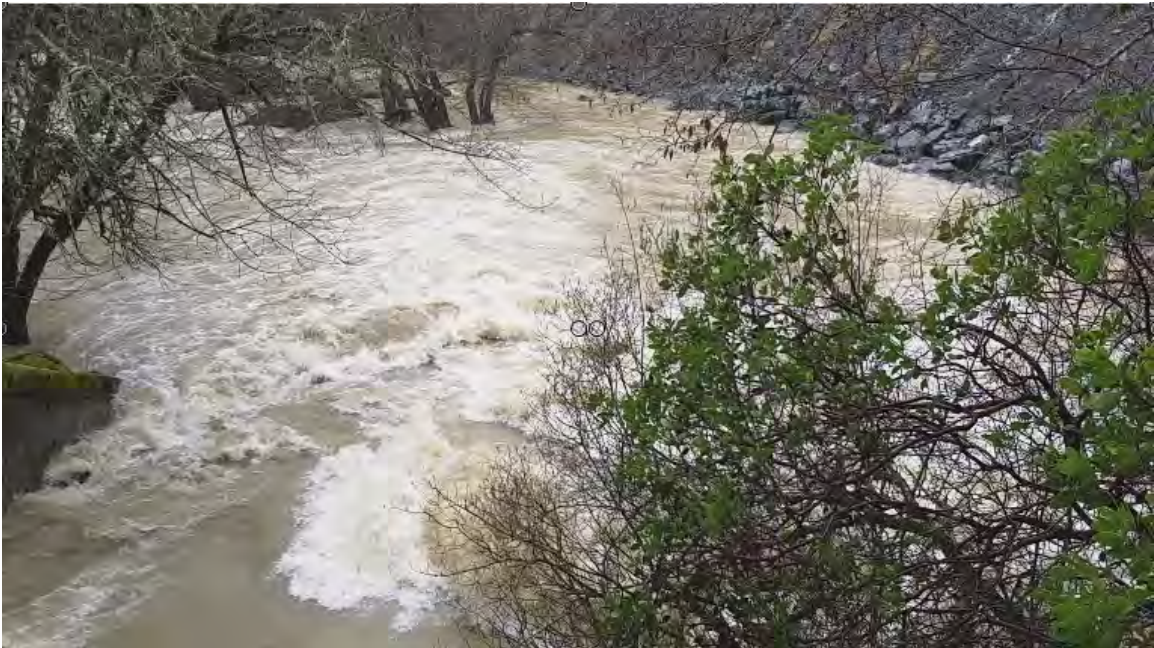
FIGURE 9-4. RATTLESNAKE CREEK OUTLET DURING HIGH FLOW. THE PRIMARY FLOW EXITING THE FISHWAY FOLLOWS THE NEW FISHWAY ORIENTATION AWAY FROM THE RIGHT BANK. AN EDDY FORMS ON THE RIGHT CREATING SOME SCOUR ALONG THE SIDE OF THE FISHWAY. PHOTO TAKEN FEBRUARY 27, 2019 BY M. LANG.

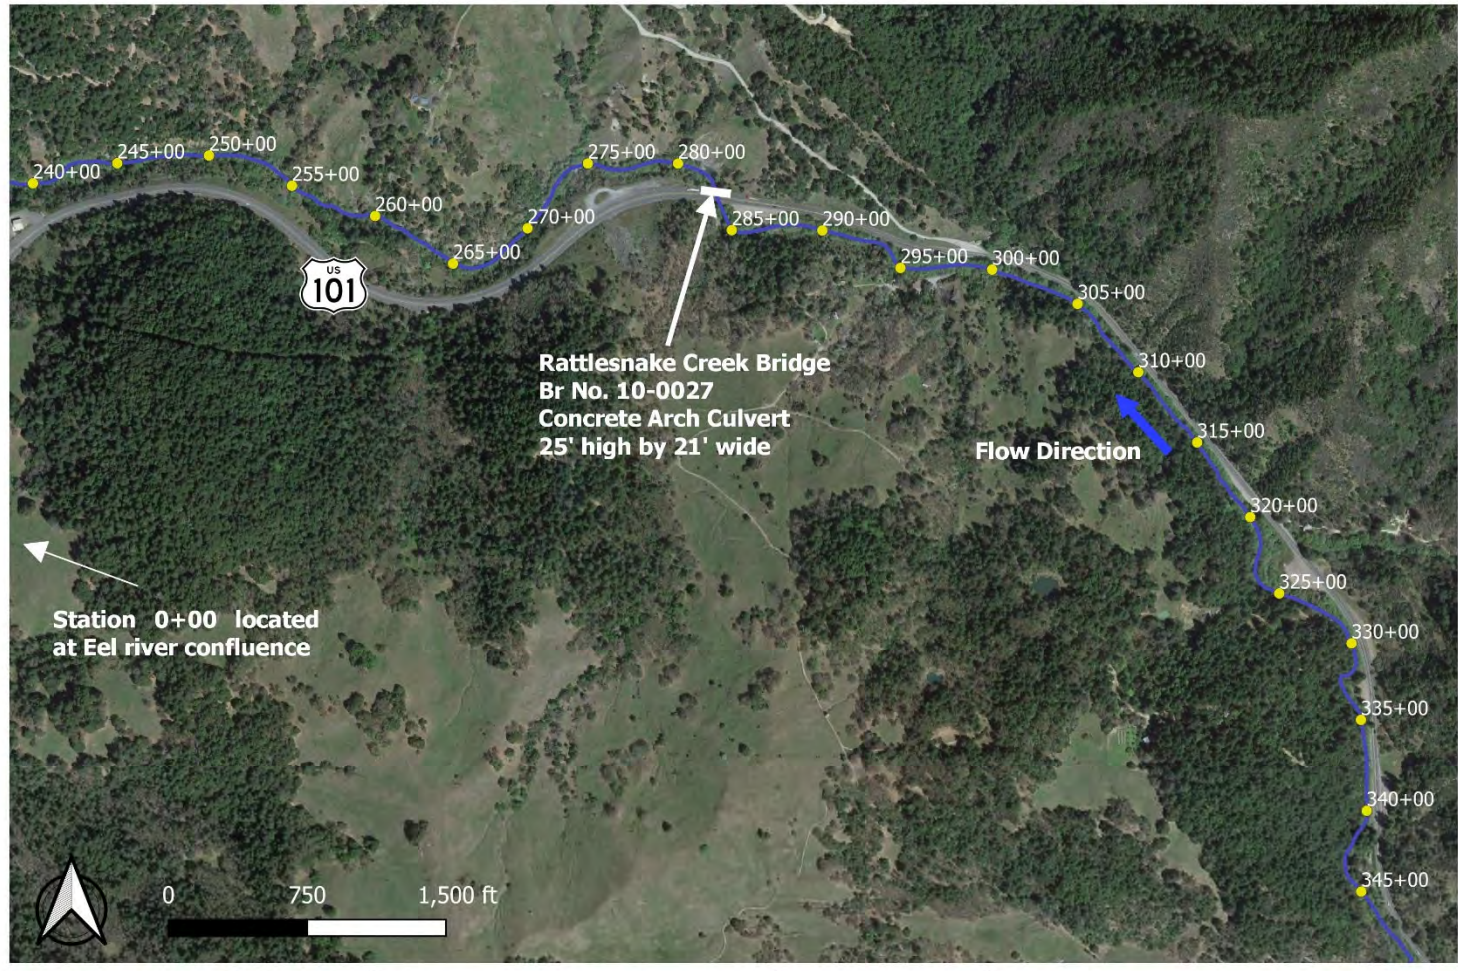
<p>Datums: Horizontal: NAD83 State Plane CA Zone 1 Vertical: NAVD88</p>	<p align="center">Rattlesnake Creek MEN 101 PM 81.40 Site Map and Channel Stationing</p>	<p>Caltrans Design Guidance for Full-Span Crossings Fish Passage Restoration Project</p>
<p>Image Source: Google 2015</p>		<p>HSU Sponsored Programs Foundation Fish Passage Engineering (S4085)</p>

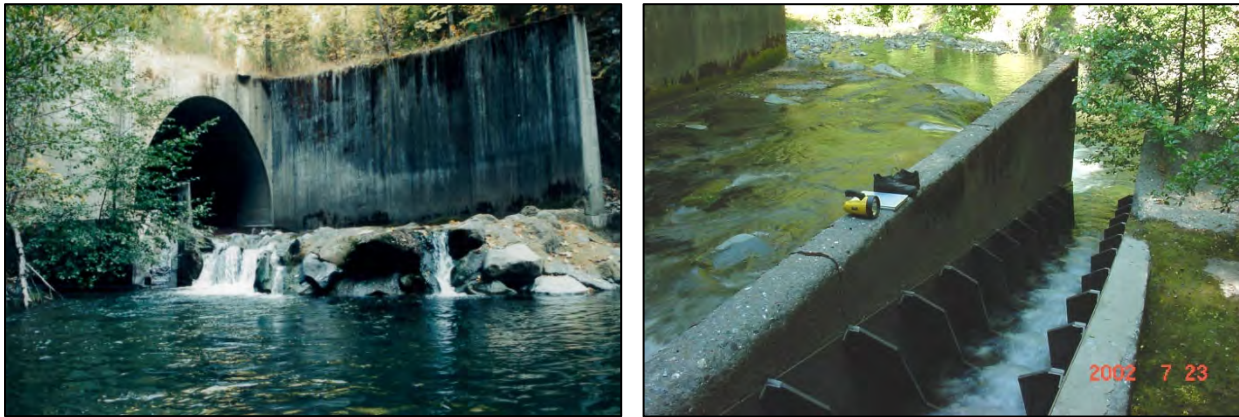
FIGURE 10-1. CEDAR CREEK CROSSING OUTLET AND FISH LADDER BEFORE THE 2017 MODIFICATIONS. PHOTO ON LEFT PROVIDED BY M. MOLINAR CALTRANS, PHOTO ON RIGHT BY M. LANG.

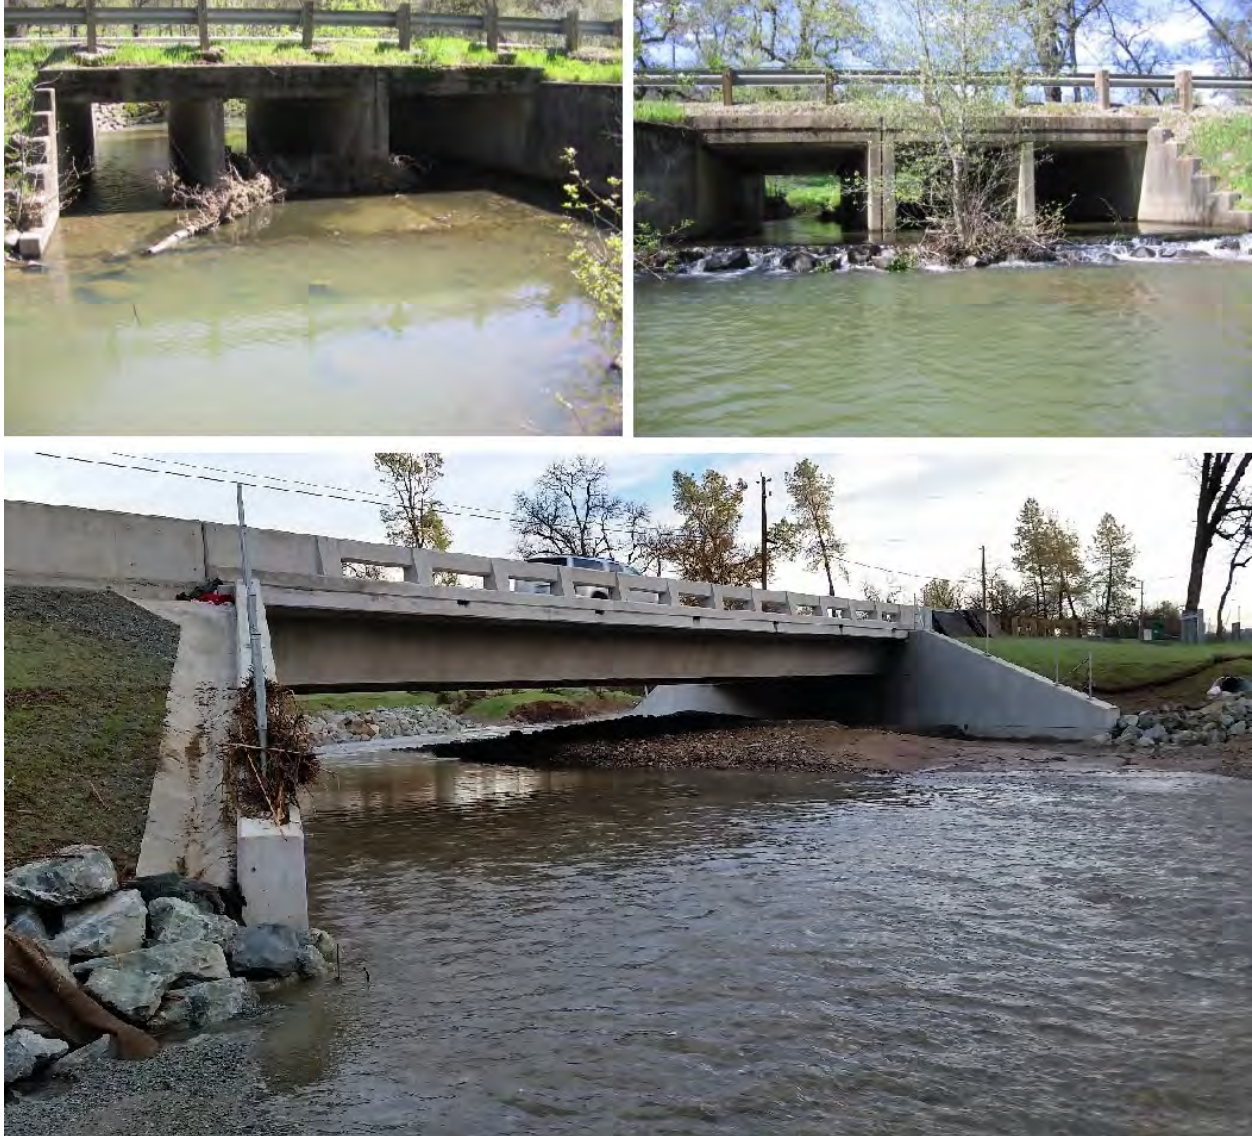
FIGURE 11-1. YANK (LEMM) CREEK CROSSING BEFORE THE BRIDGE CONSTRUCTION (TOP) AND LOOKING DOWNSTREAM AT THE REPLACEMENT BRIDGE IN 2015 (BOTTOM). THE TOP, LEFT PHOTO IS LOOKING DOWNSTREAM AT THE CROSSING AND THE TOP, RIGHT PHOTO IS LOOKING UPSTREAM SHOWING THE PERCHED APRON. NOTE THE HIGH WATER MARK DEBRIS ON THE INLET, LEFT WINGWALL. PHOTOS PROVIDED BY M. MOLINAR, CALTRANS.

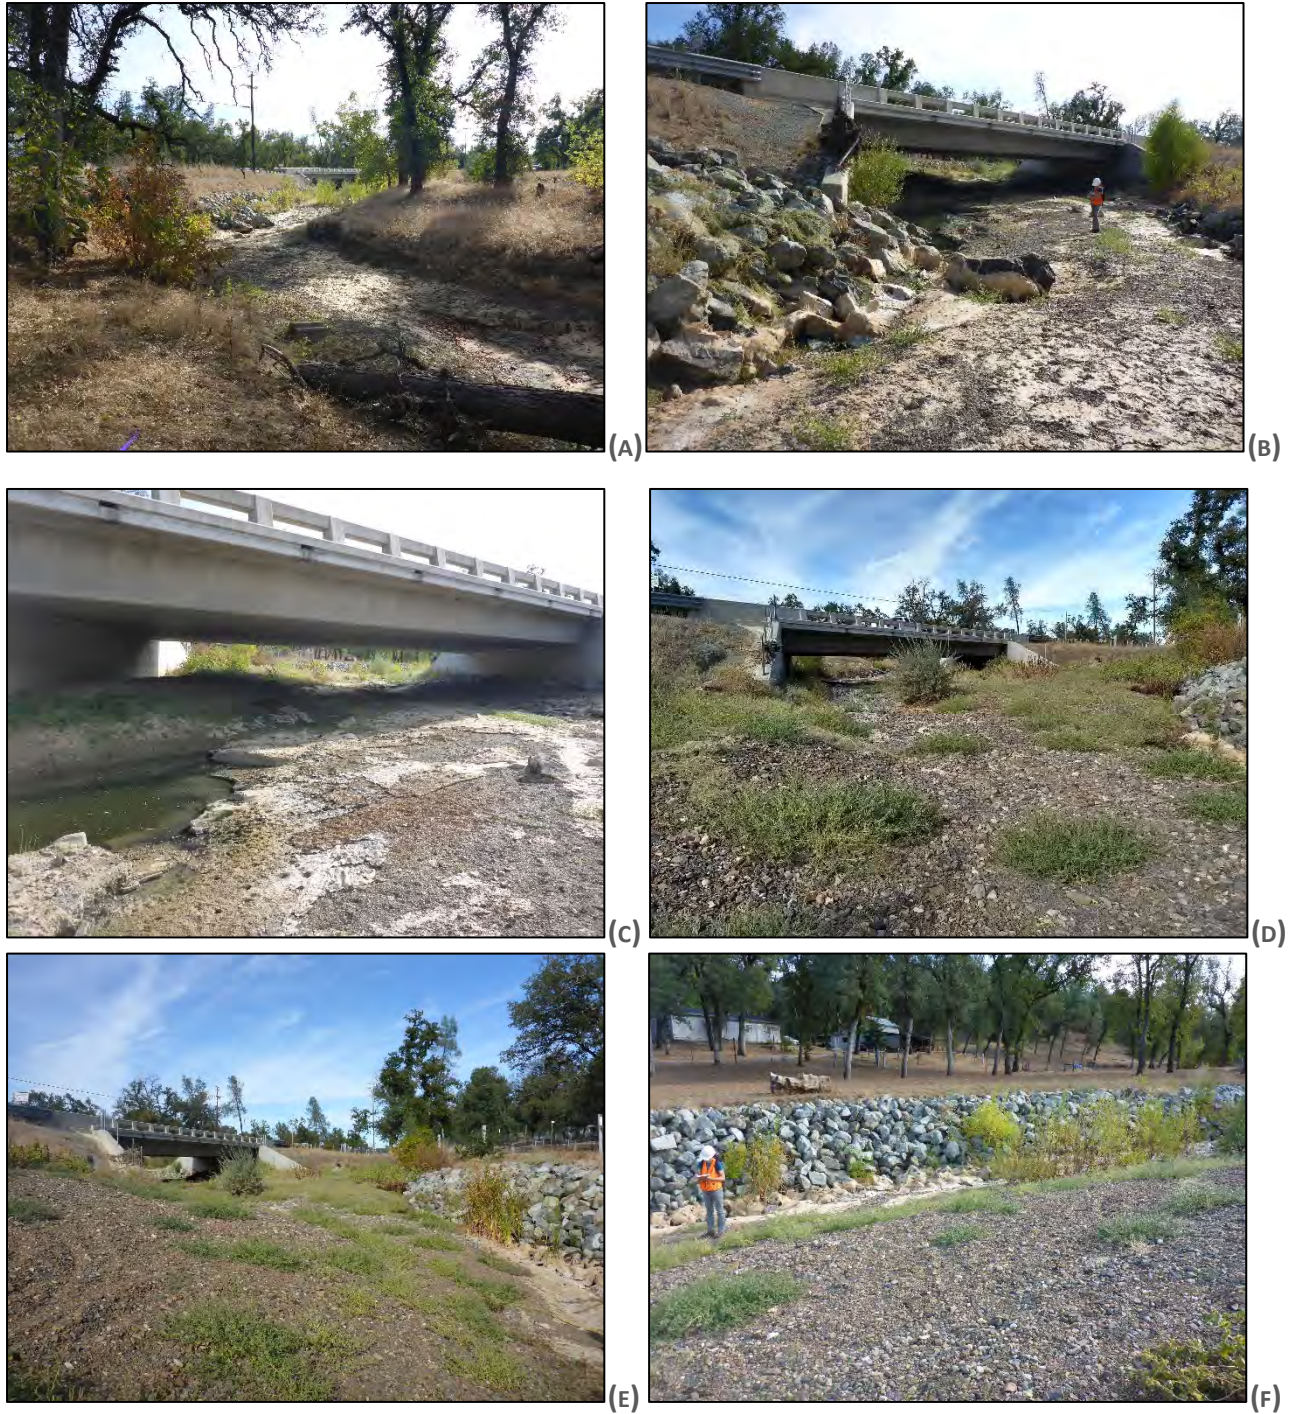
FIGURE 11-2. YANK (LEMM) CREEK (A) UPSTREAM CHANNEL, (B) LOOKING DOWNSTREAM AT THE BRIDGE- NOTE HIGH WATER DEBRIS ON LEFT BANK, (C) CHANNEL UNDER THE BRIDGE SHOWING SKEW FROM LEFT TO RIGHT BANK (D) LOOKING UPSTREAM AT THE BRIDGE – NOTE HIGH WATER DEBRIS ON RIGHT BANK, (E) LOOKING UPSTREAM AT BRIDGE AND 90-DEGREE CHANNEL BEND, AND (F) ARMORED DOWNSTREAM CHANNEL AFTER 90-DEGREE BEND. PHOTOS TAKEN OCT 4, 2019 BY M. LOVE AND M. LANG.

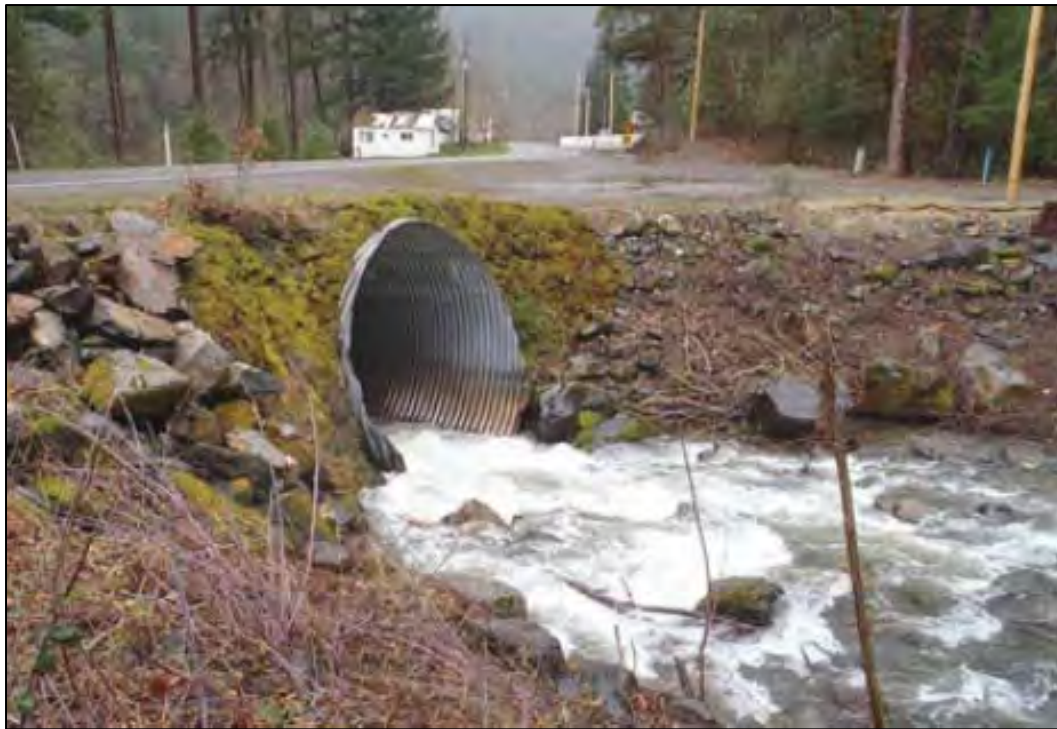
FIGURE 12-1. FORT GOFF CREEK CROSSING BEFORE THE BRIDGE CONSTRUCTION IN 2014. PHOTOS PROVIDED BY CALTRANS.

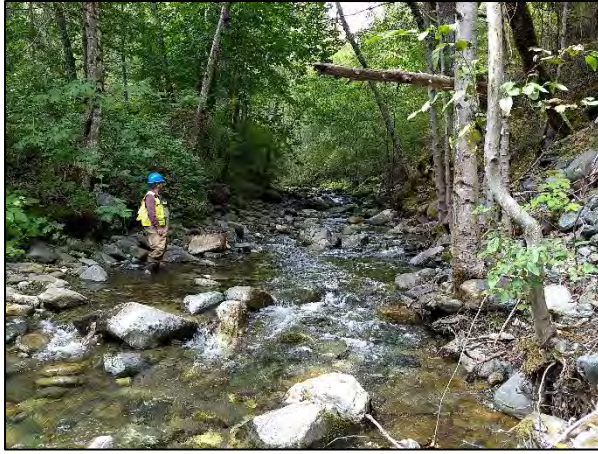
FIGURE 12-2. FORT GOFF CREEK BRIDGE AND STREAMBED FOLLOWING CROSSING REPLACEMENT (A) LOOKING DOWNSTREAM AT BRIDGE AND (B) LOOKING UPSTREAM AT BRIDGE. PHOTOS PROVIDED BY CALTRANS.

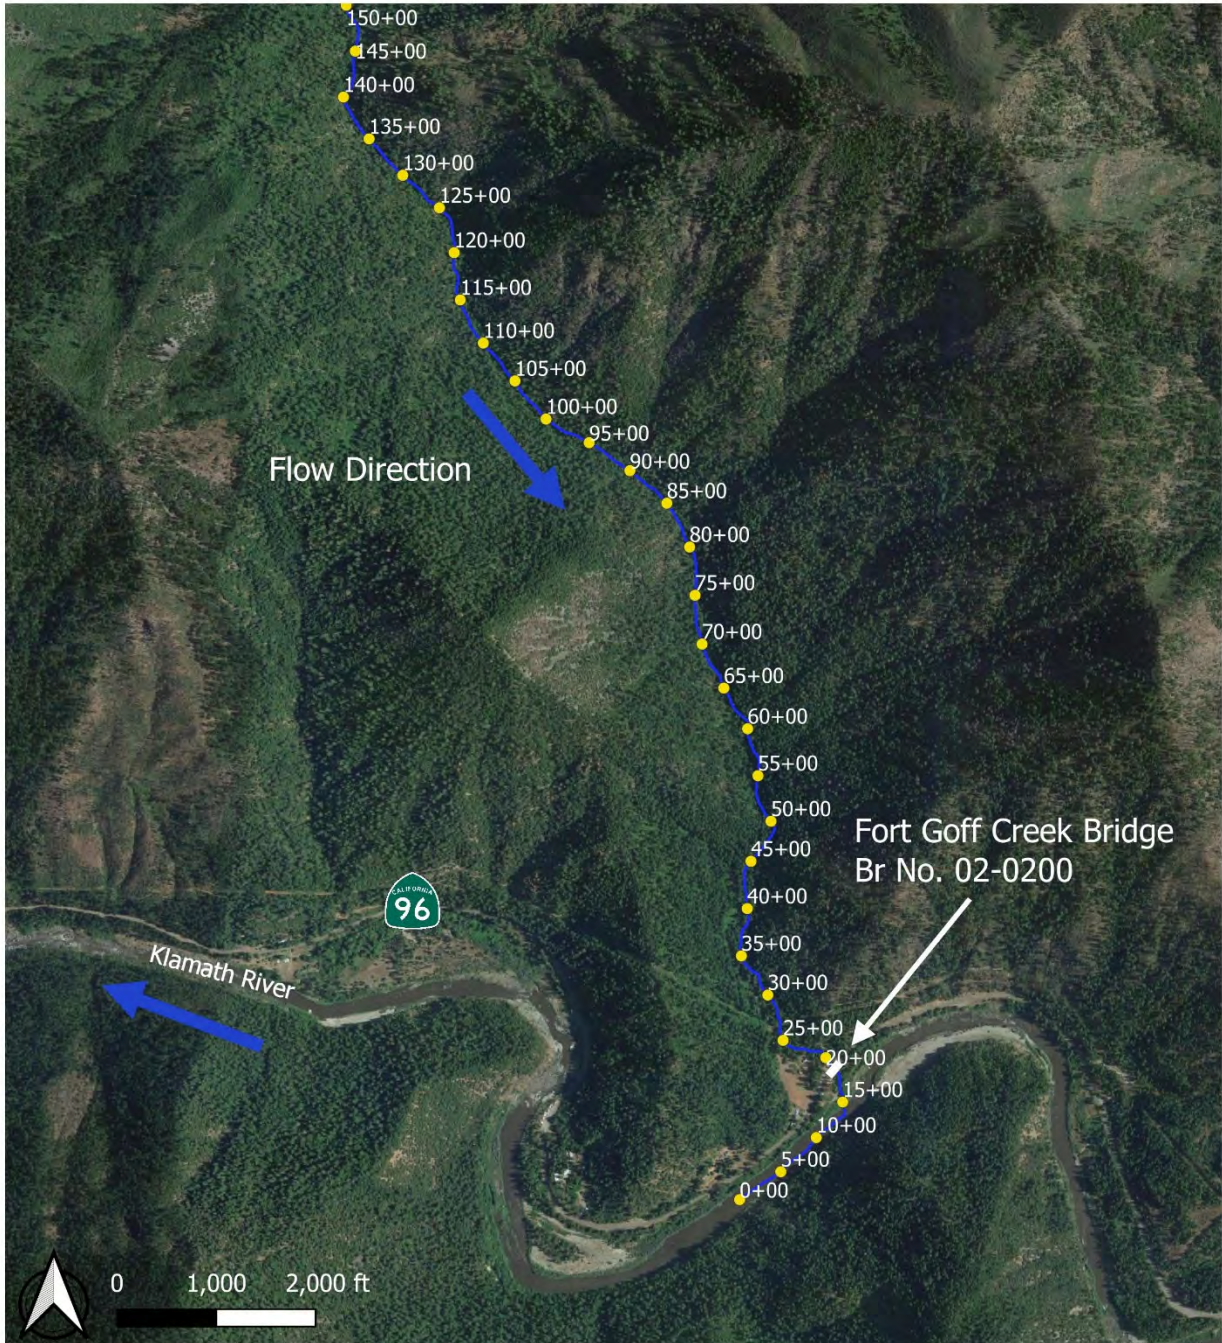
Datums: Horizontal: NAD83 State Plane CA Zone 1	Fort Goff Creek SIS 96 PM 56.0 Site Map and Channel Stationing	Caltrans Design Guidance for Full-Span Crossings Fish Passage Restoration Project
Aerial Image Source: Google 2015		HSU Sponsored Programs Foundation Fish Passage Engineering (S4085)
