FISH PASSAGE ENGINEERING PROJECT

Site Analysis Final Report

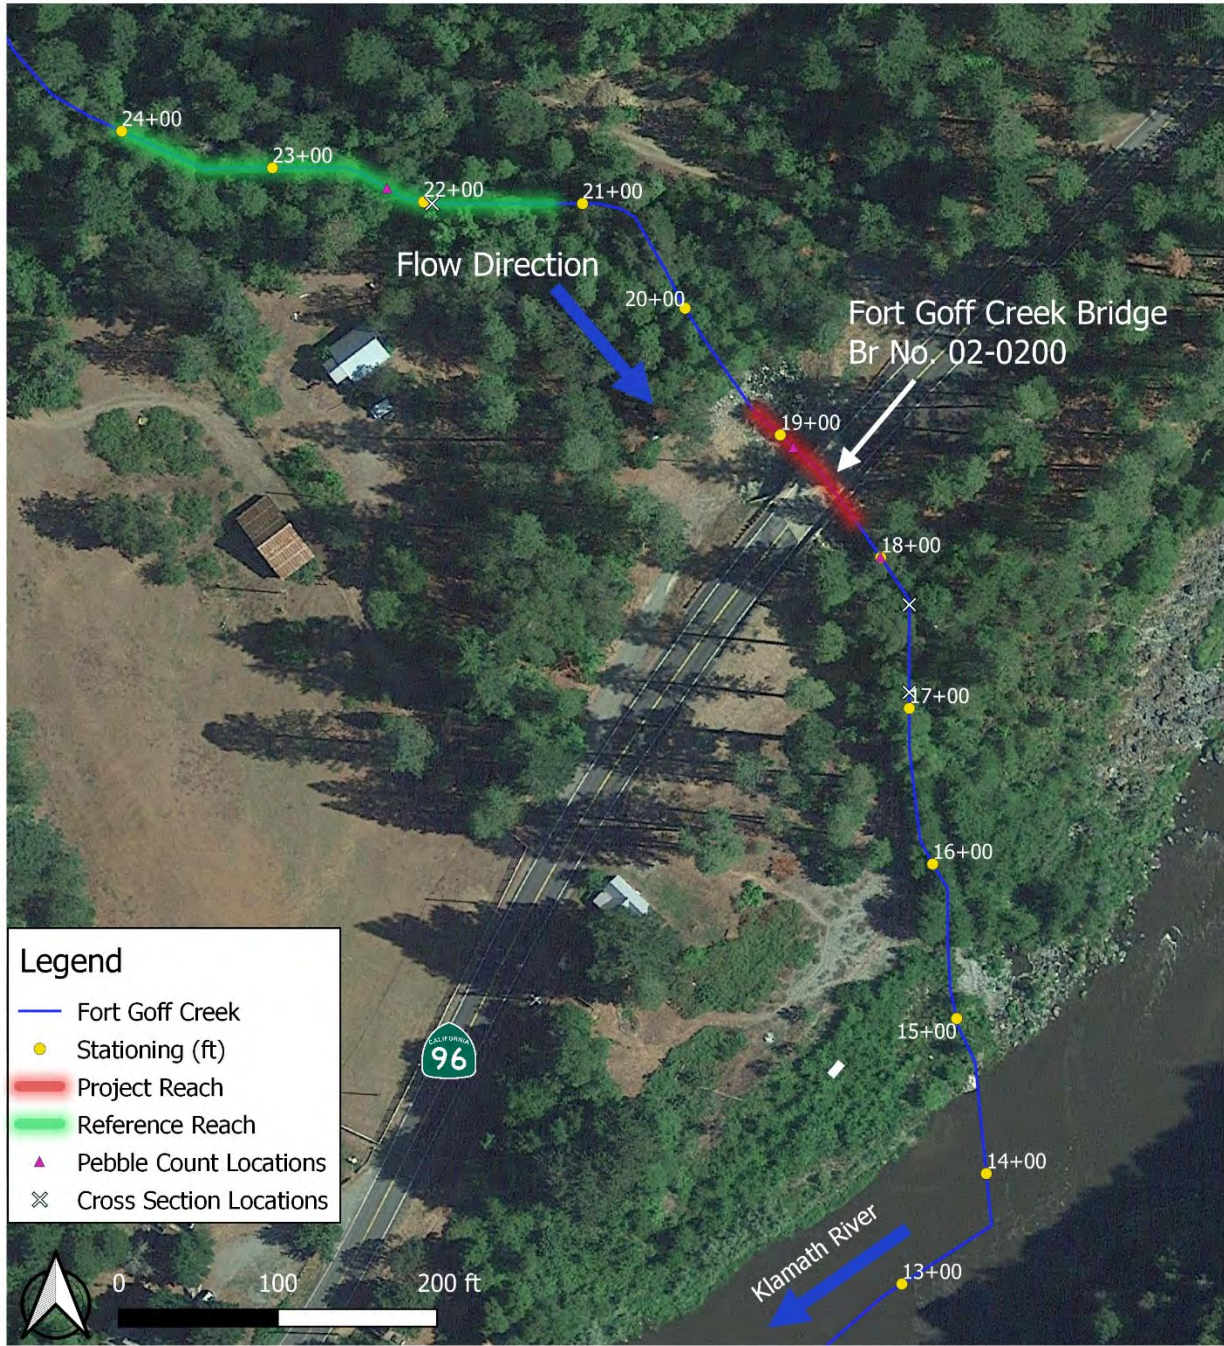
<p>Datums: Horizontal: NAD83 State Plane CA Zone 1</p>	<p>Fort Goff Creek SIS 96 PM 56.0</p> <p>Site Map and Channel Stationing Project Area</p>	<p>Caltrans Design Guidance for Full-Span Crossings Fish Passage Restoration Project</p>
<p>Aerial Image Source: Google 2015</p>		<p>HSU Sponsored Programs Foundation Fish Passage Engineering (S4085)</p>

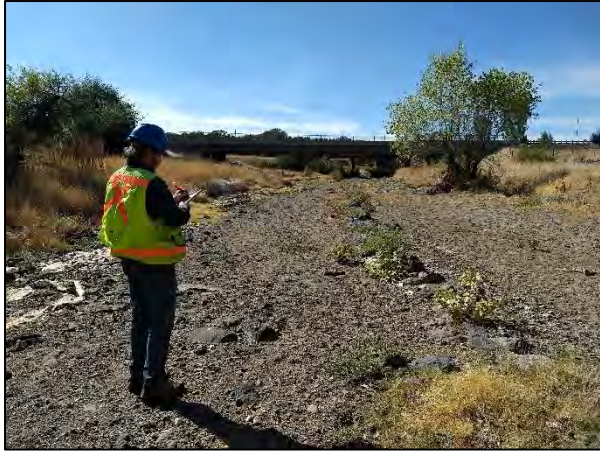
The site experiences only seasonal, intermittent flow and forms isolated pool as the it dries out. A large pool at the downstream end of the rock weir fishway has previously stranded fish and required rescue of fall-run juvenile chinook (Pers. Comm. D. Killam CDFW). High flow and dropping flow observations are recommended to confirm that the weirs continue to function over the range of flows intended as the rock locations and porosity vary.

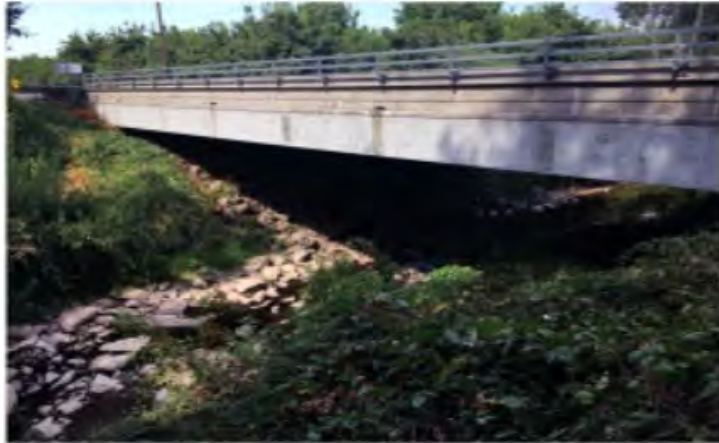
Looking Upstream at Bridge Outlet Post-Remediation. Photo taken on 09/12/2018 and courtesy of PSMFC.

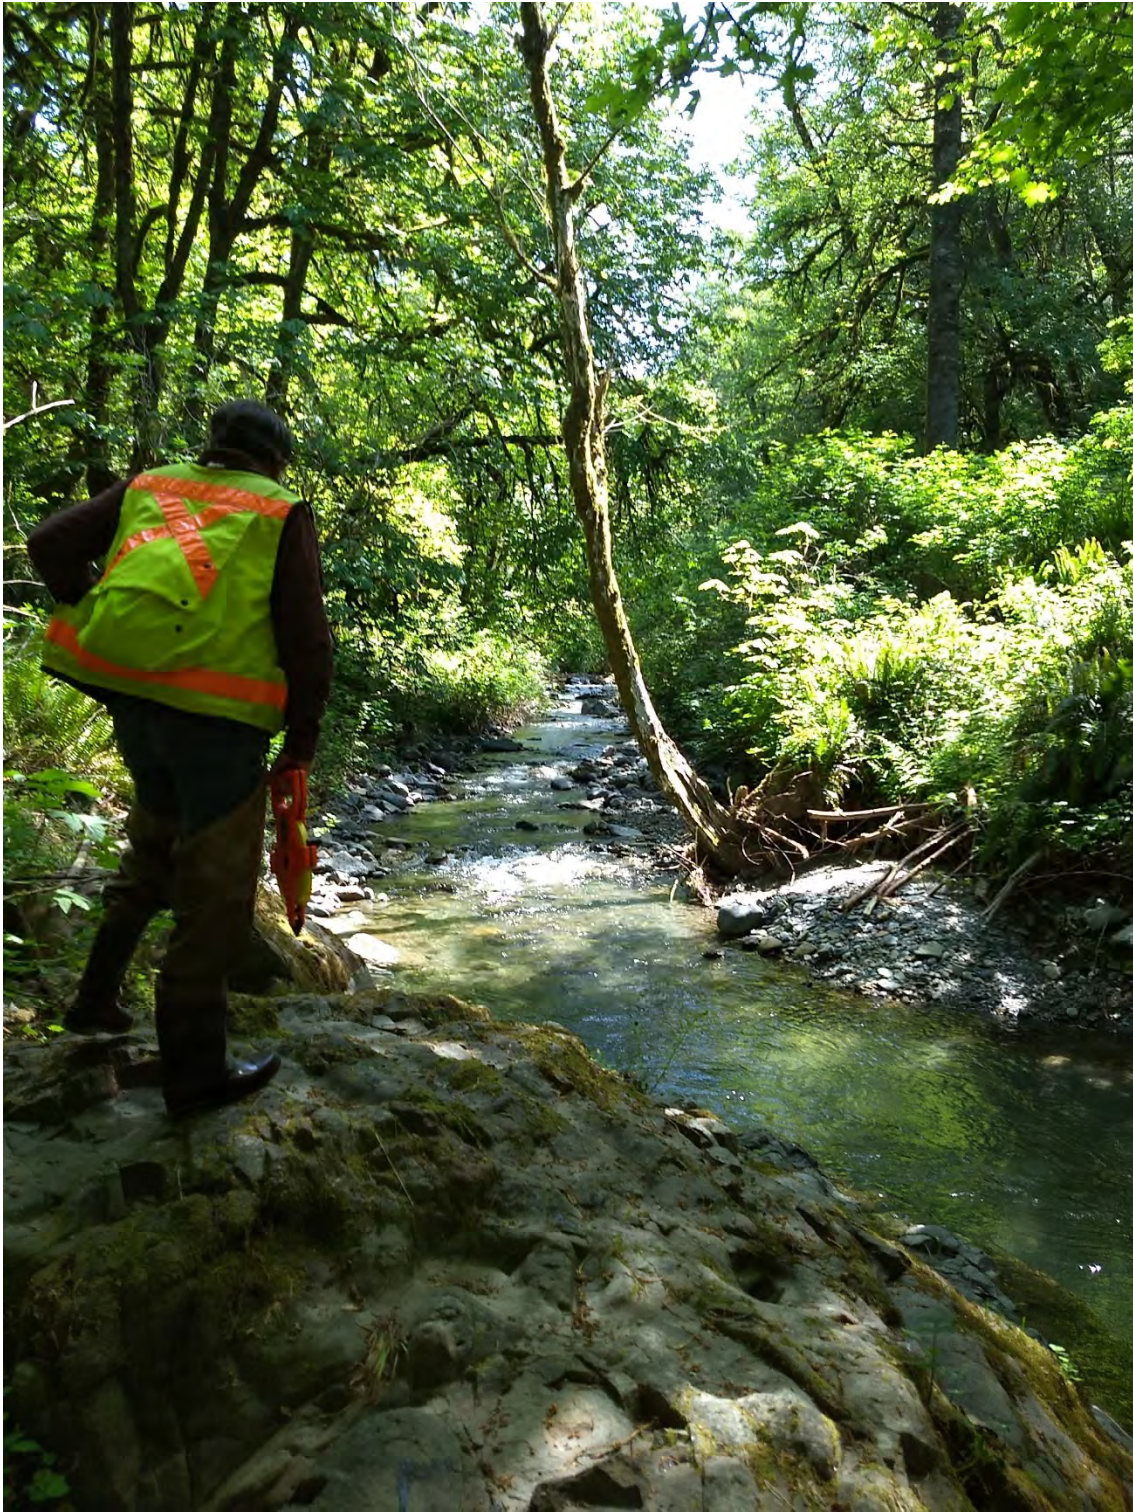
Figure 7. Possible reference reach upstream of project site.

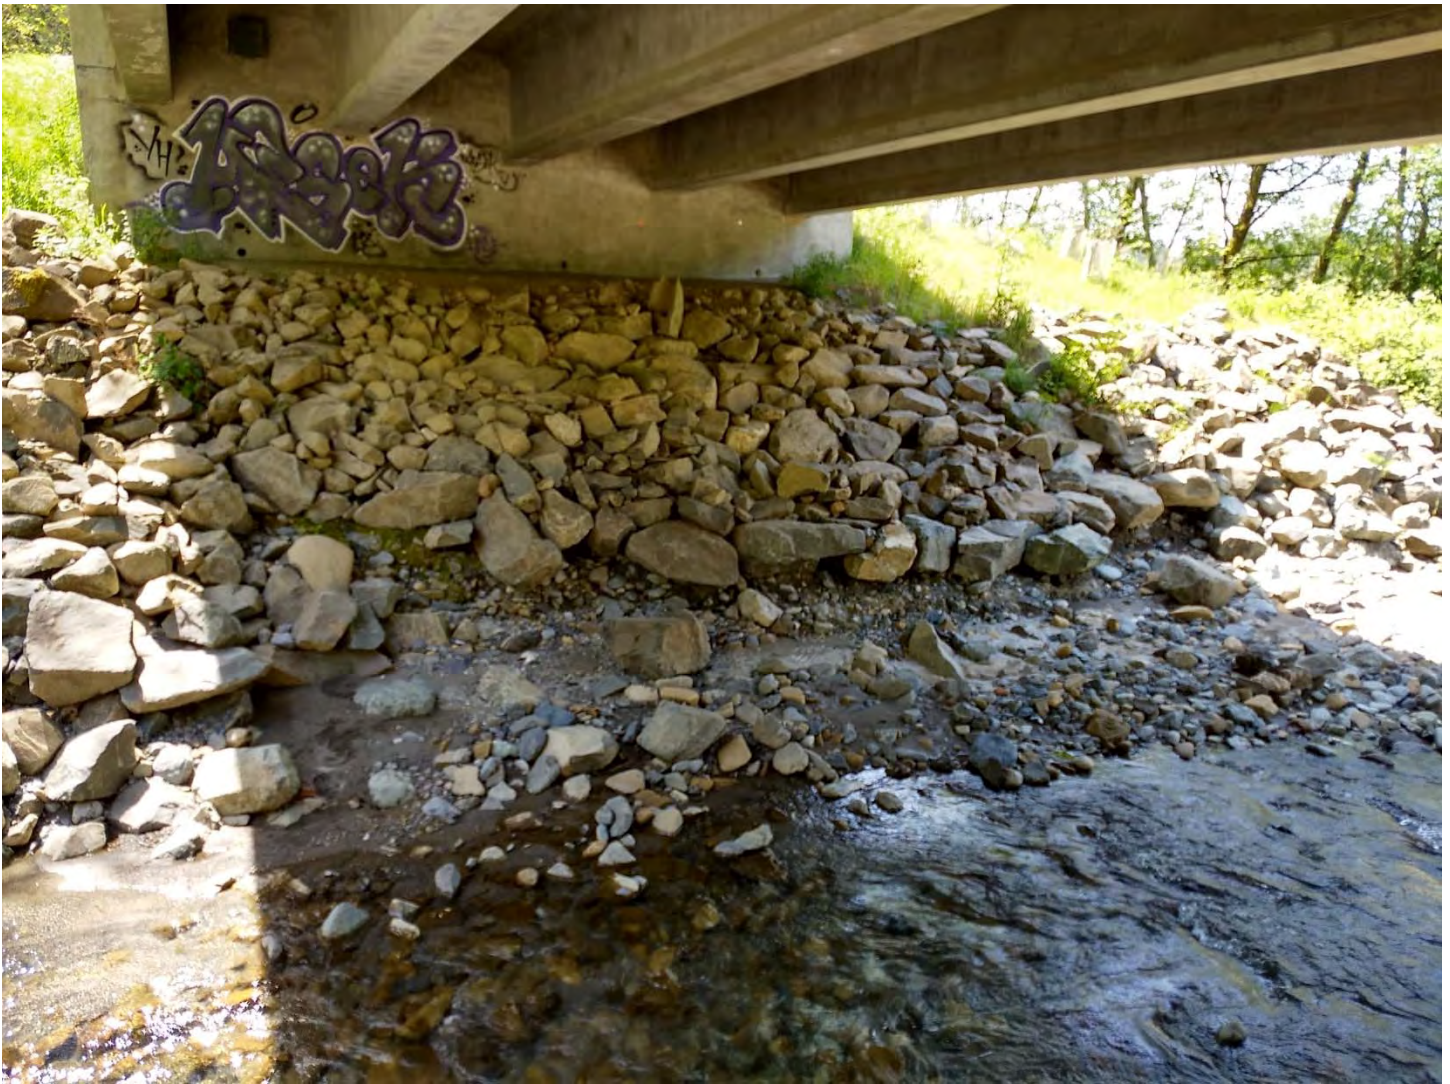
Figure 5. Left bank erosion of rip rap toe. Lowest rock appears to be missing.

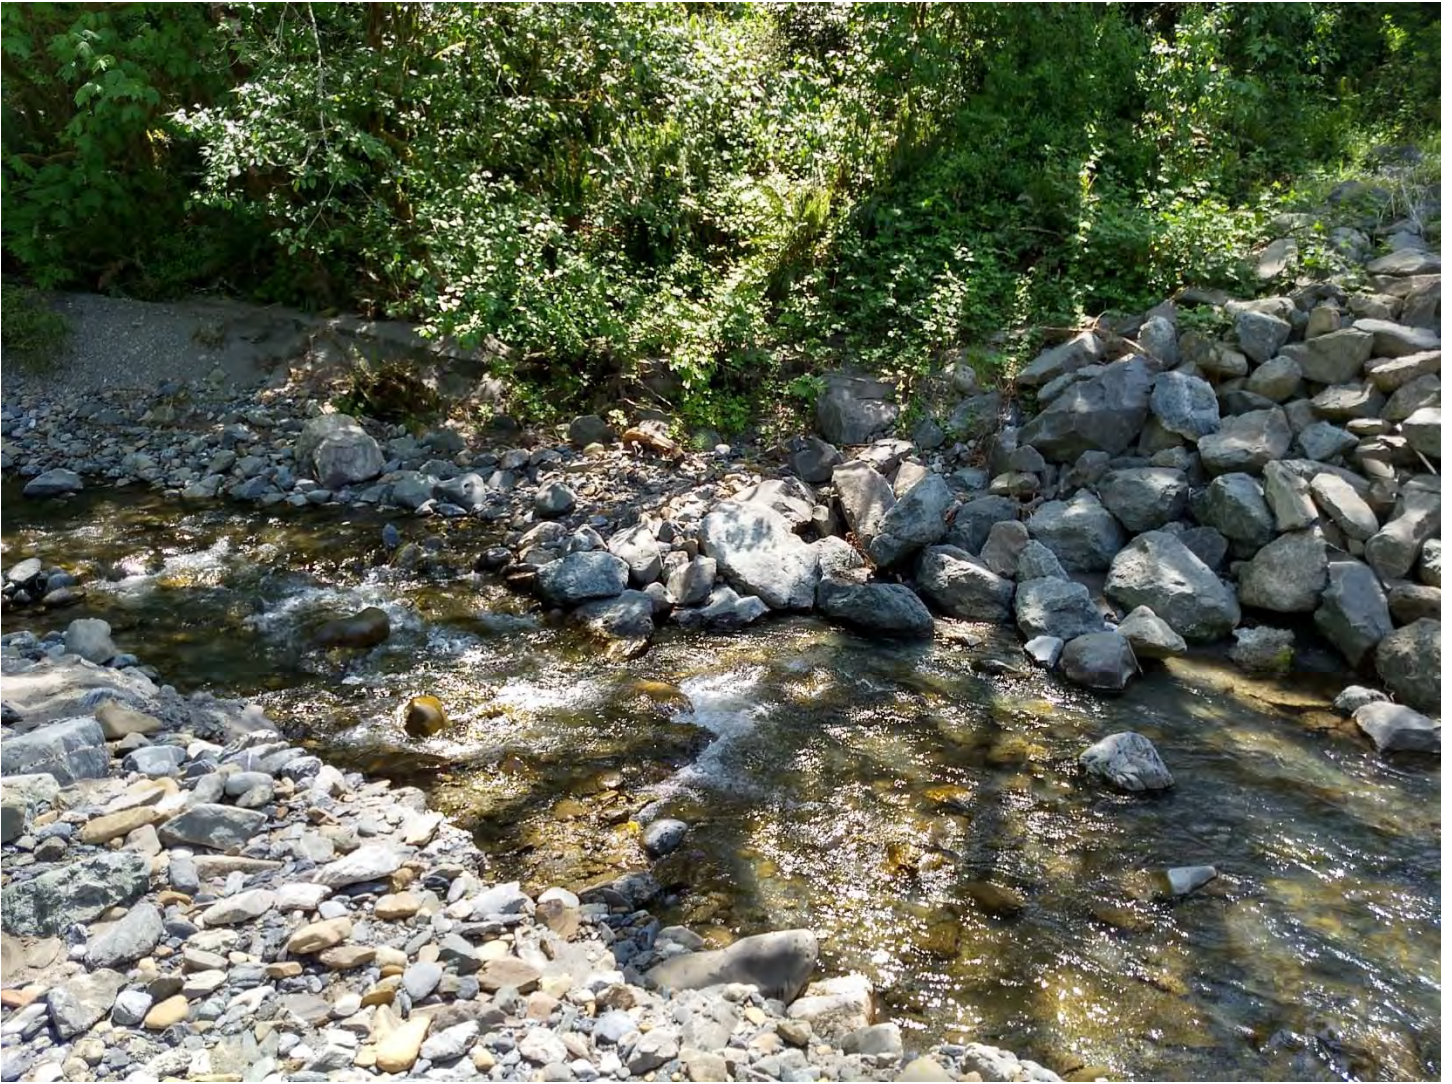
Figure 6. Missing/eroded rock weir grade control at upstream end of project site. Fish passage conditions are not compromised by the missing rock weirs.

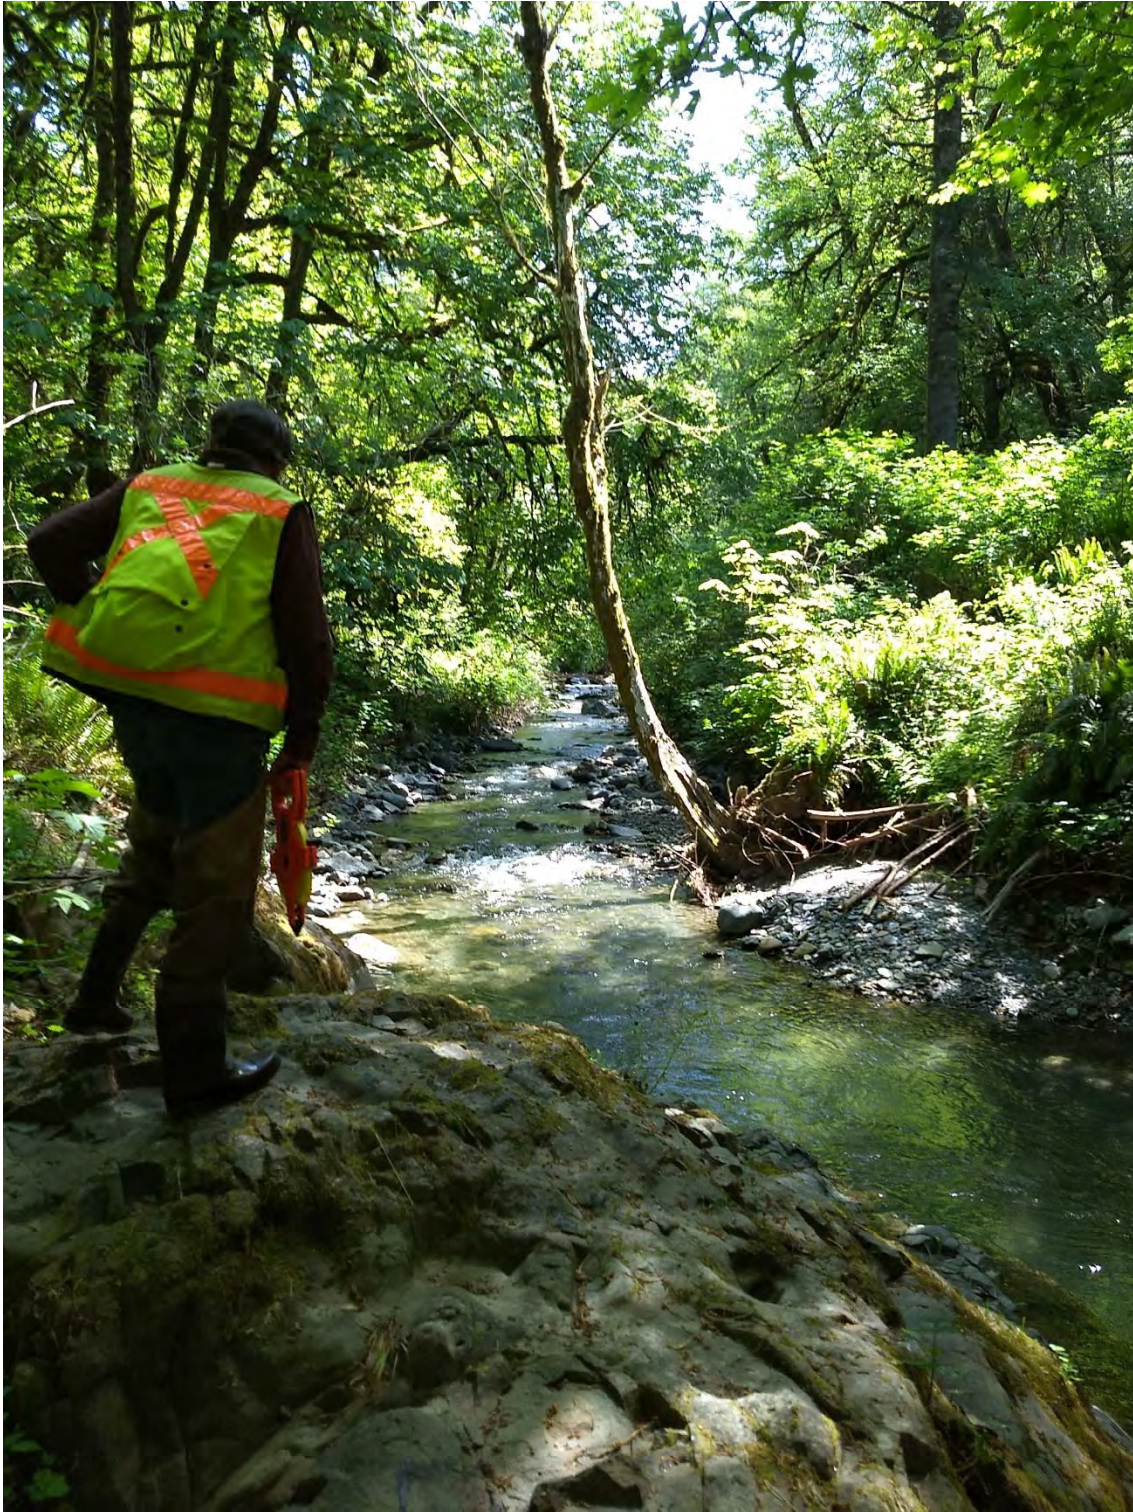
Figure 7. Possible reference reach upstream of project site.

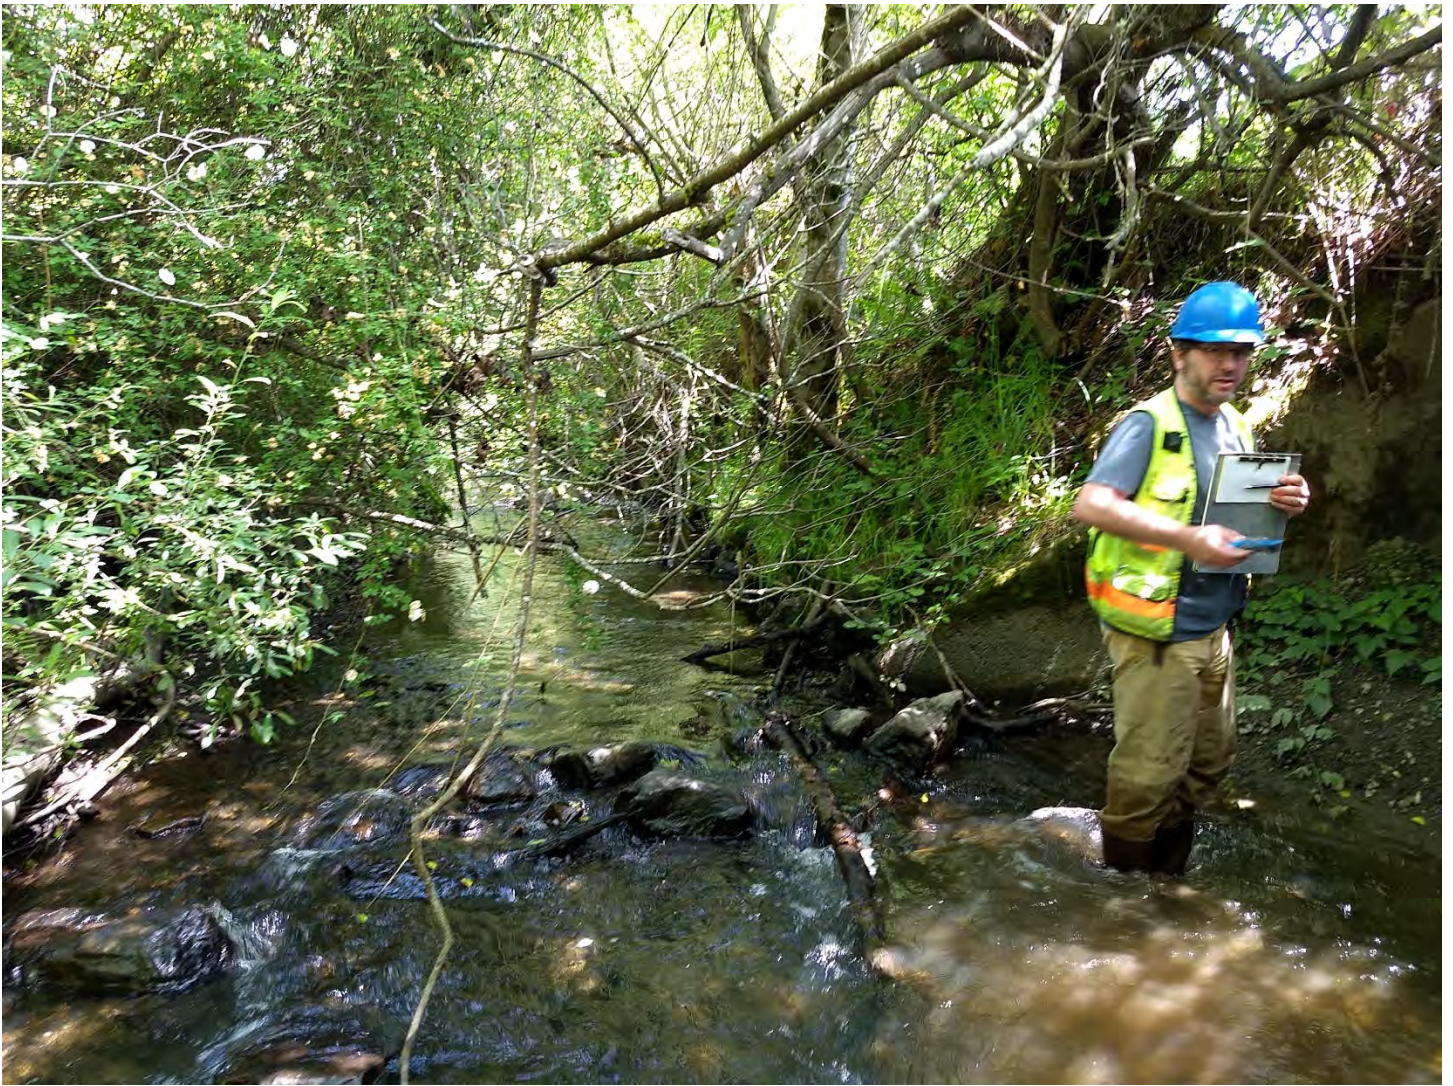
Figure 7. Upstream channel above the HUM299 Hall Creek bridge right at the confluence of Hall Creek (left) and a channel draining the ranch to the east. Photo taken by M. Lang June 6, 2020.

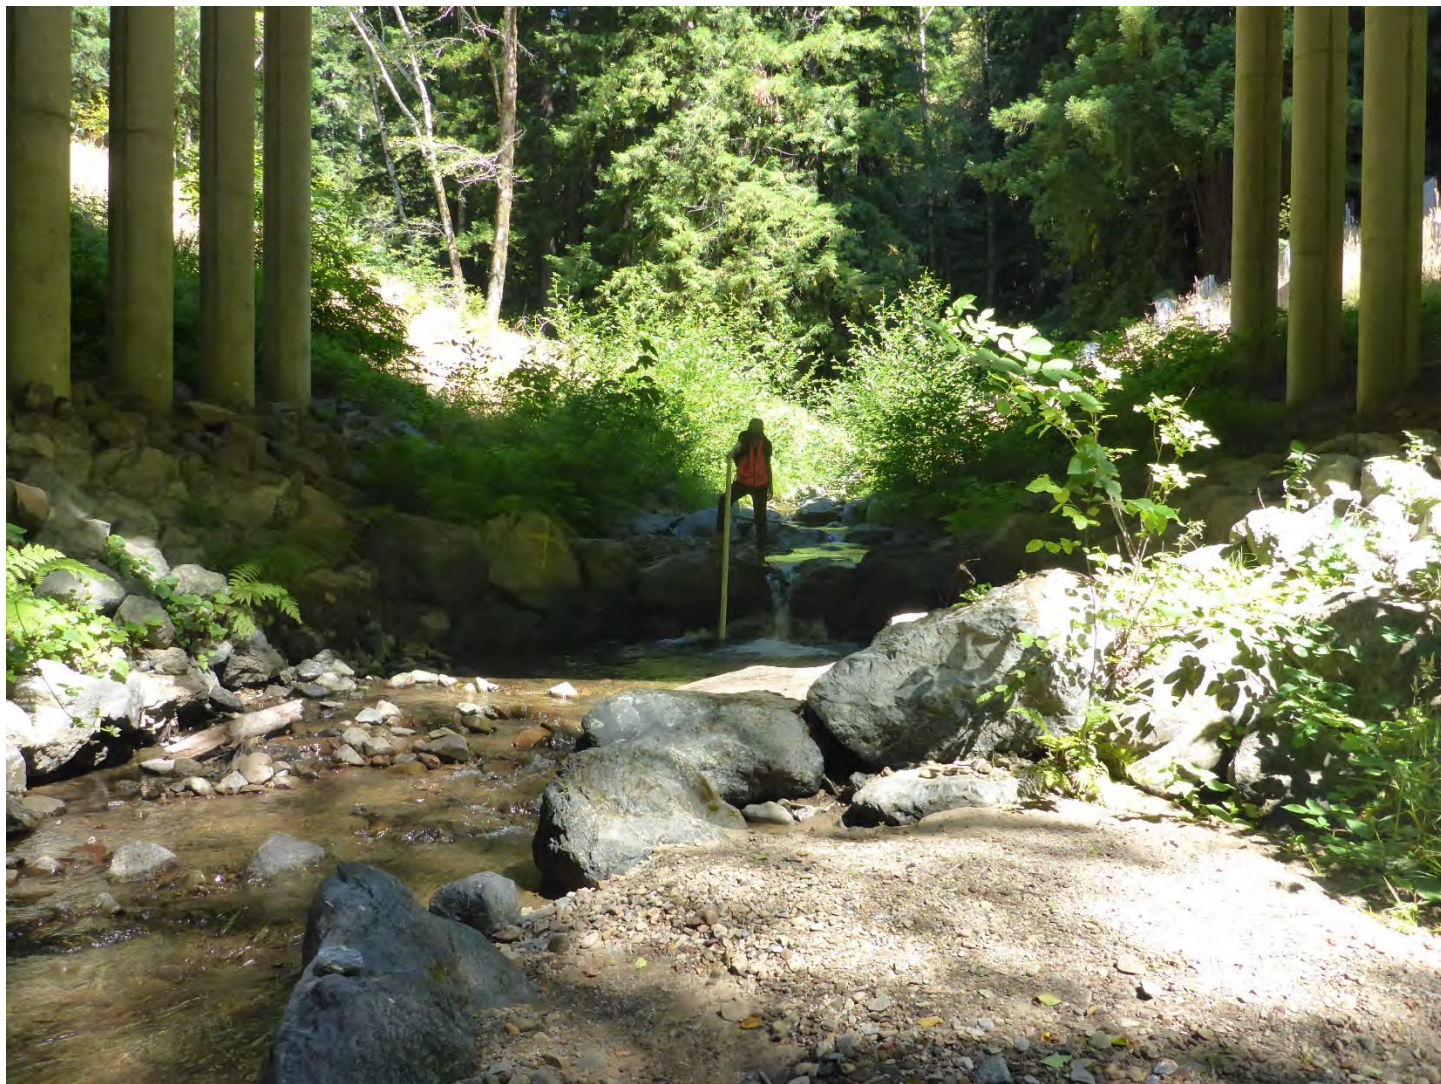
Figure 1. Most downstream rock weir that has failed is in foreground. The next weir is currently in place but now has a 1.8 ft elevation drop at low flow. Photo by Michael Love on 7/17/2019.

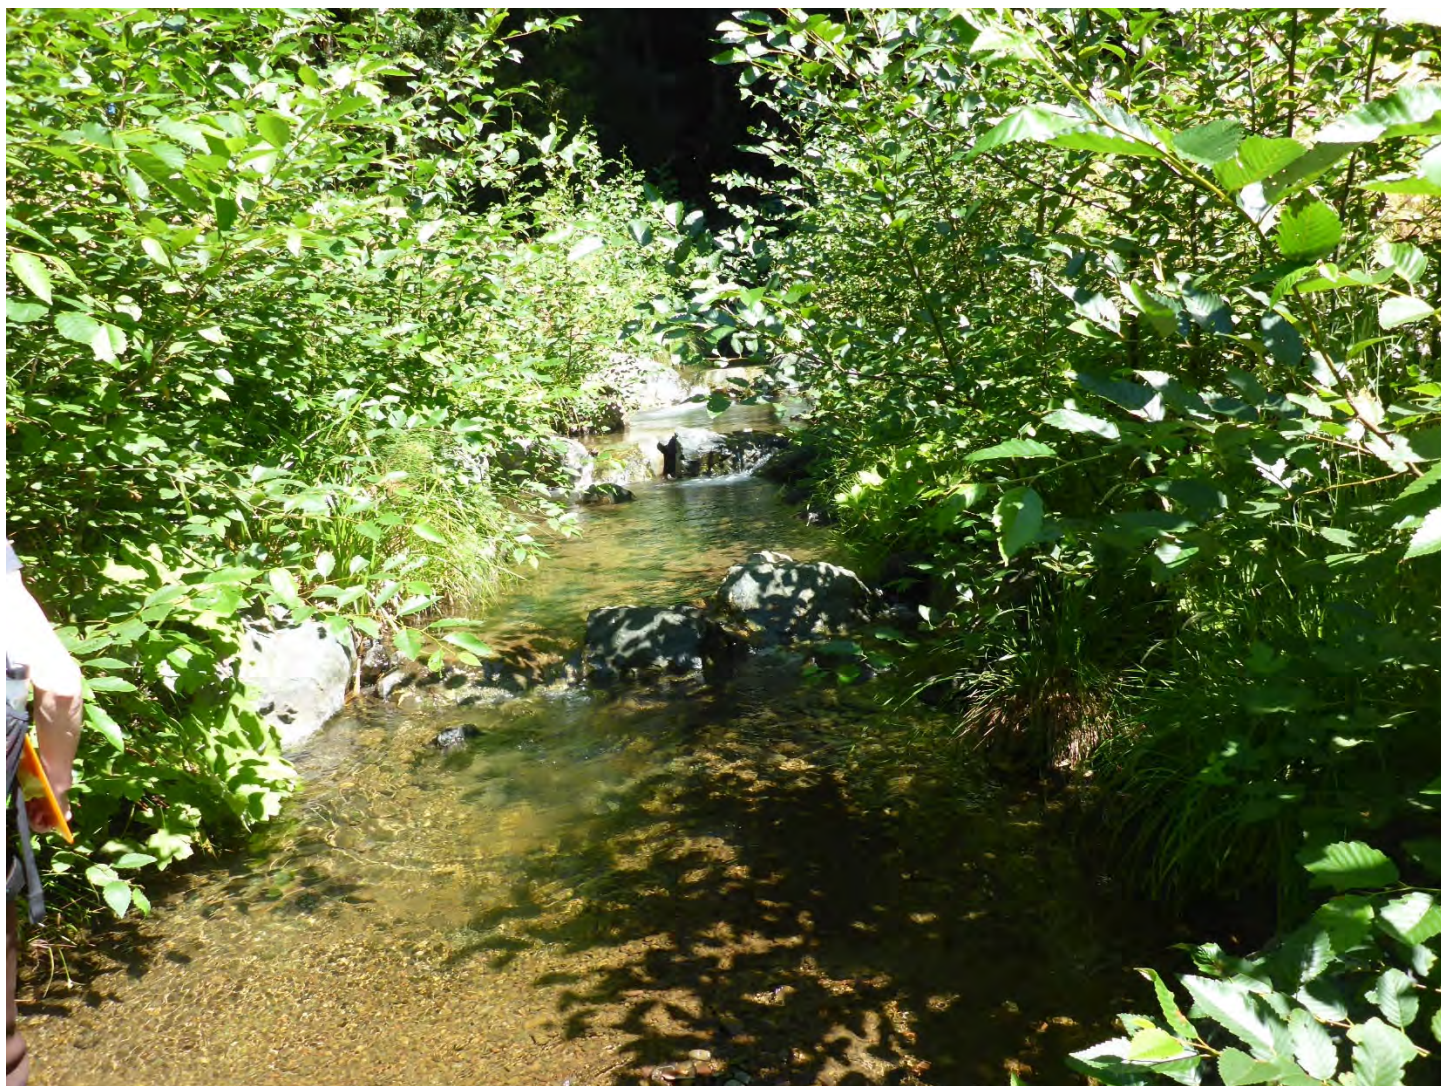
Figure 2. Upstream rock weirs with deep plunge pools. Photo by Michael Love on 7/17/2019.

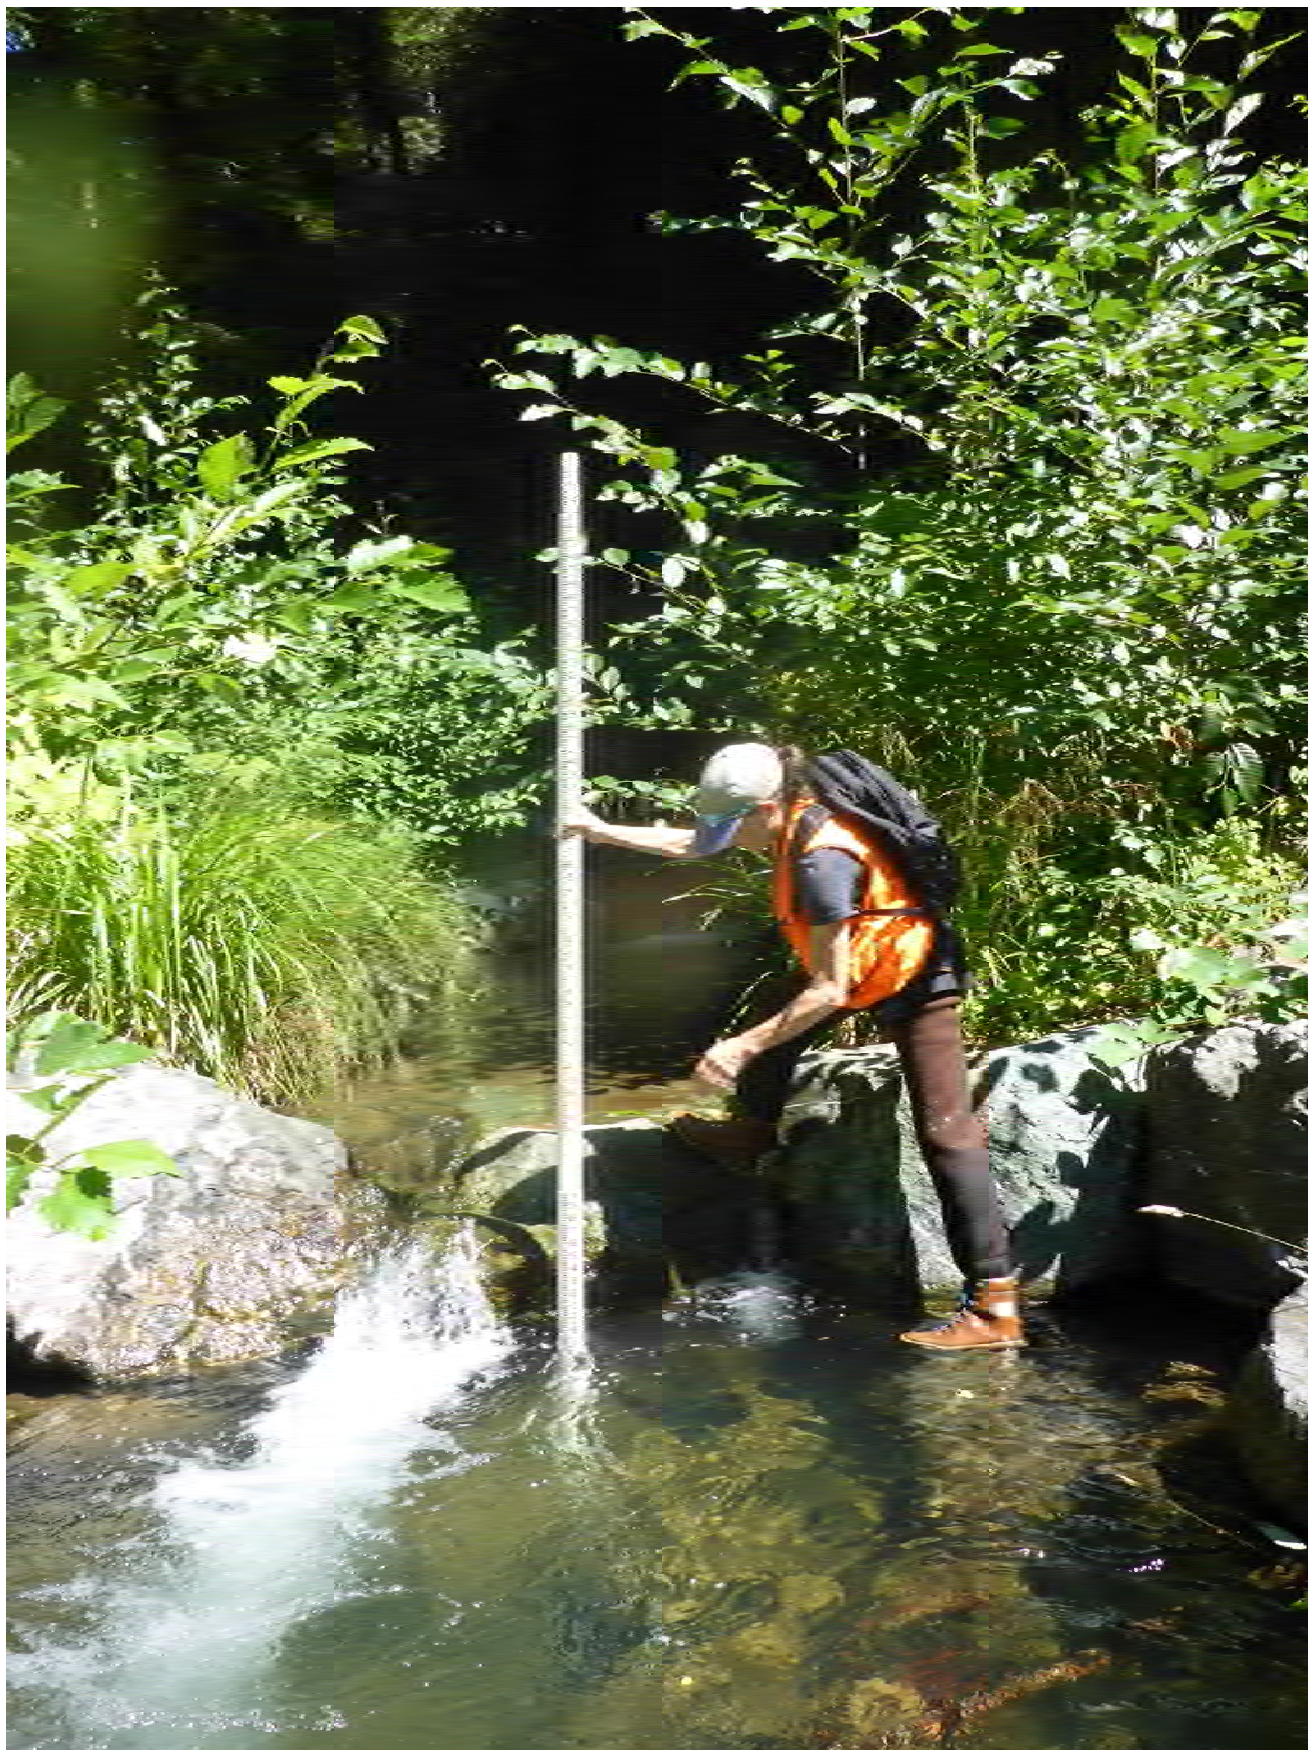
Figure 3. Upstream rock weir with deep plunge pool exposing foundation rock. Photo by Michael Love on 7/17/2019.

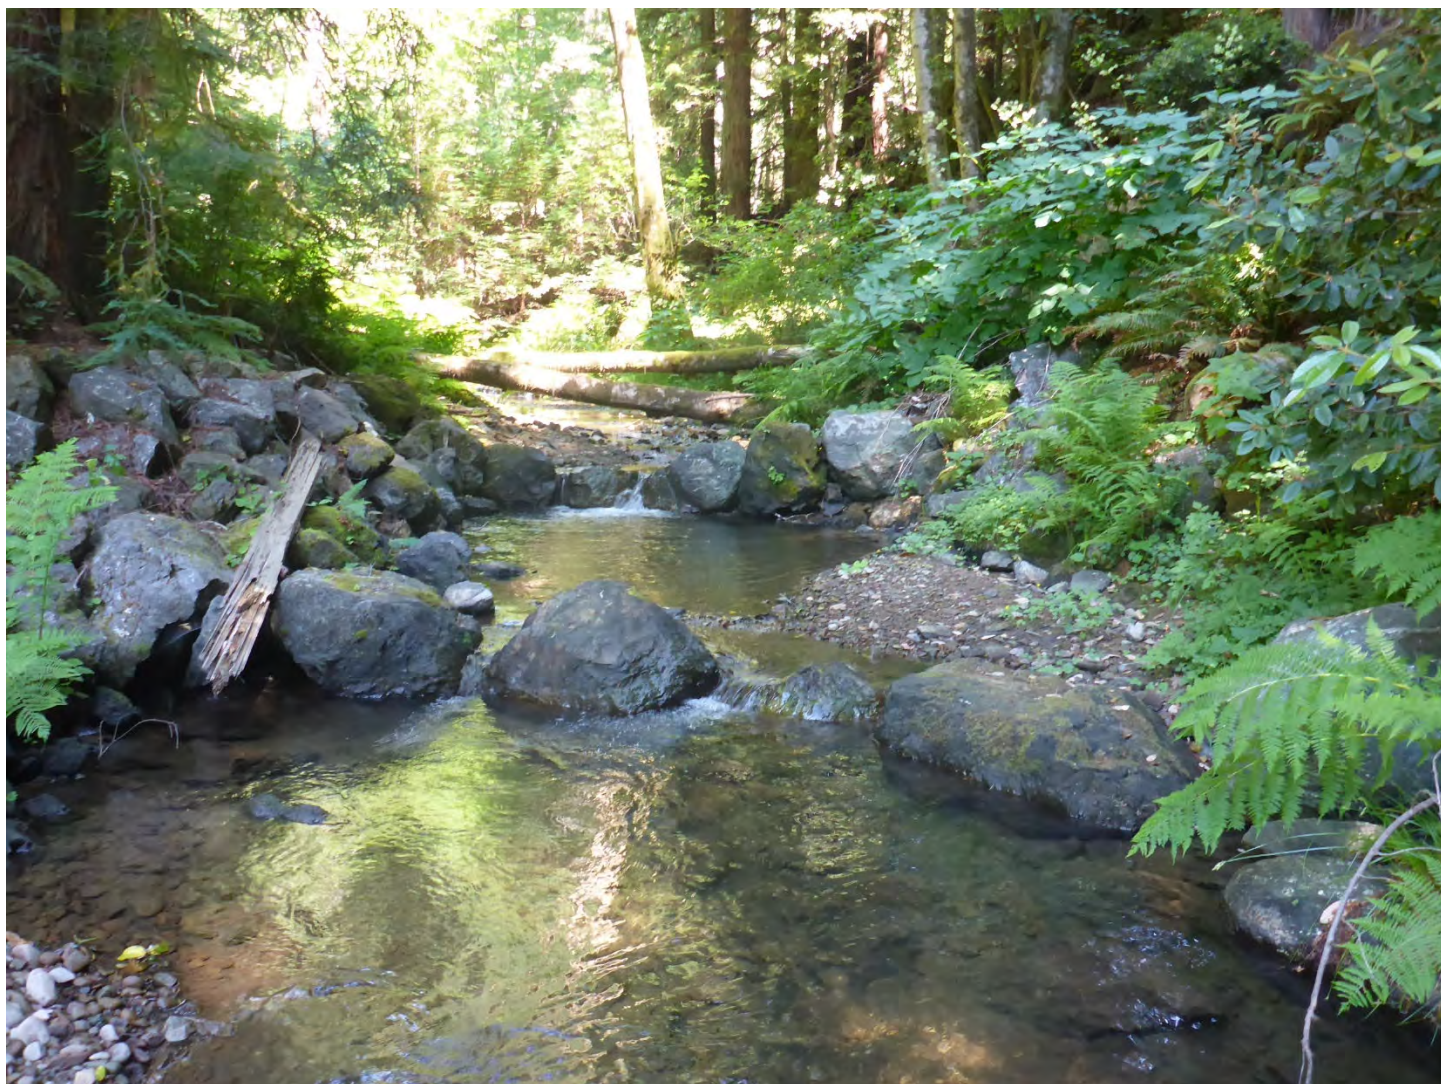
Figure 4. The two most upstream weirs in wider, lower gradient channel region and without the deep plunge pools.
Photo by Michael Love on 7/17/2019.

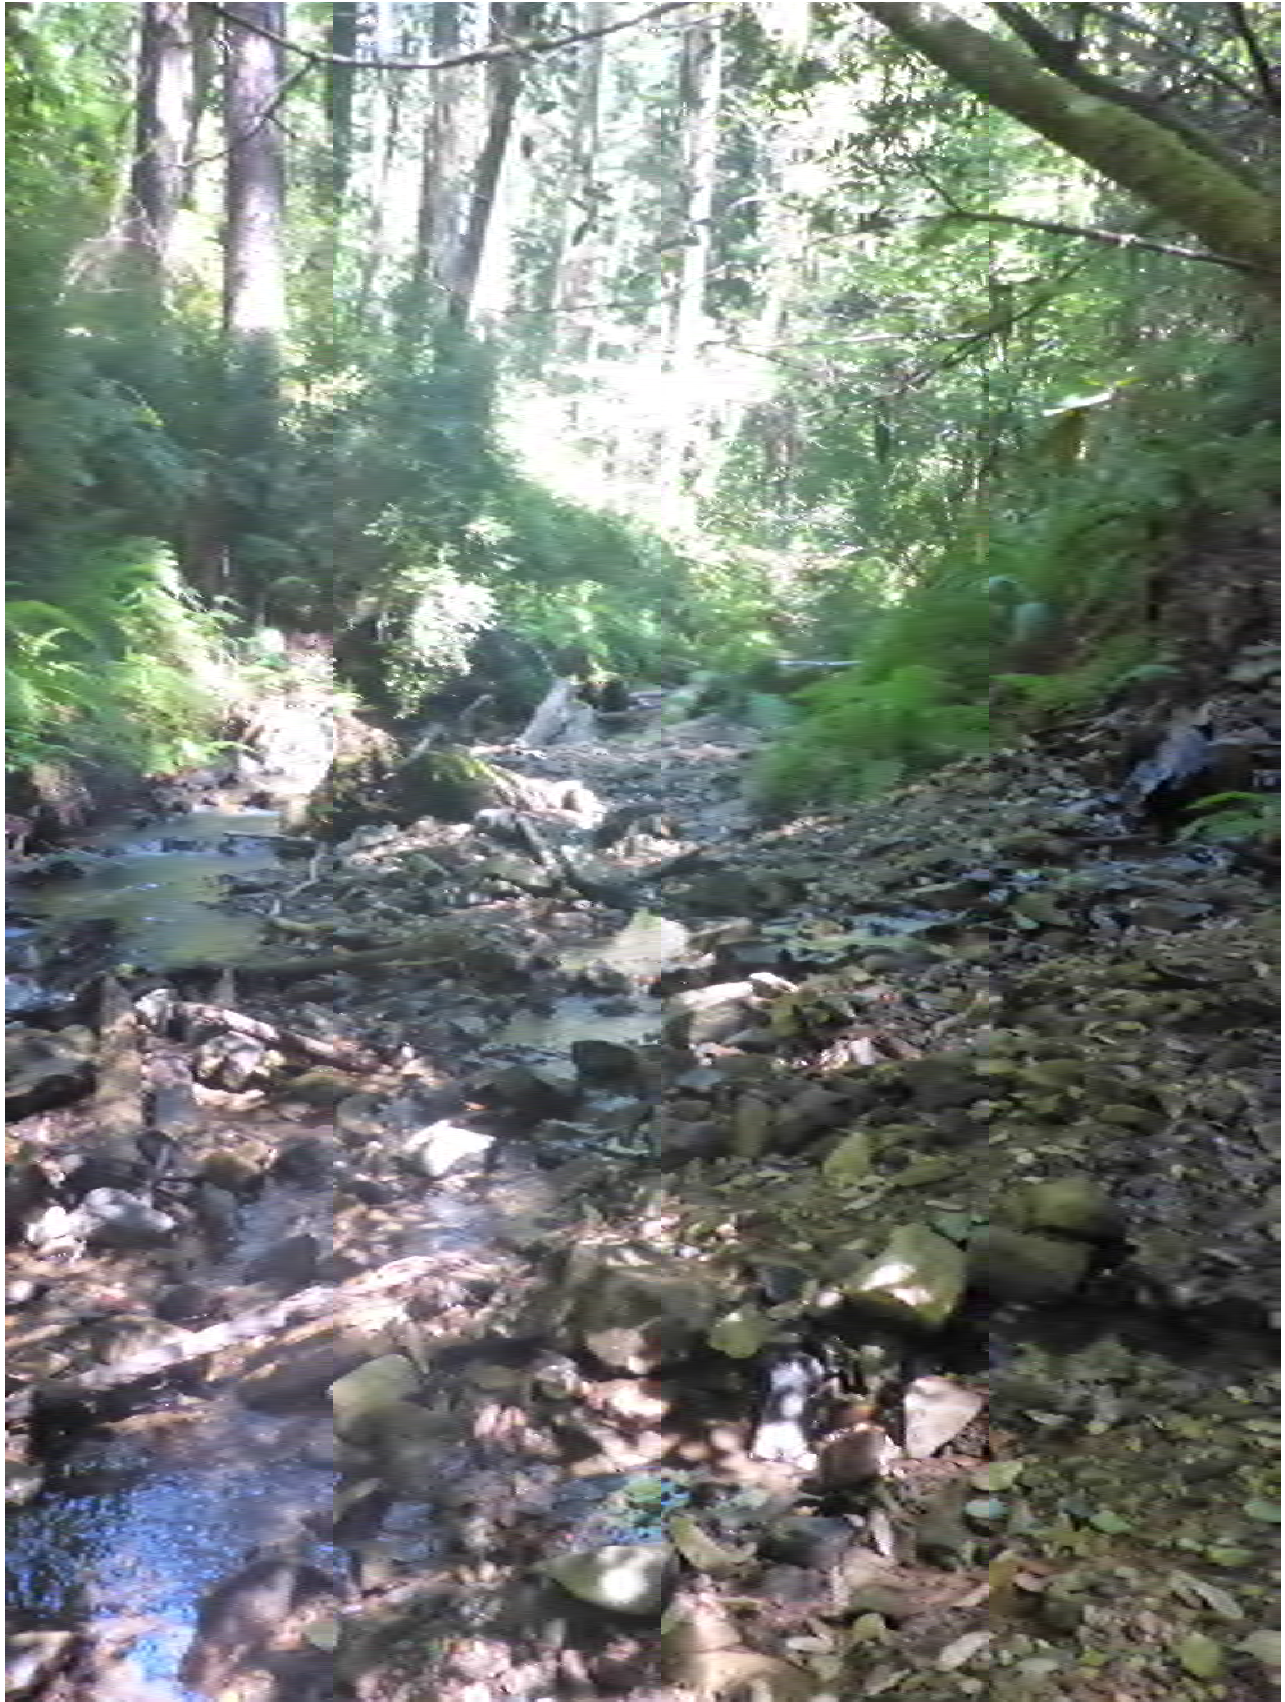
Figure 6. Channel upstream and out of project area to be used as a reference reach. Photo by Michael Love on 7/17/2019.

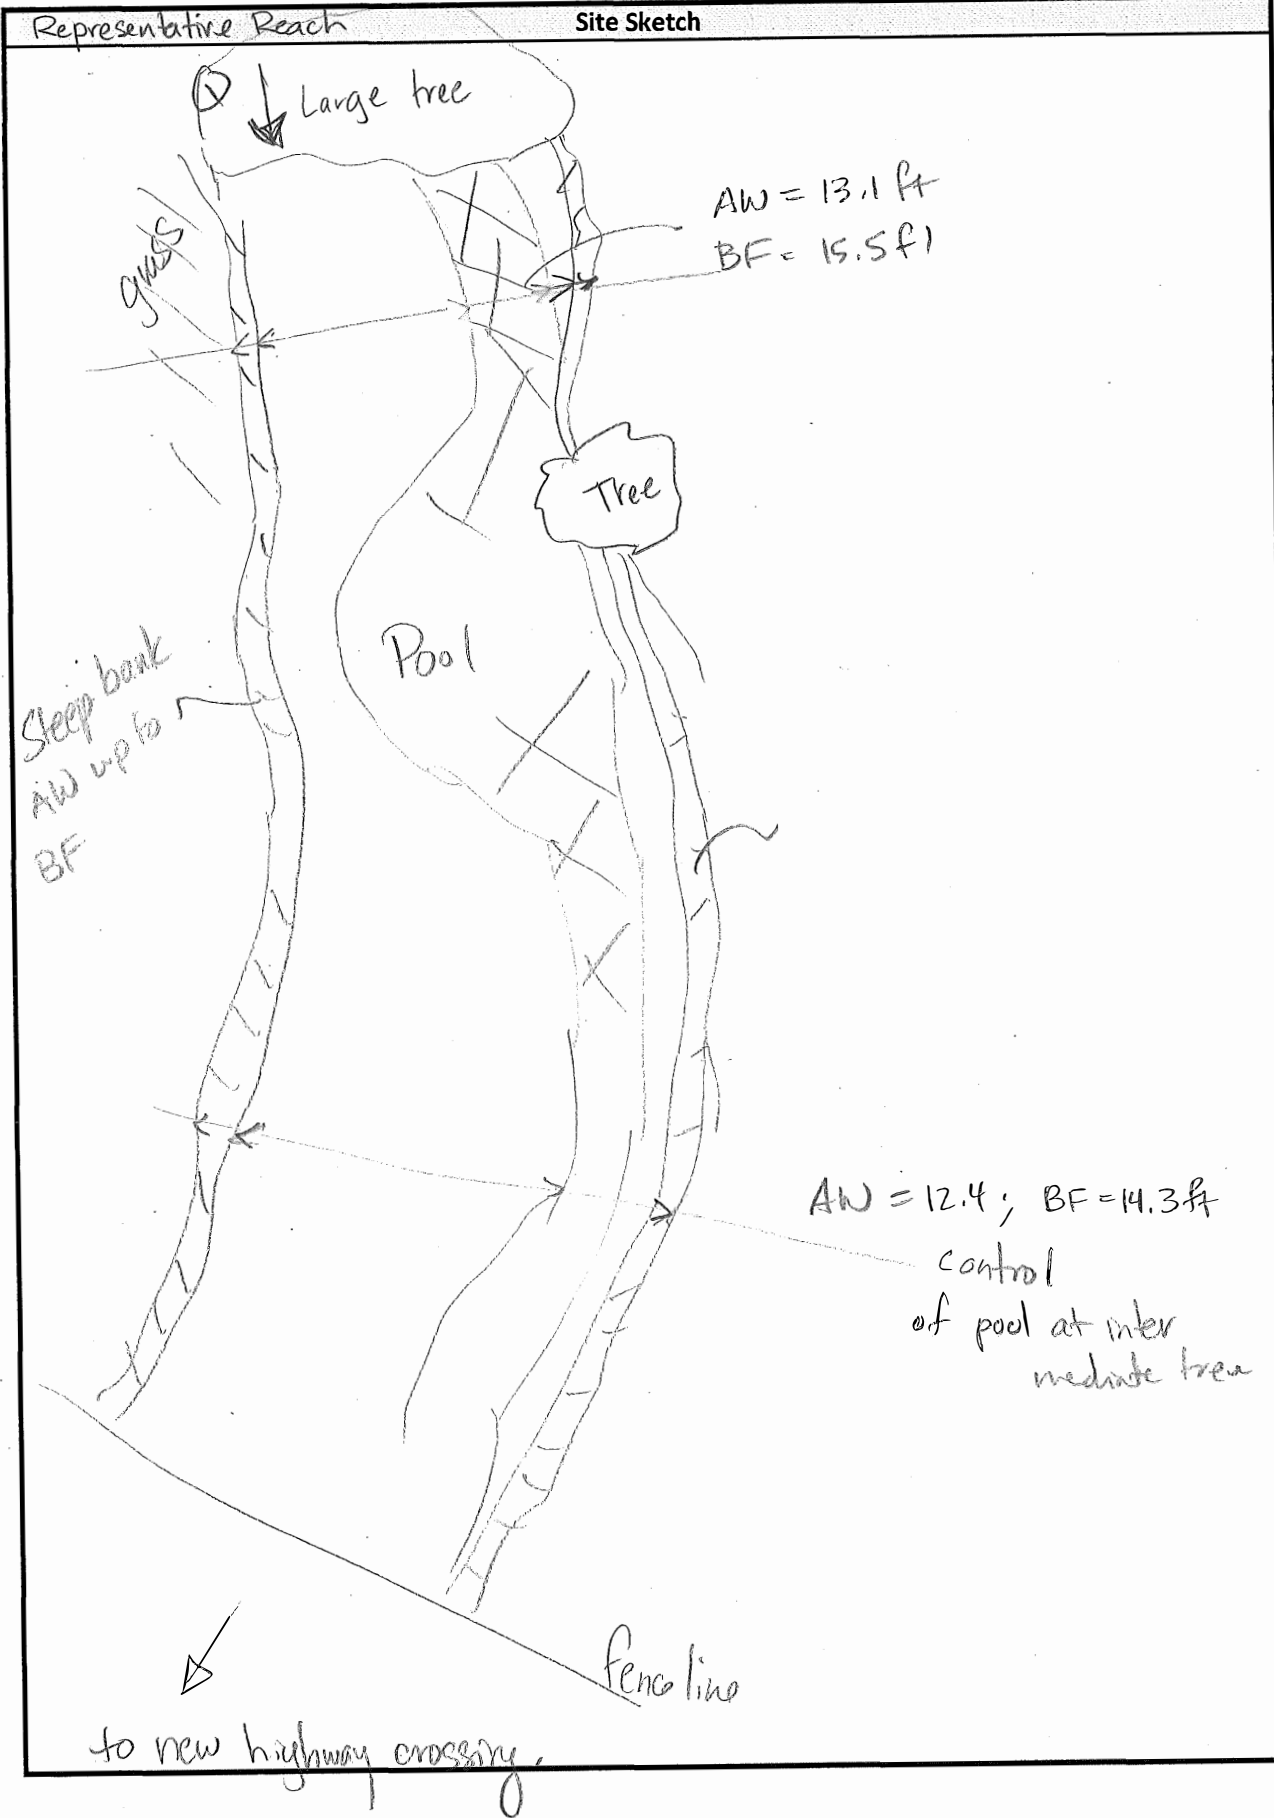
Pebble counts US, in project and in representative reach.
