FISH PASSAGE ENGINEERING PROJECT

Site Analysis Final Report

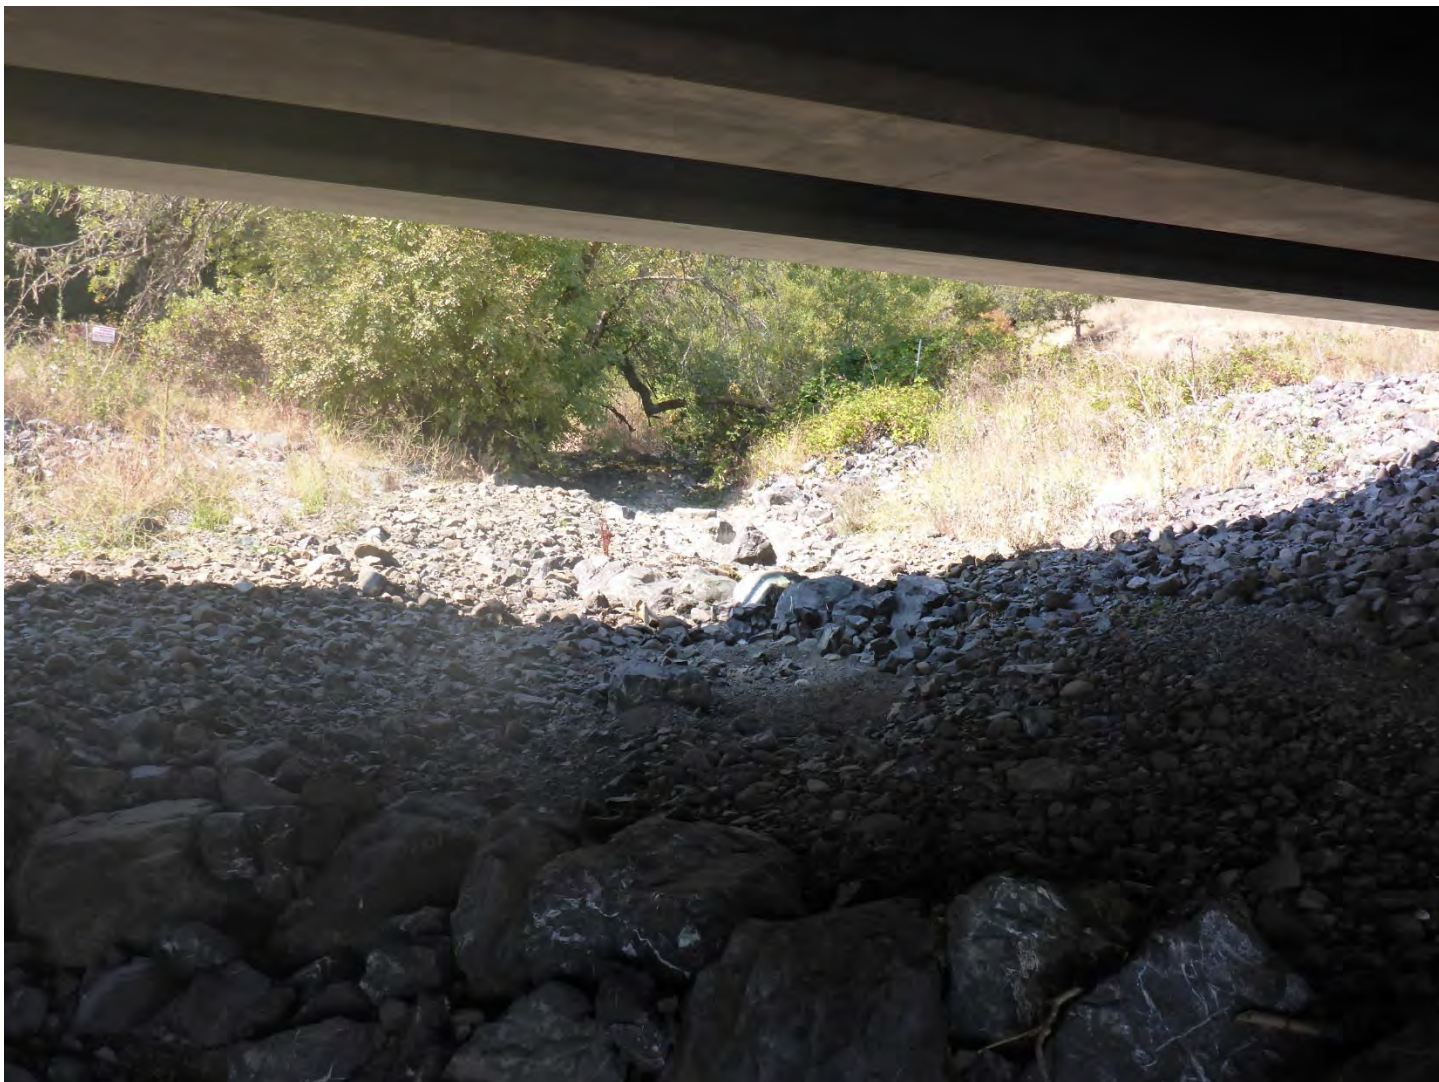
Figure 1. View looking upstream from beneath the new bridge. The most upstream V-shaped rock weir is in the foreground and the straight rock weir upstream of this weir is missing. Photo by Michael Love on 9/12/2019.

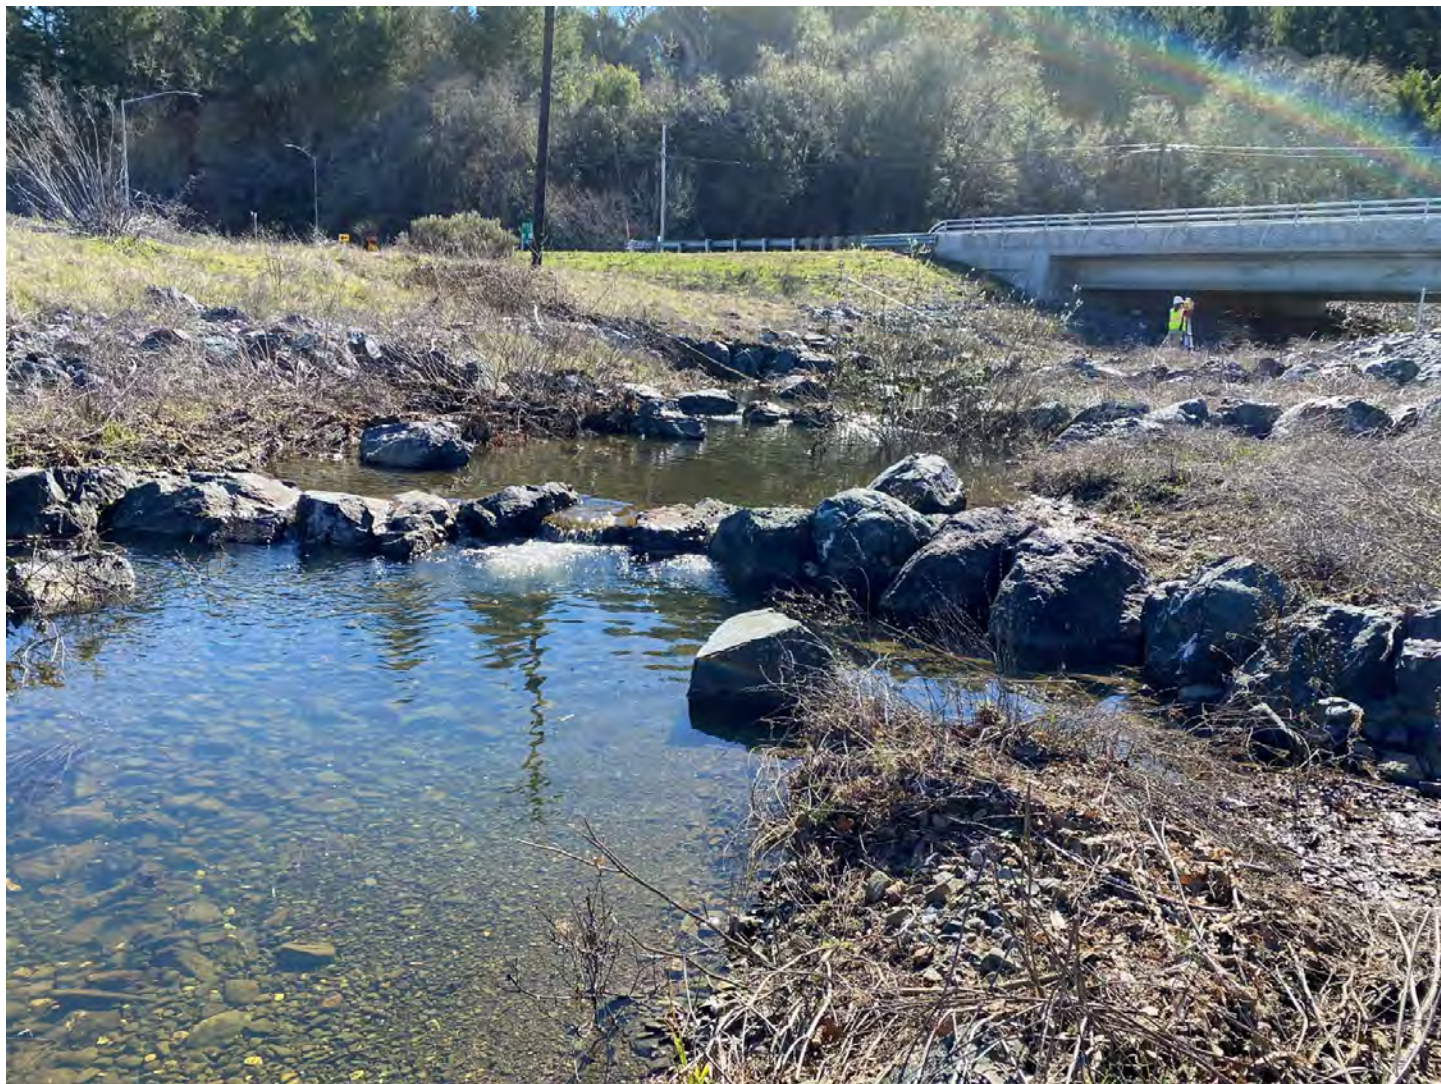
Figure 2. Intact and fully functioning rock weirs viewed from downstream looking upstream at new bridge. Photo by Michael Love on 2/24/2021.

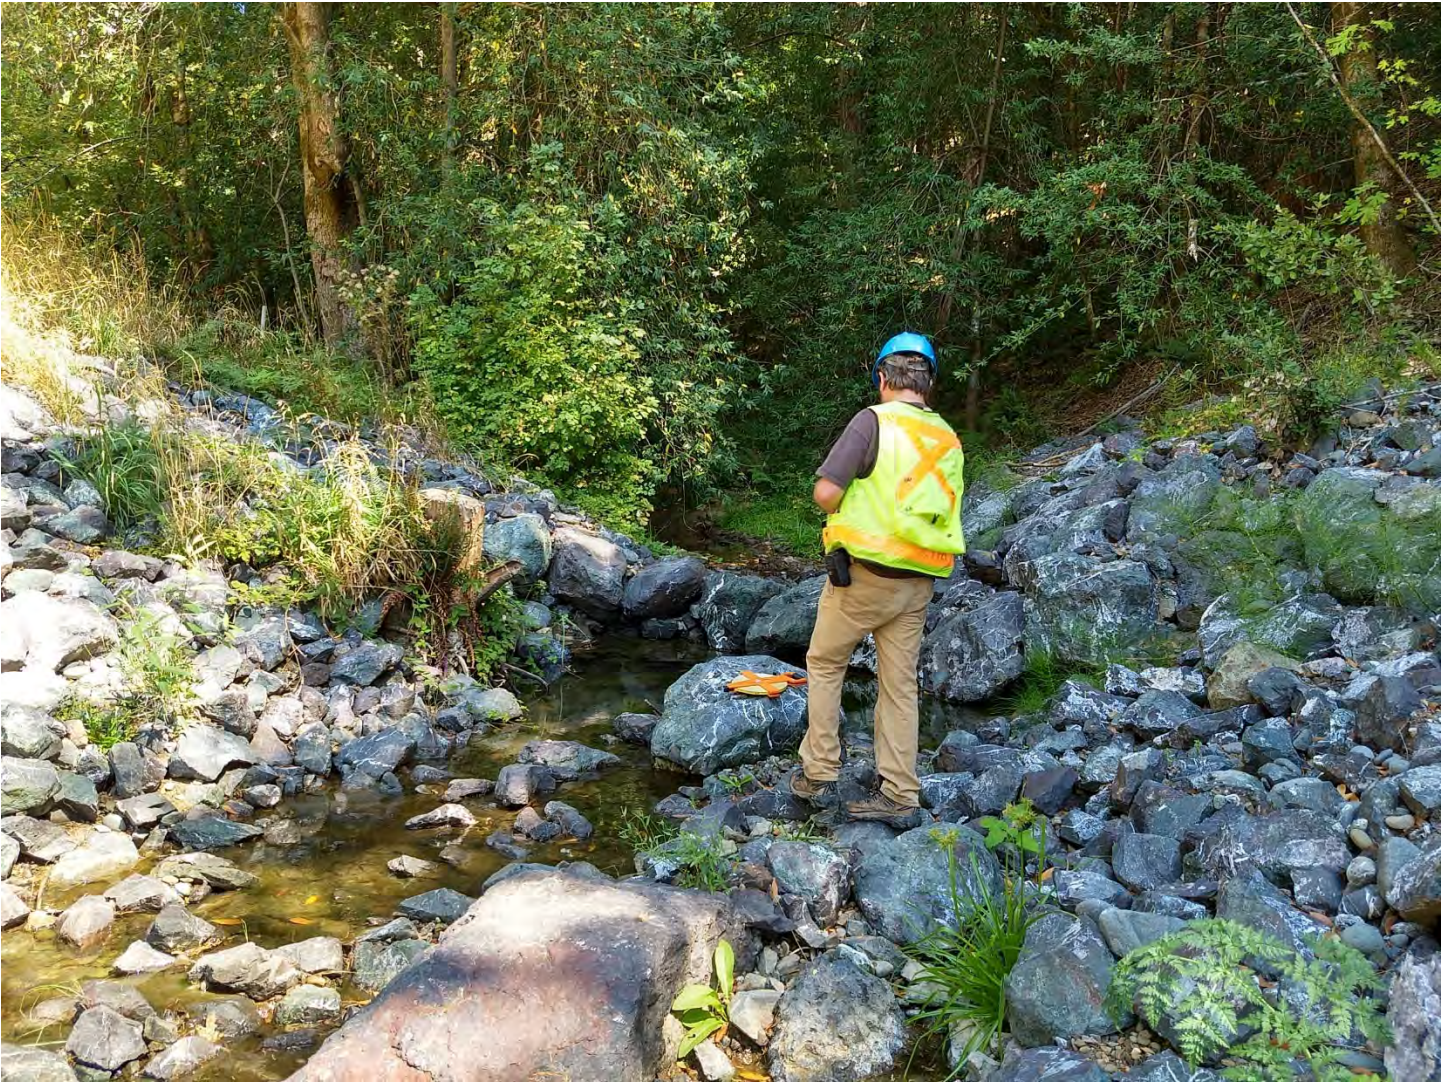
Figure 2. Close-up view of the upstream rock weir. The footing rocks are exposed in the pool increasing the potential for weir failure. Note that the low flow is going through the rocks in the weir rather than over the crest. Photo by Margaret Lang on 9/12/2019.

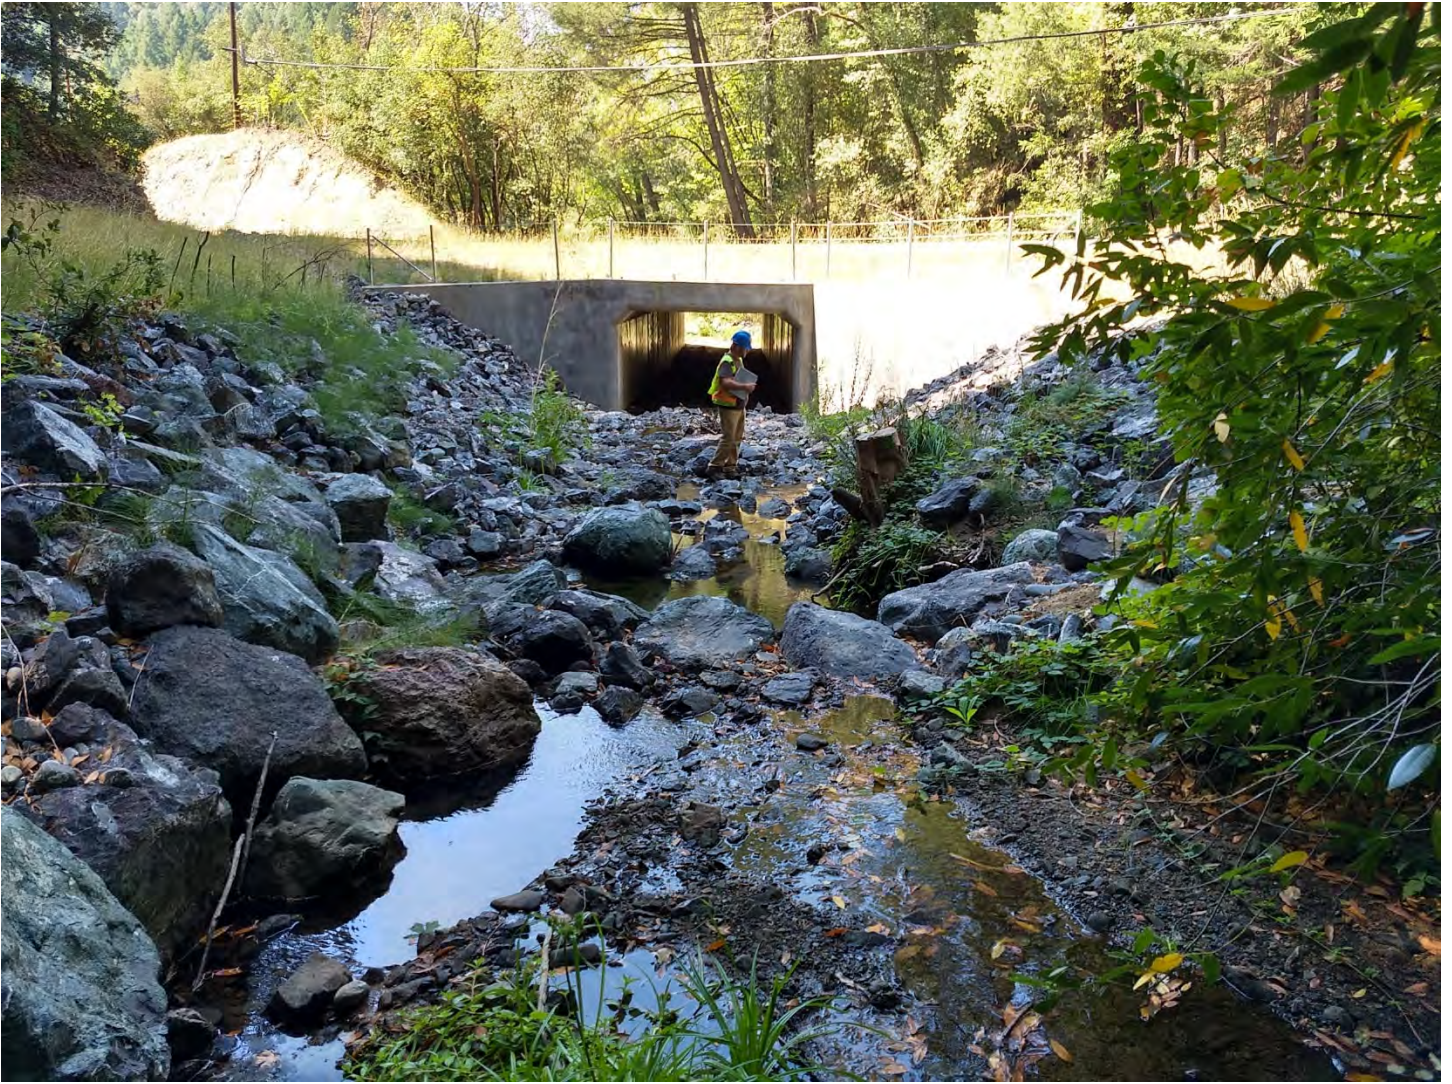
Figure 3. Culvert inlet looking downstream from the upstream project boundary. Stream flow was low but continuous upstream of the culvert during this site visit. Photo by Margaret Lang on 9/12/2019.

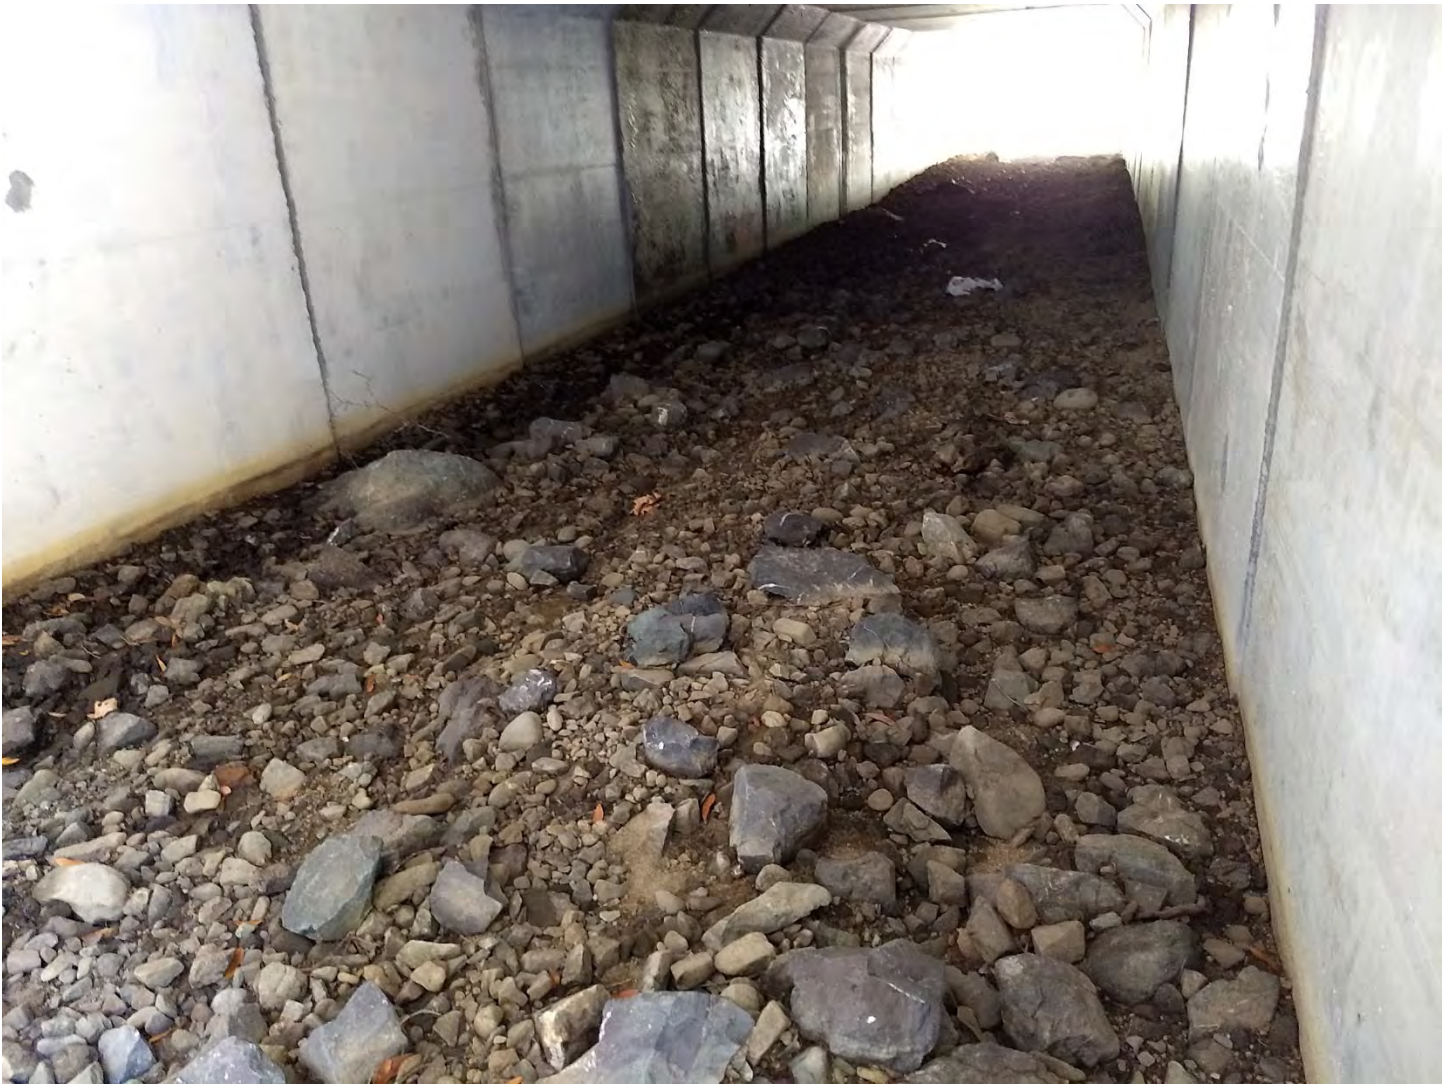
Figure 4. The culvert's invert and natural substrate bottom. The culvert substrate is almost a plain bed with the larger disruptor rocks mostly buried. At this low flow, there was no flow in the culvert, but it was very moist along the left side. Photo by Margaret Lang on 9/12/2019.

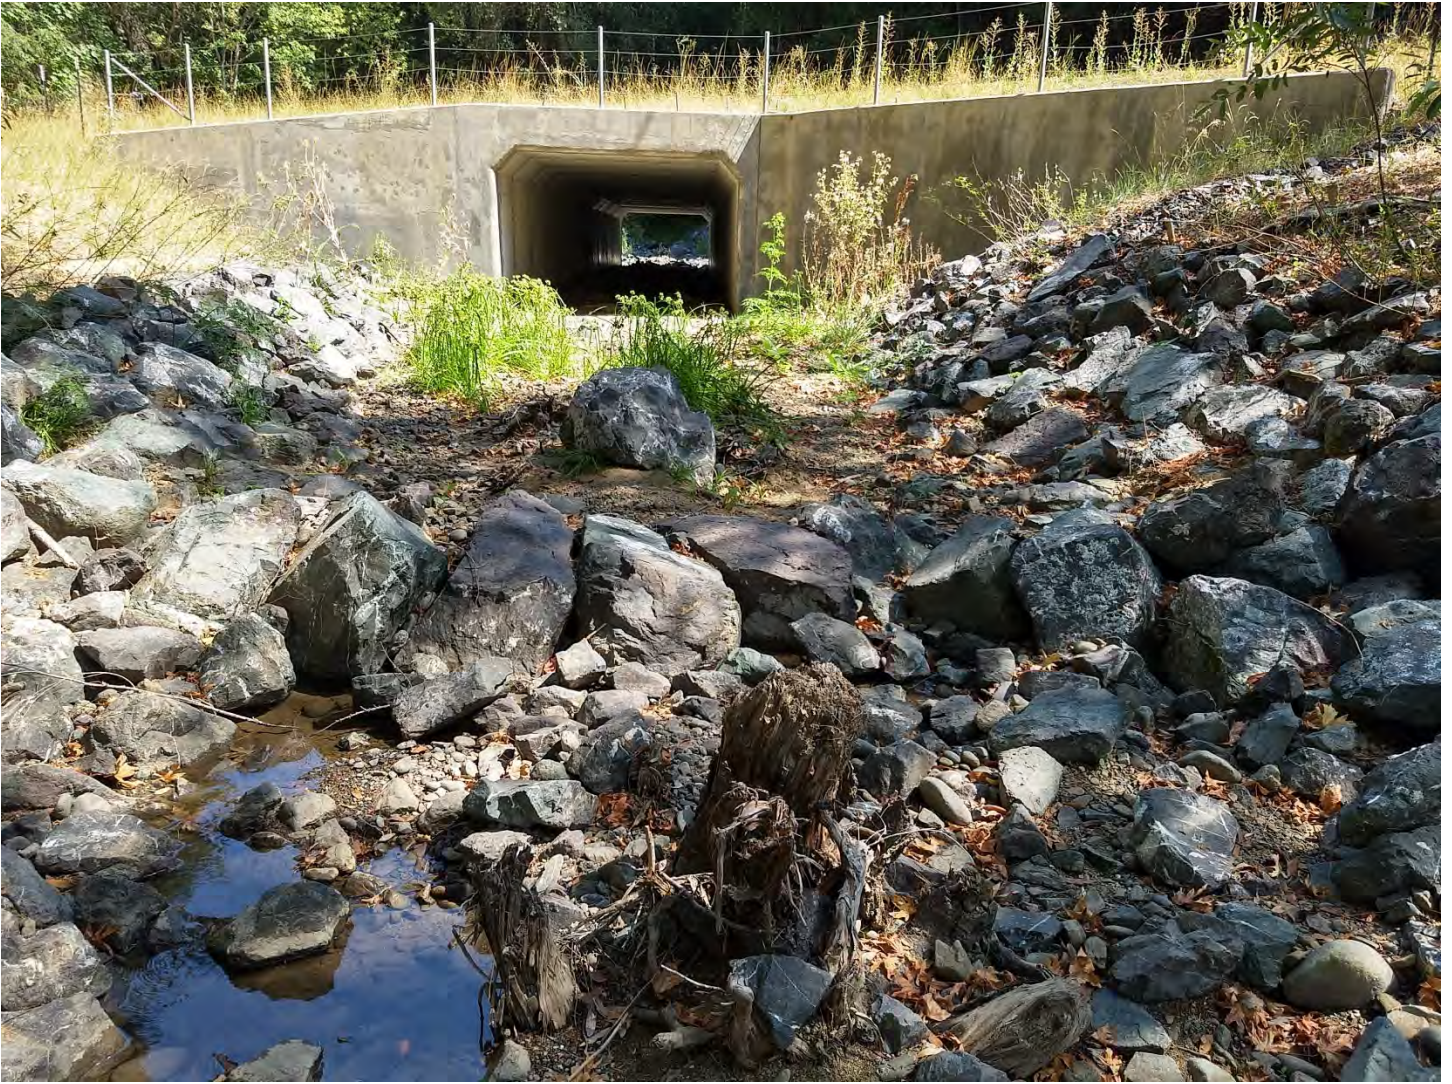
Figure 5. The culvert outlet looking upstream. The flow becomes discontinuous starting at the culvert inlet and remains discontinuous through the culvert and within the downstream project reach. Photo by Margaret Lang on 9/12/2019.

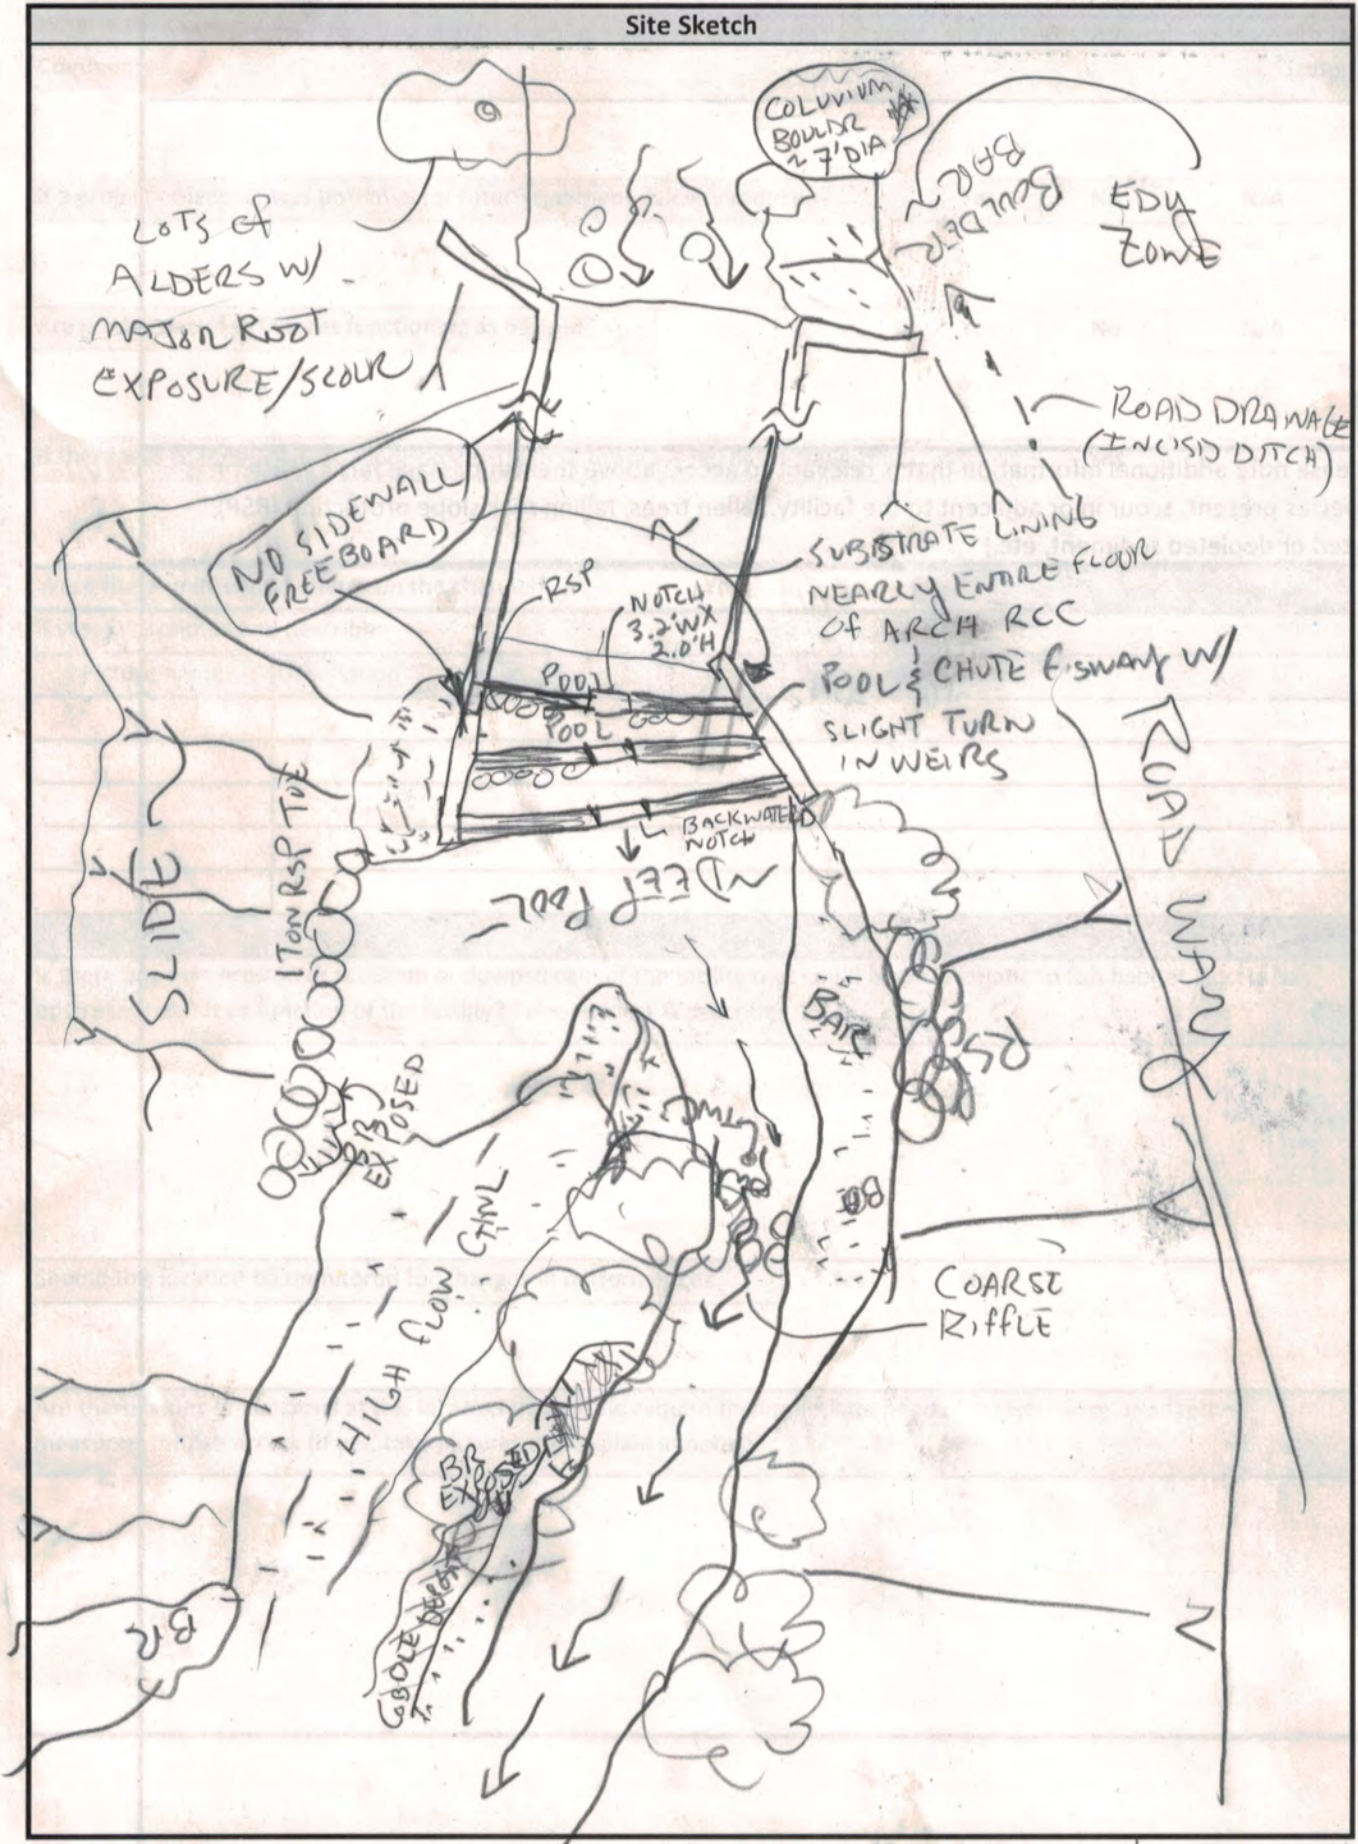
TWC CAN DROP ~ 1' STILL MEET 2" DROP CAMERA

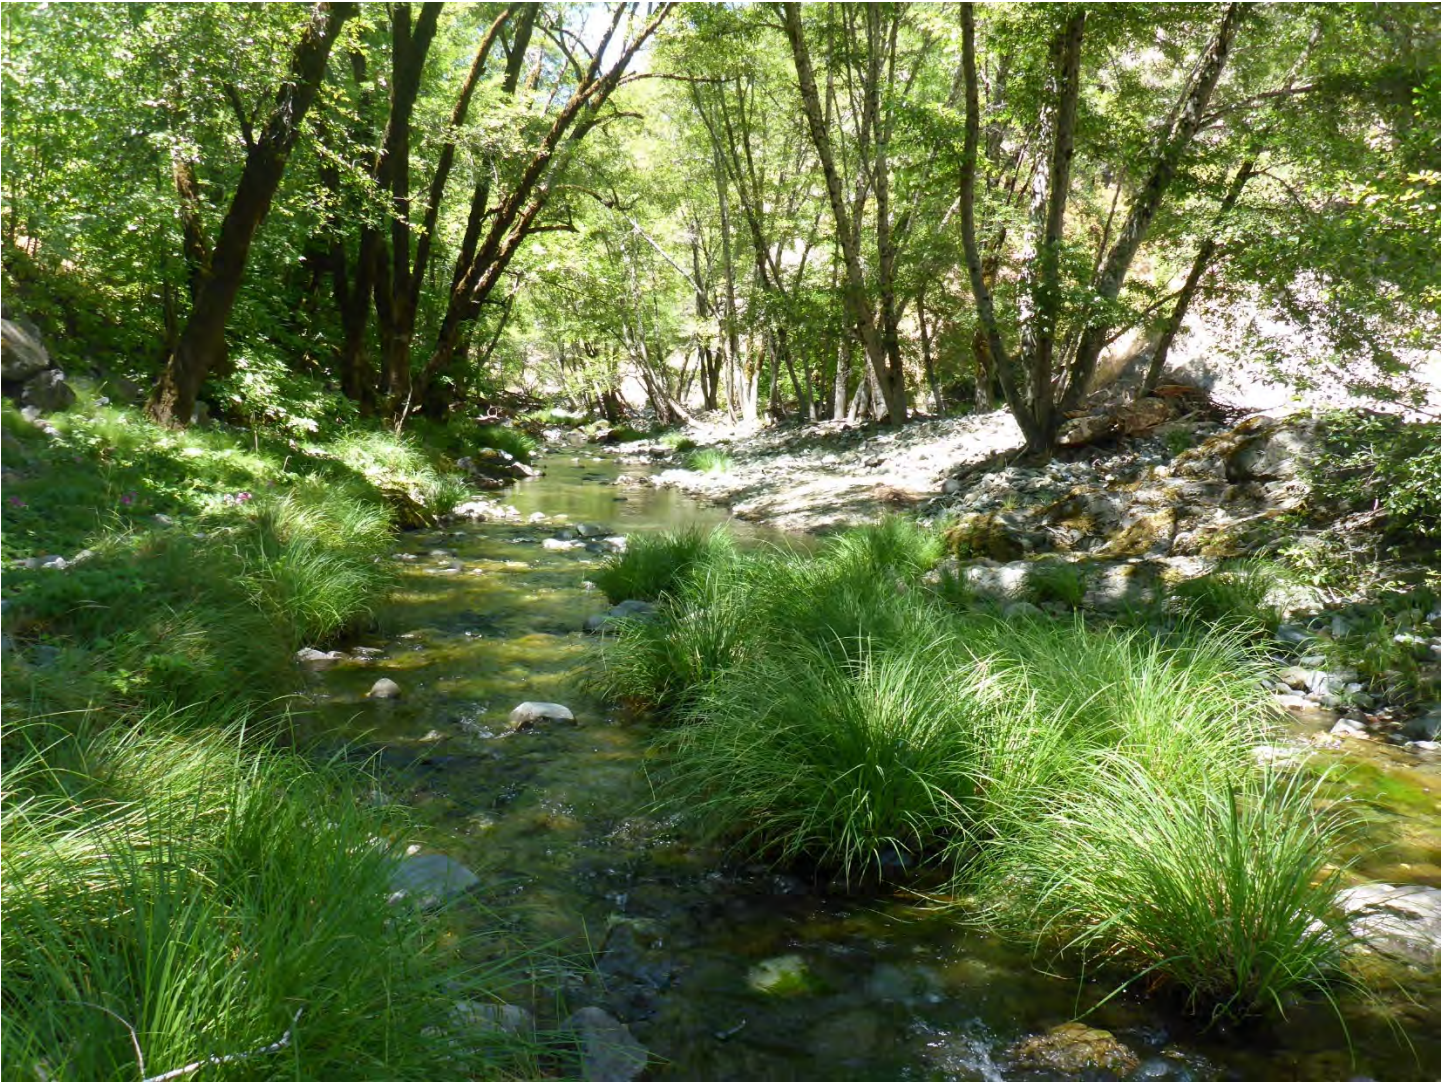
Figure 9. Downstream channel looking downstream from the outlet pool tailwater control. Photo M. Love on July 17, 2019.

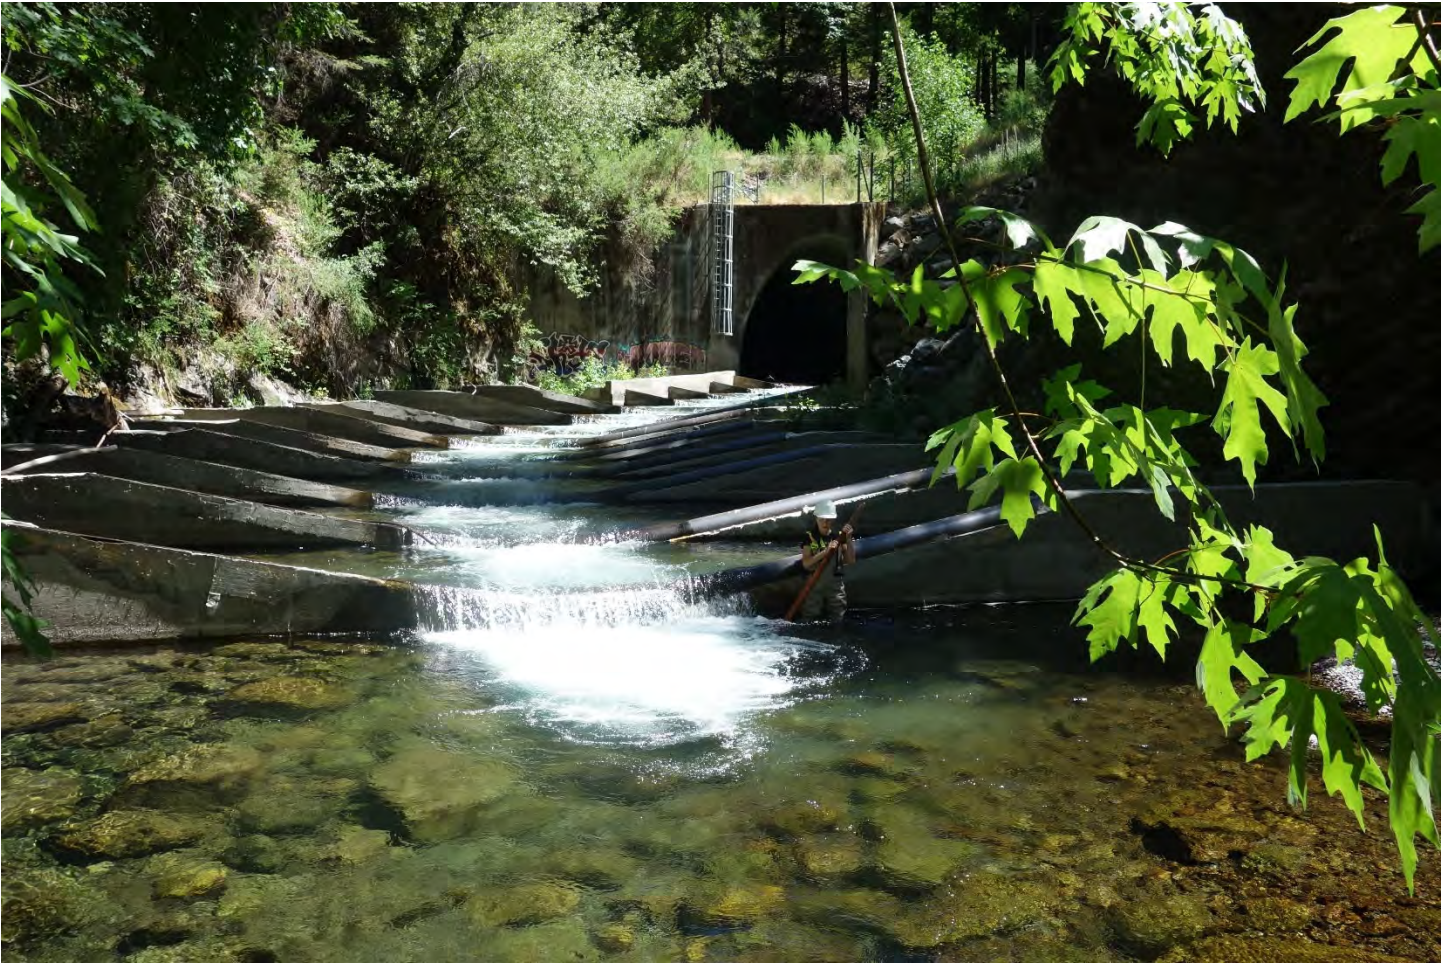
Figure 5. Cedar Creek outlet fishway looking upstream. The drop heights over the weirs under these conditions ranged from 1.25 ft (drop height at most downstream weir) to 0.4 ft; all but two drop heights were less than 0.75 ft. Photo taken June 3, 2021.

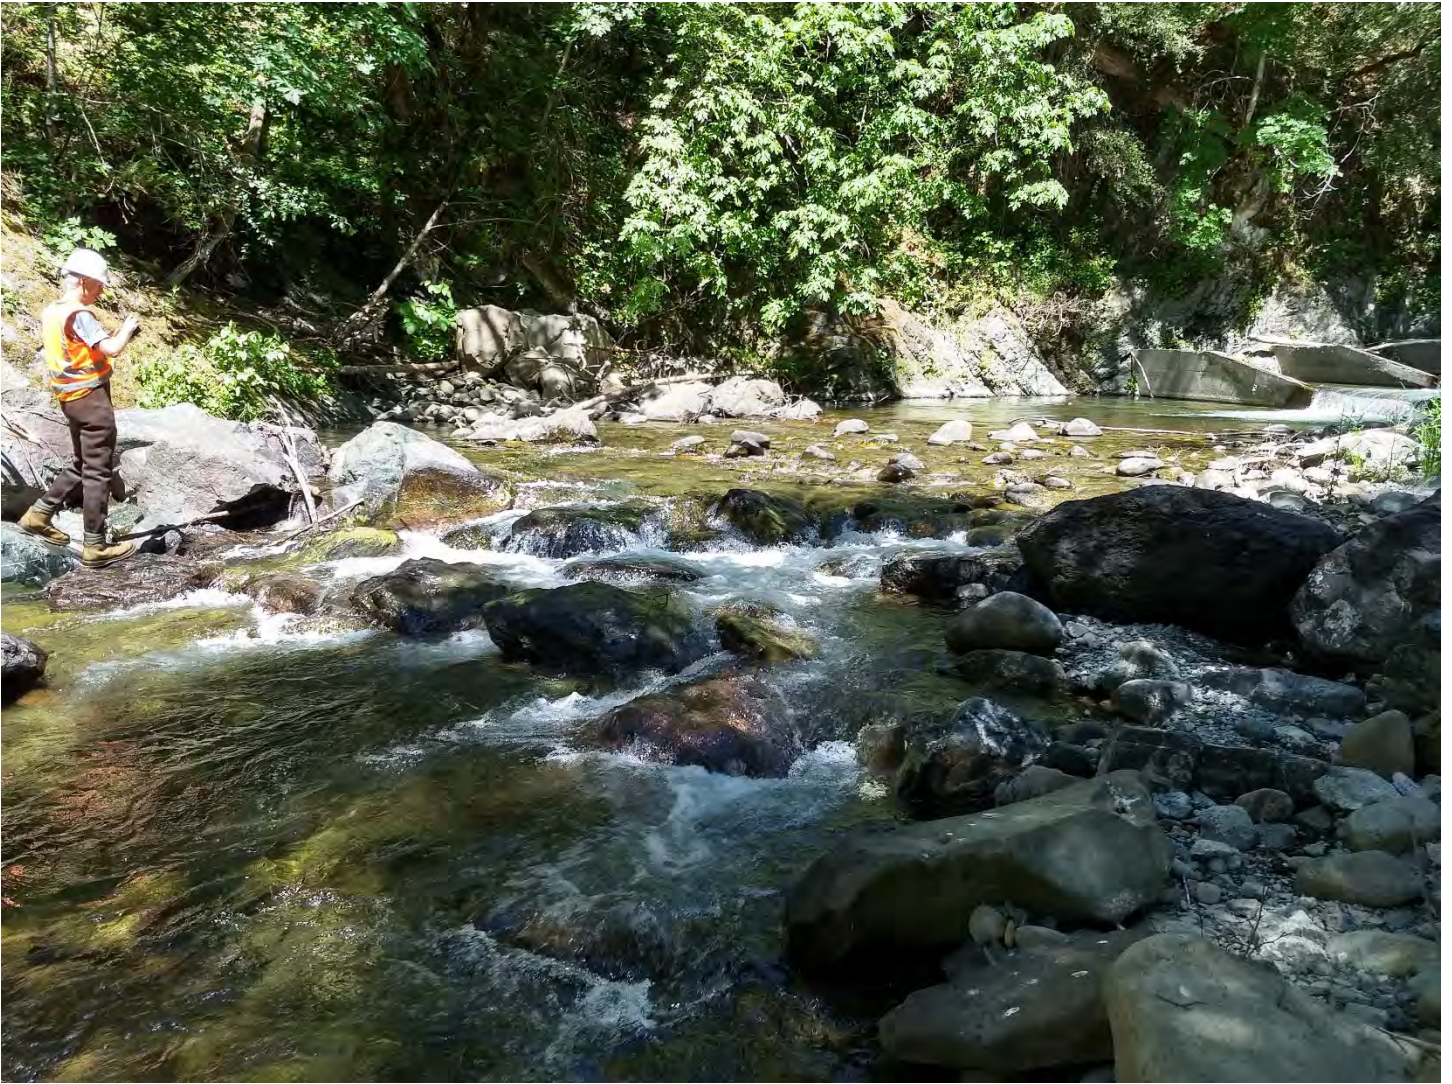
Figure 6. Looking upstream from the rock weir locations. In the foreground, the most downstream of the two rock weirs is somewhat intact. The most upstream rock weir is no longer present but its bank rocks are still present. The missing rock weir creates a larger drop height at the last fishway weir (~1.25 ft compared to 0.5 ft at most of the other weirs). Photo taken June 3, 2021.

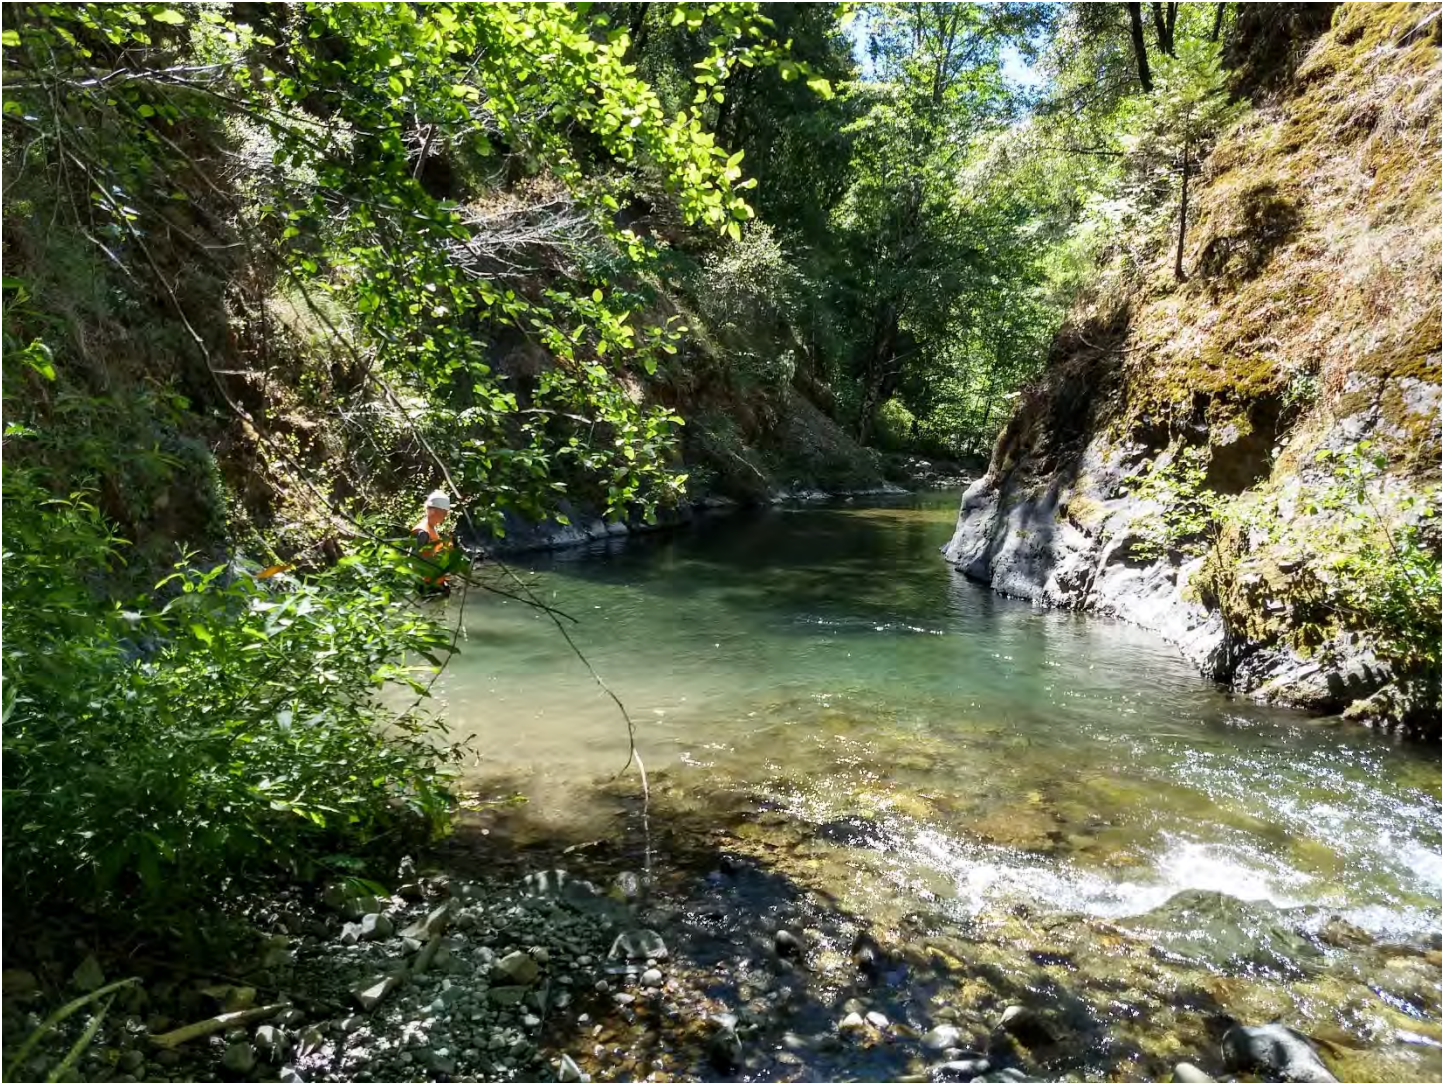
Figure 7. Cedar Creek downstream channel looking downstream from the rock weirs. Photo taken June 3, 2021.

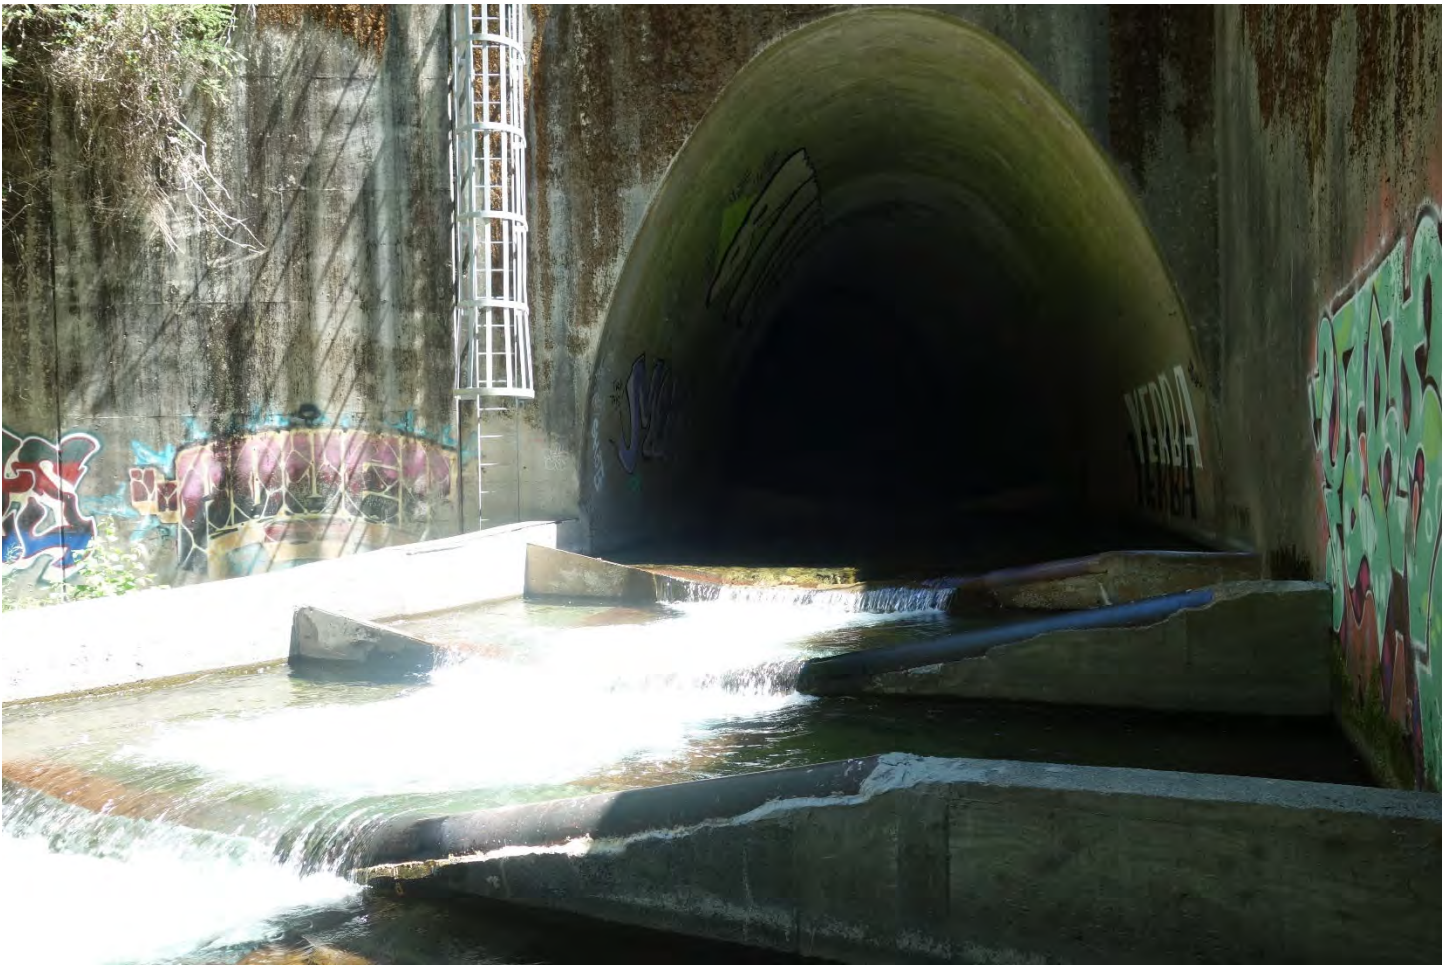
Figure 10. Cedar Creek culvert outlet weirs showing some of the crumbling concrete weir edges, especially around the installed steel plate coverings. Photo taken June 3, 2021.

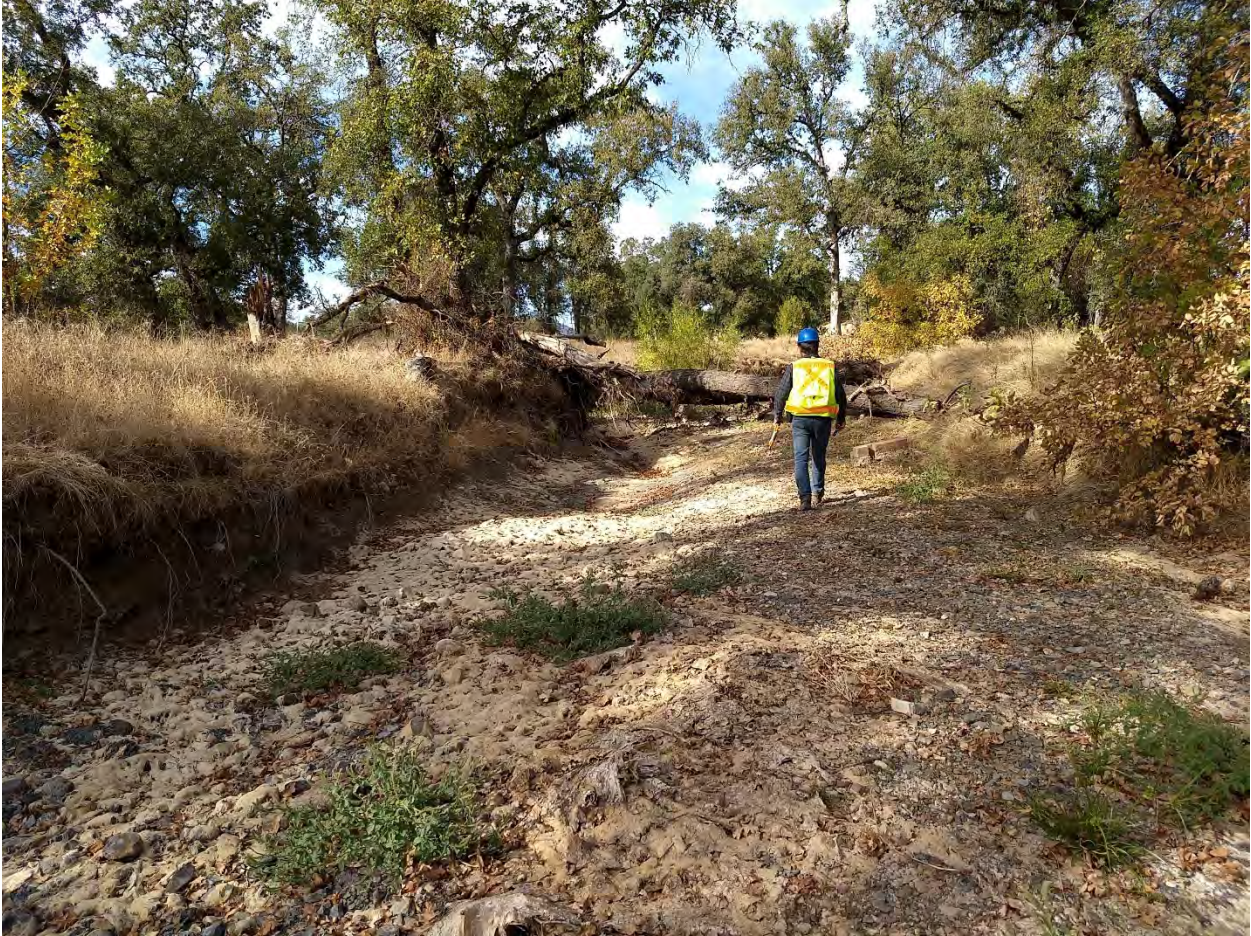
Figure 6. Lemm/Yank Creek channel upstream of the 299 crossing, looking upstream. Photo taken October 4, 2019.

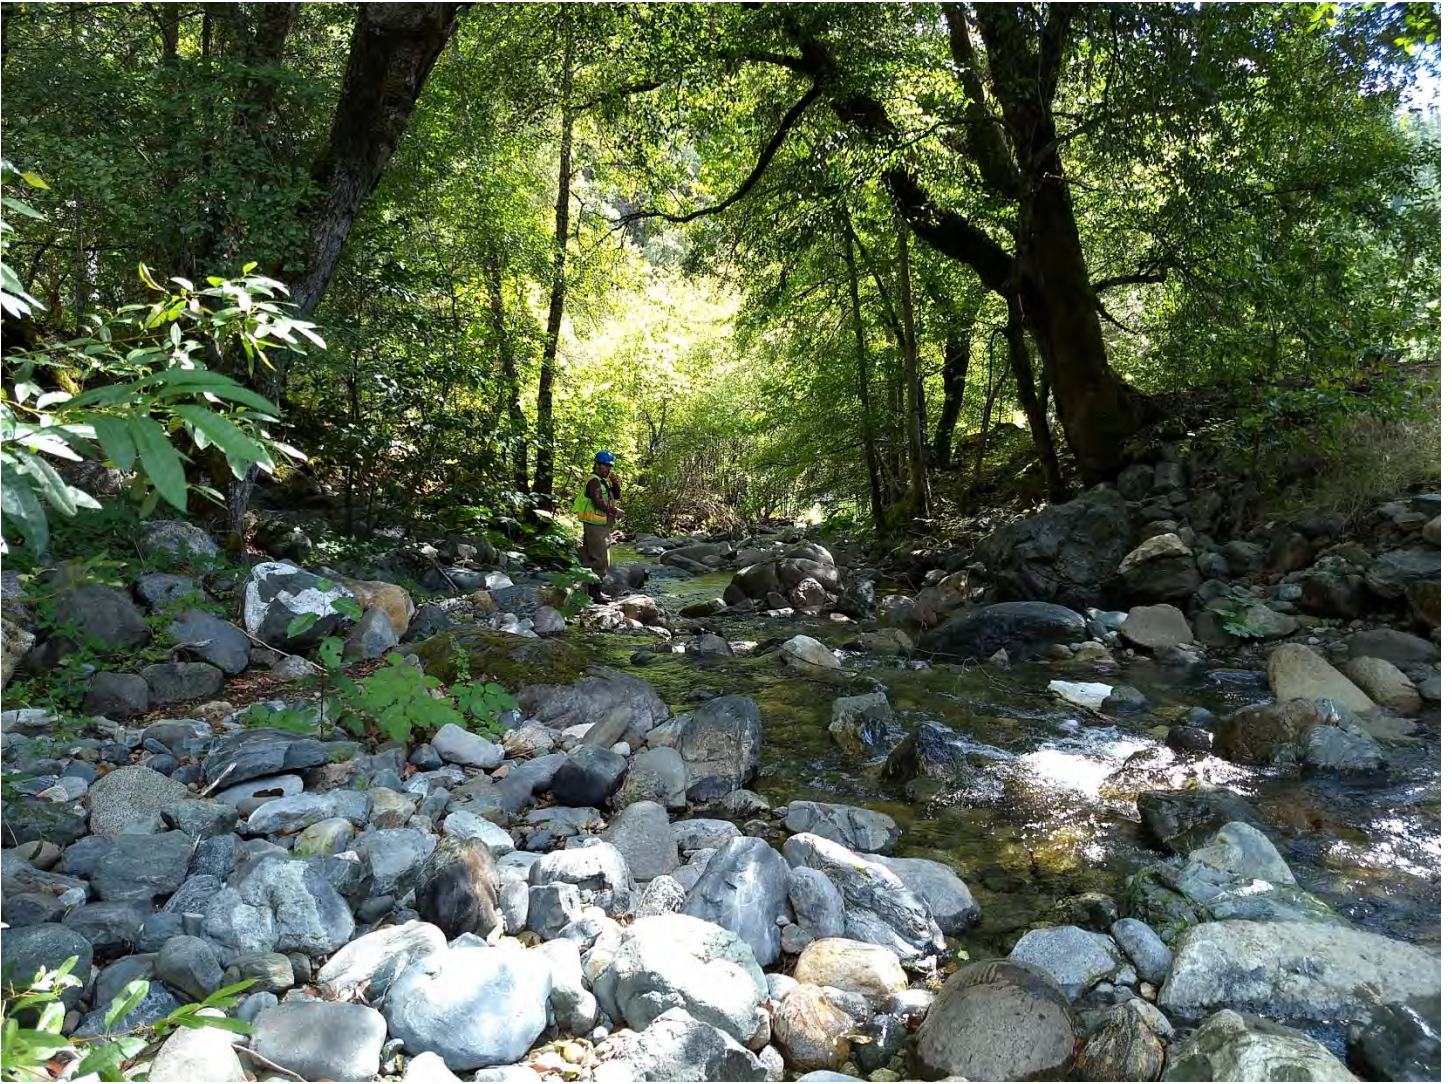
Figure 7. Channel downstream and out of project area just above the confluence with the Klamath River. Photo by M. Lang on 9/19/2019.
