FISH PASSAGE ENGINEERING PROJECT

Site Analysis Final Report

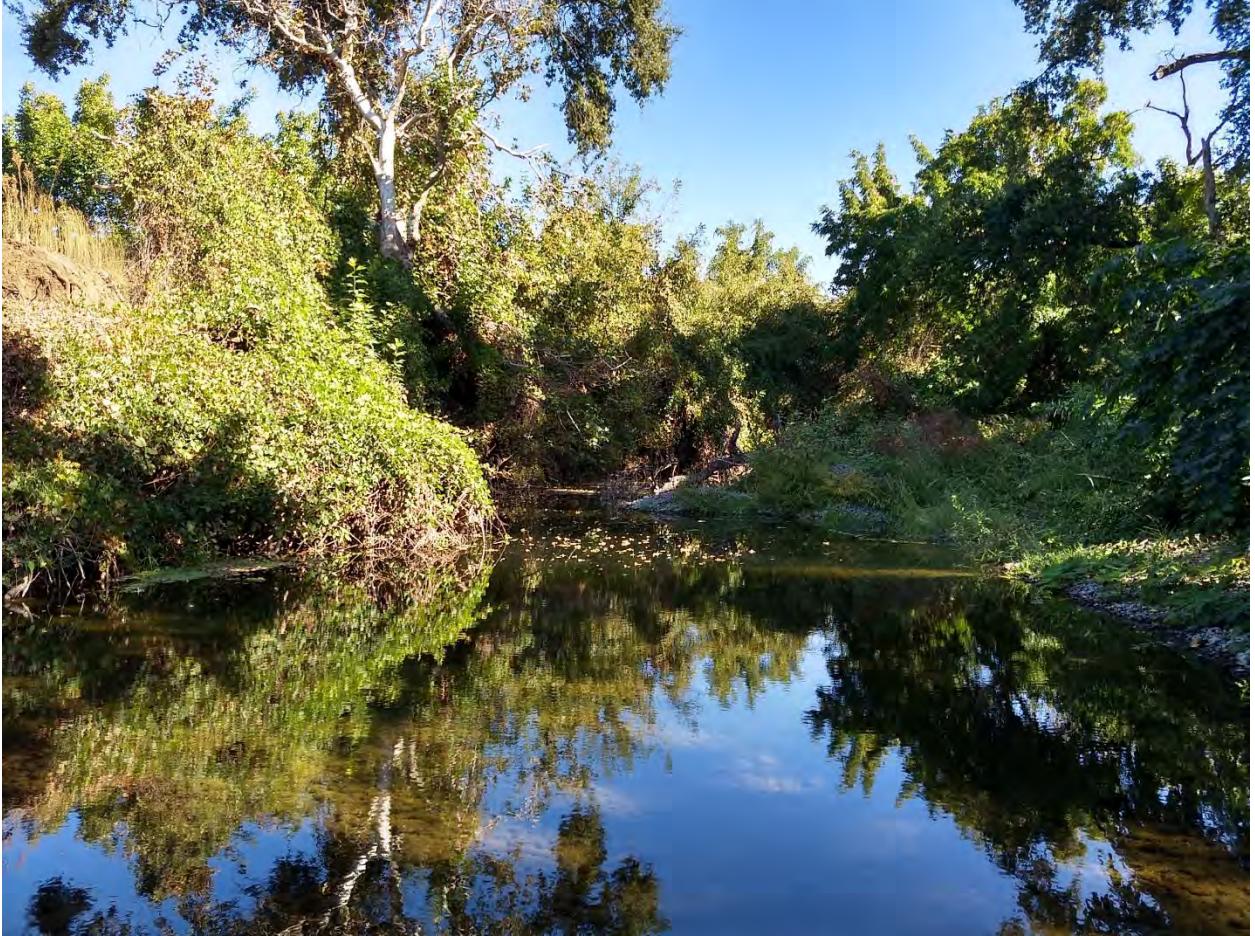
Figure 4. Craig Creek looking downstream. The downstream channel is highly incised due to regional conditions unrelated to the crossing. Photo taken October 4, 2019.

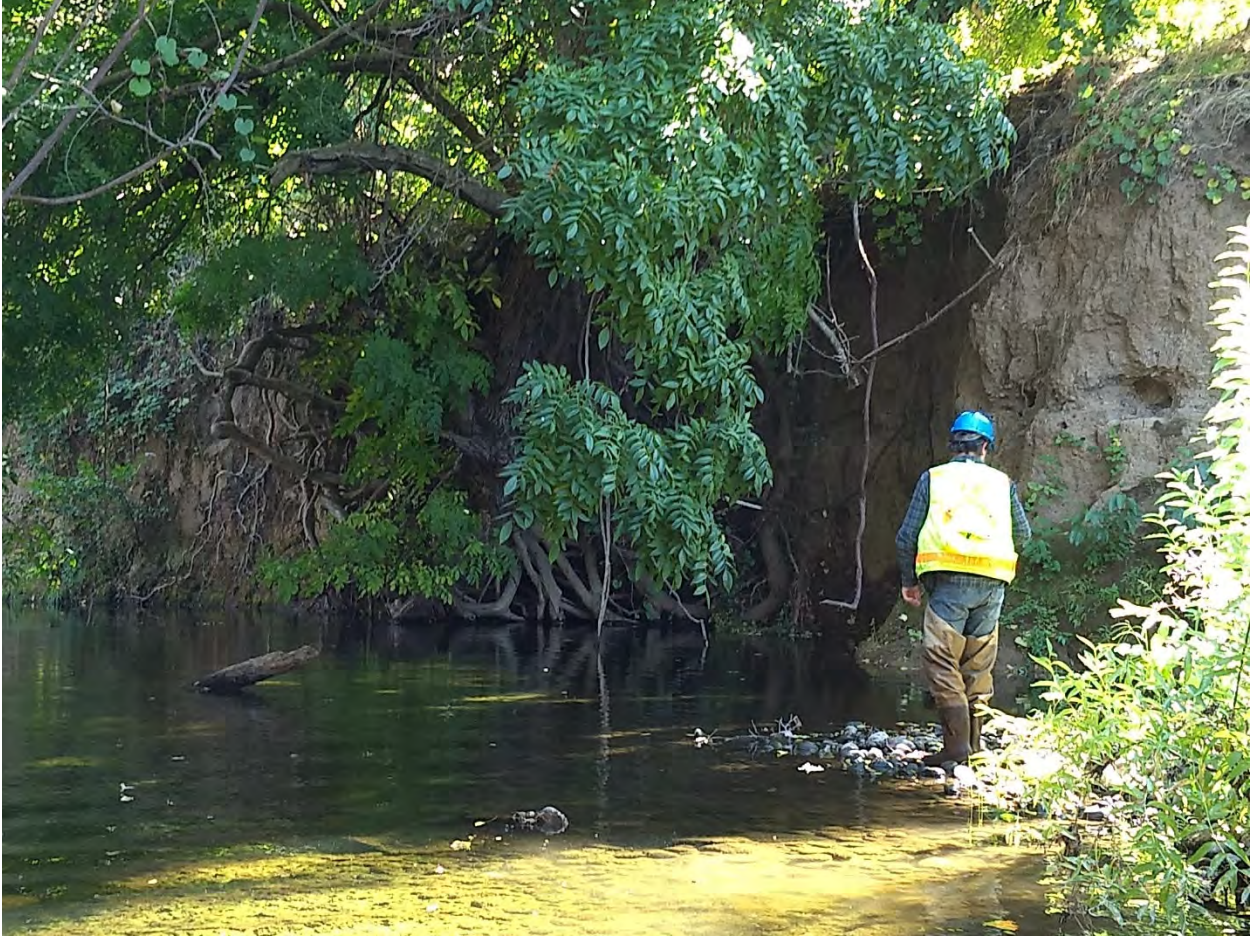
Figure 5. Craig Creek downstream channel showing extreme incision that is not related to the crossing but could influence conditions through the crossing. Photo taken October 4, 2019.

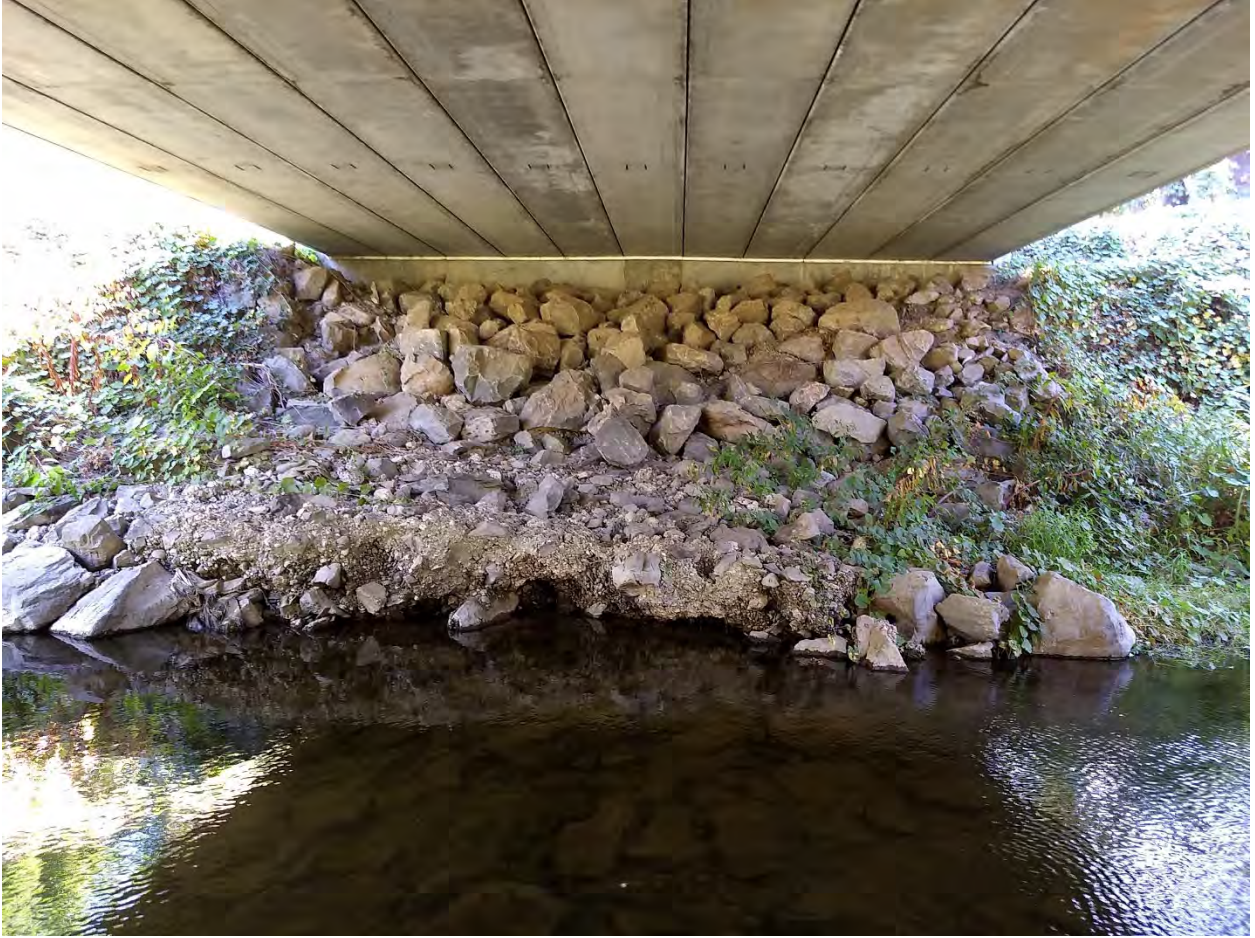
Figure 6. Craig Creek Right bank erosion and loss of bank protection by undercutting at the crossing. Photo taken October 4, 2019.

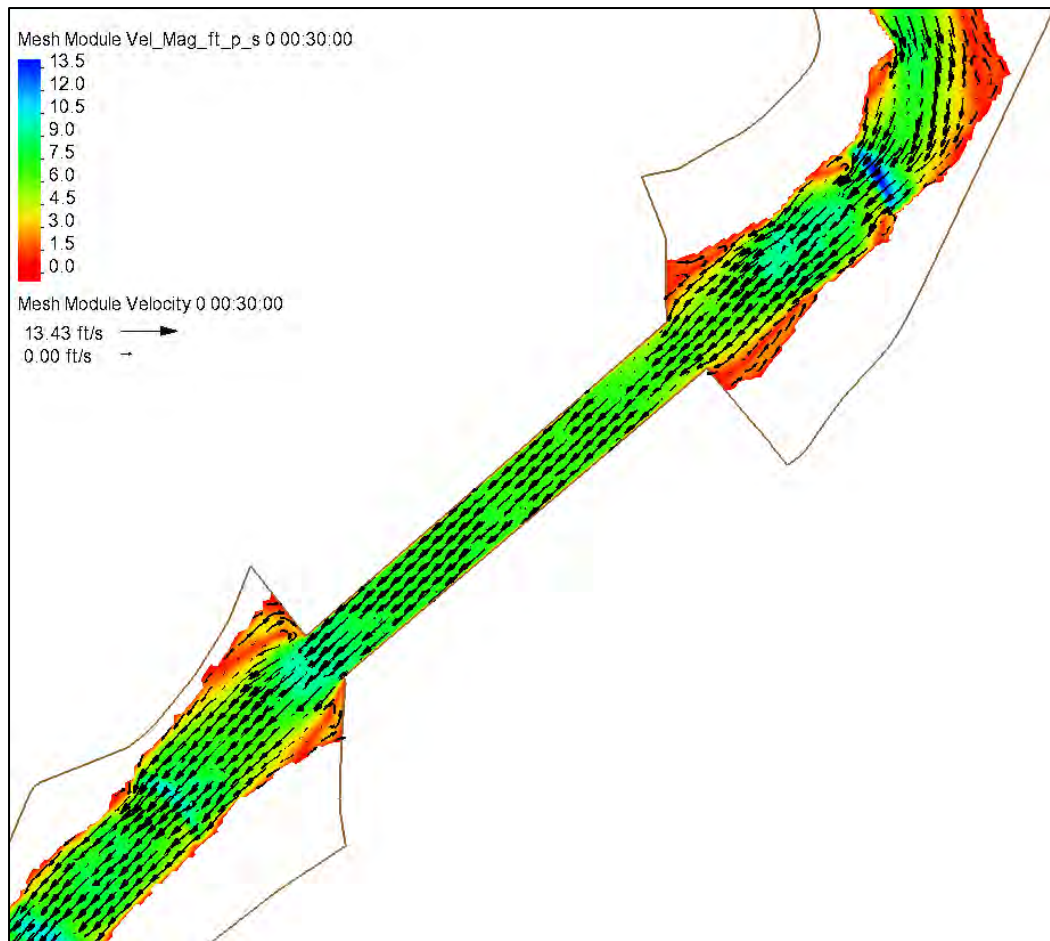
FIGURE 7. VELOCITY FOR $Q_{100\text{-YEAR}} = 263$ CFS. MAXIMUM VELOCITY OCCURS OVER THE UPSTREAM ROCK WEIR SHOWN HERE AS A BLUE PATCH IN THE UPSTREAM CHANNEL SECTION.

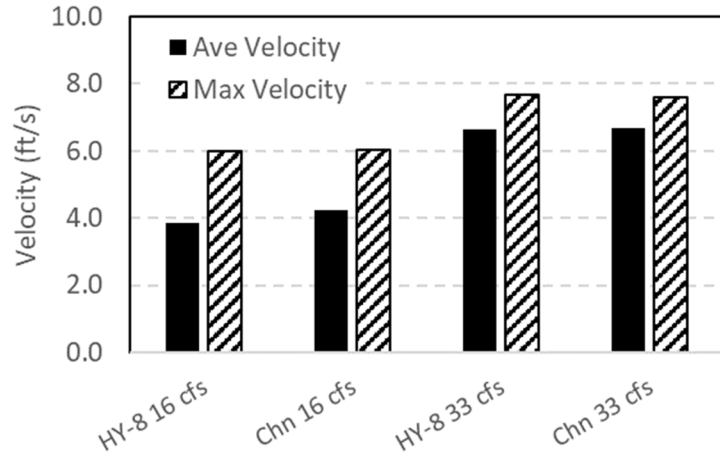
a) Upstream Rock Weir

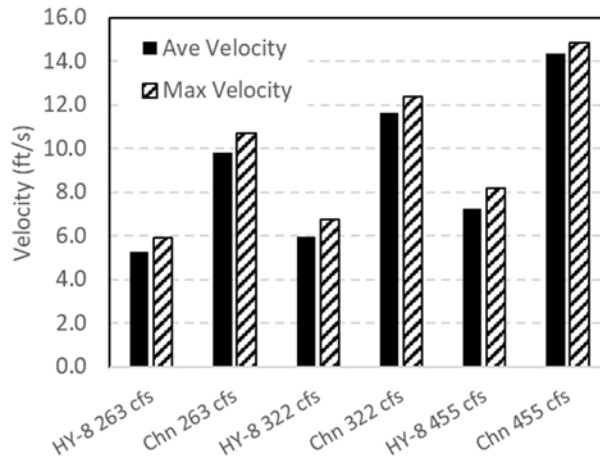
FIGURE 13. COMPARISON OF AVERAGE AND MAXIMUM VELOCITIES AT CROSS SECTIONS ACROSS THE ROCK WEIR, INLET AND OUTLET FOR THE THREE ESTIMATES OF THE $Q_{100\text{-YEAR}}$ (263 CFS – AECOM; 322 CFS – HSU & 455 CFS – PCI).

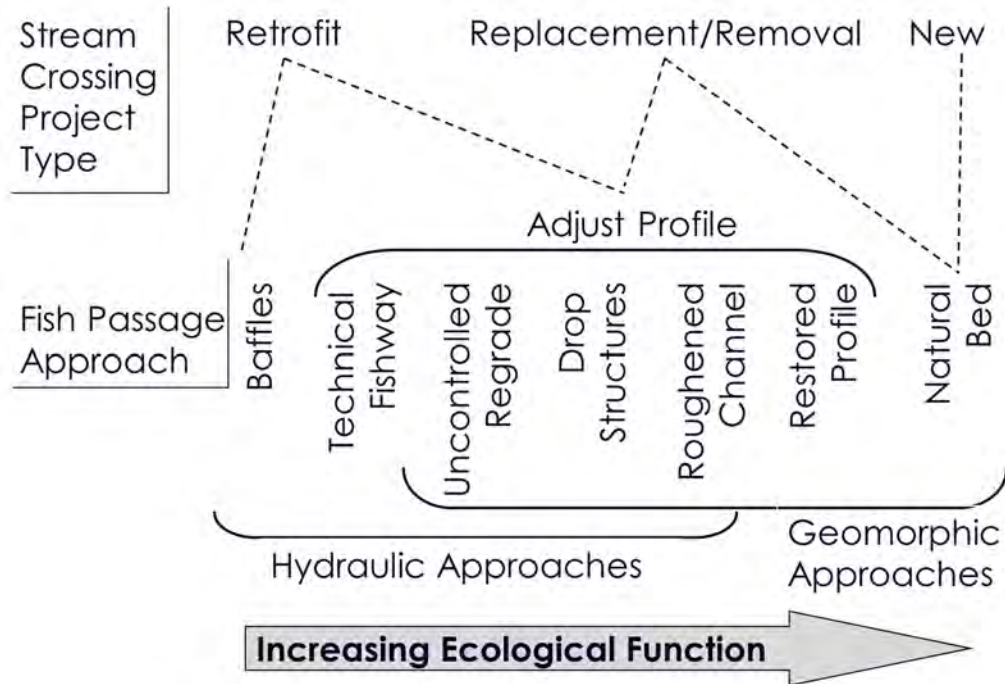
Figure 1. Hierarchy of fish passage solution approaches. Adapted from CDFG, 2009.
