CALIFORNIA FISH PASSAGE ADVISORY COMMITTEE

Connectivity Case Studies

Salsipuedes Creek Bridge Scour Mitigation Project

Little Lost Man Creek Fish Passage Project

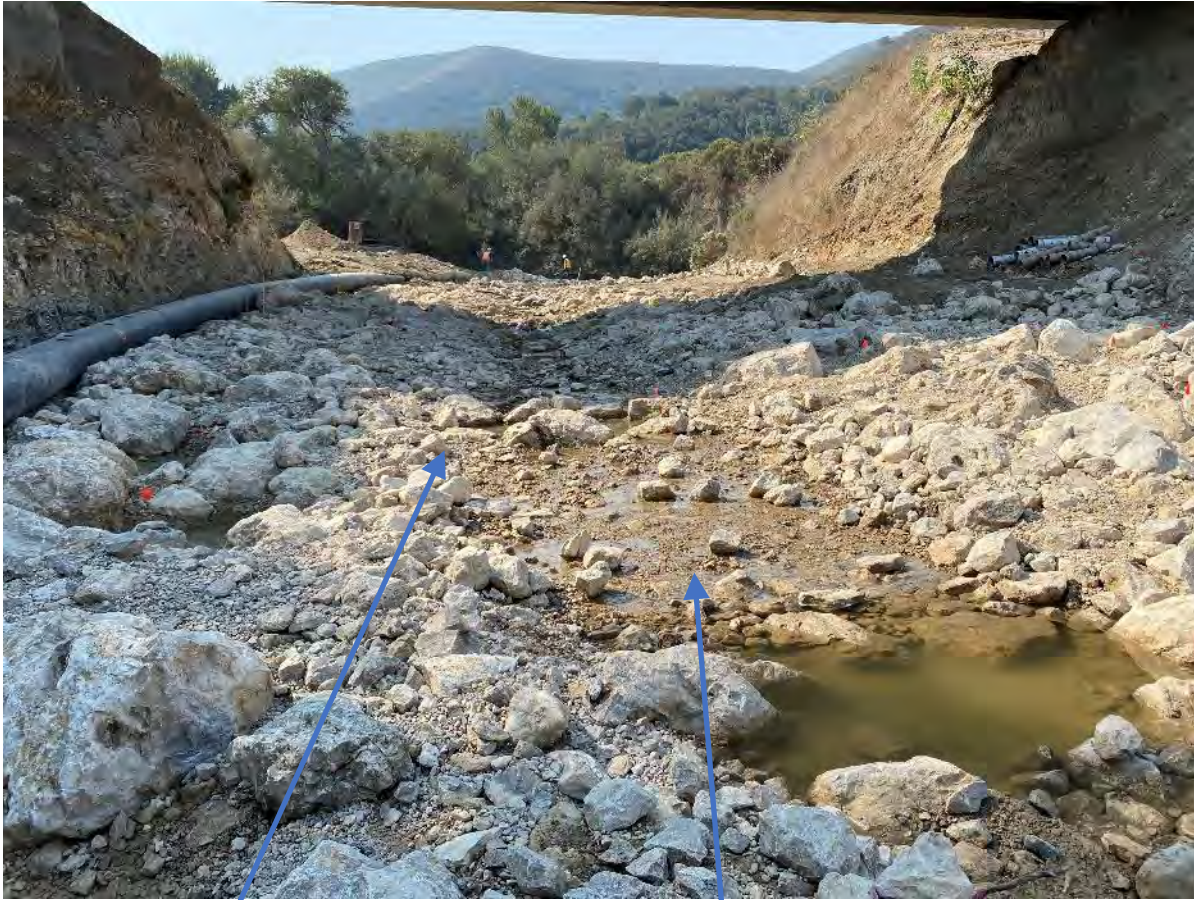
Stability Boulder Sill

Low Flow Channel

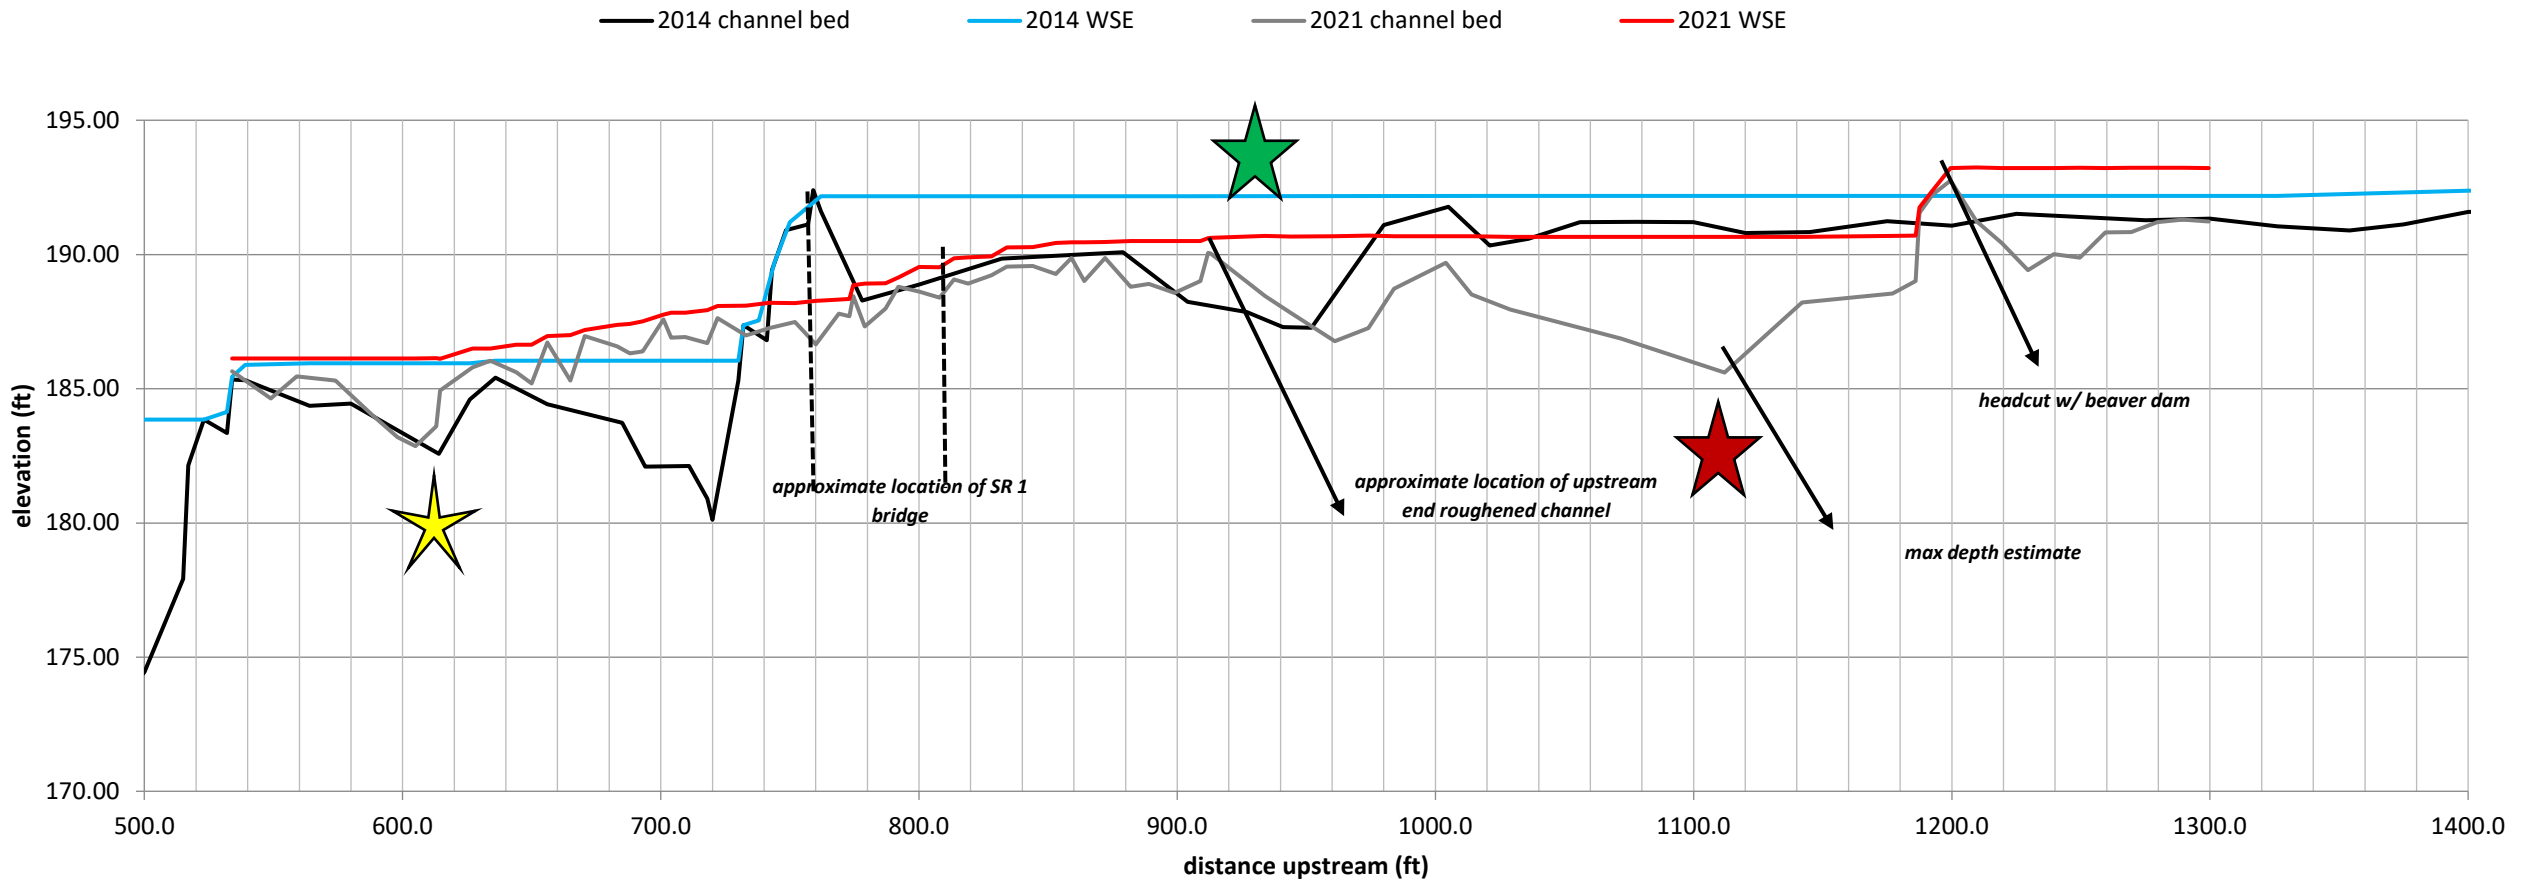
Longitudinal Profile 2014-2021, 6.2 VE

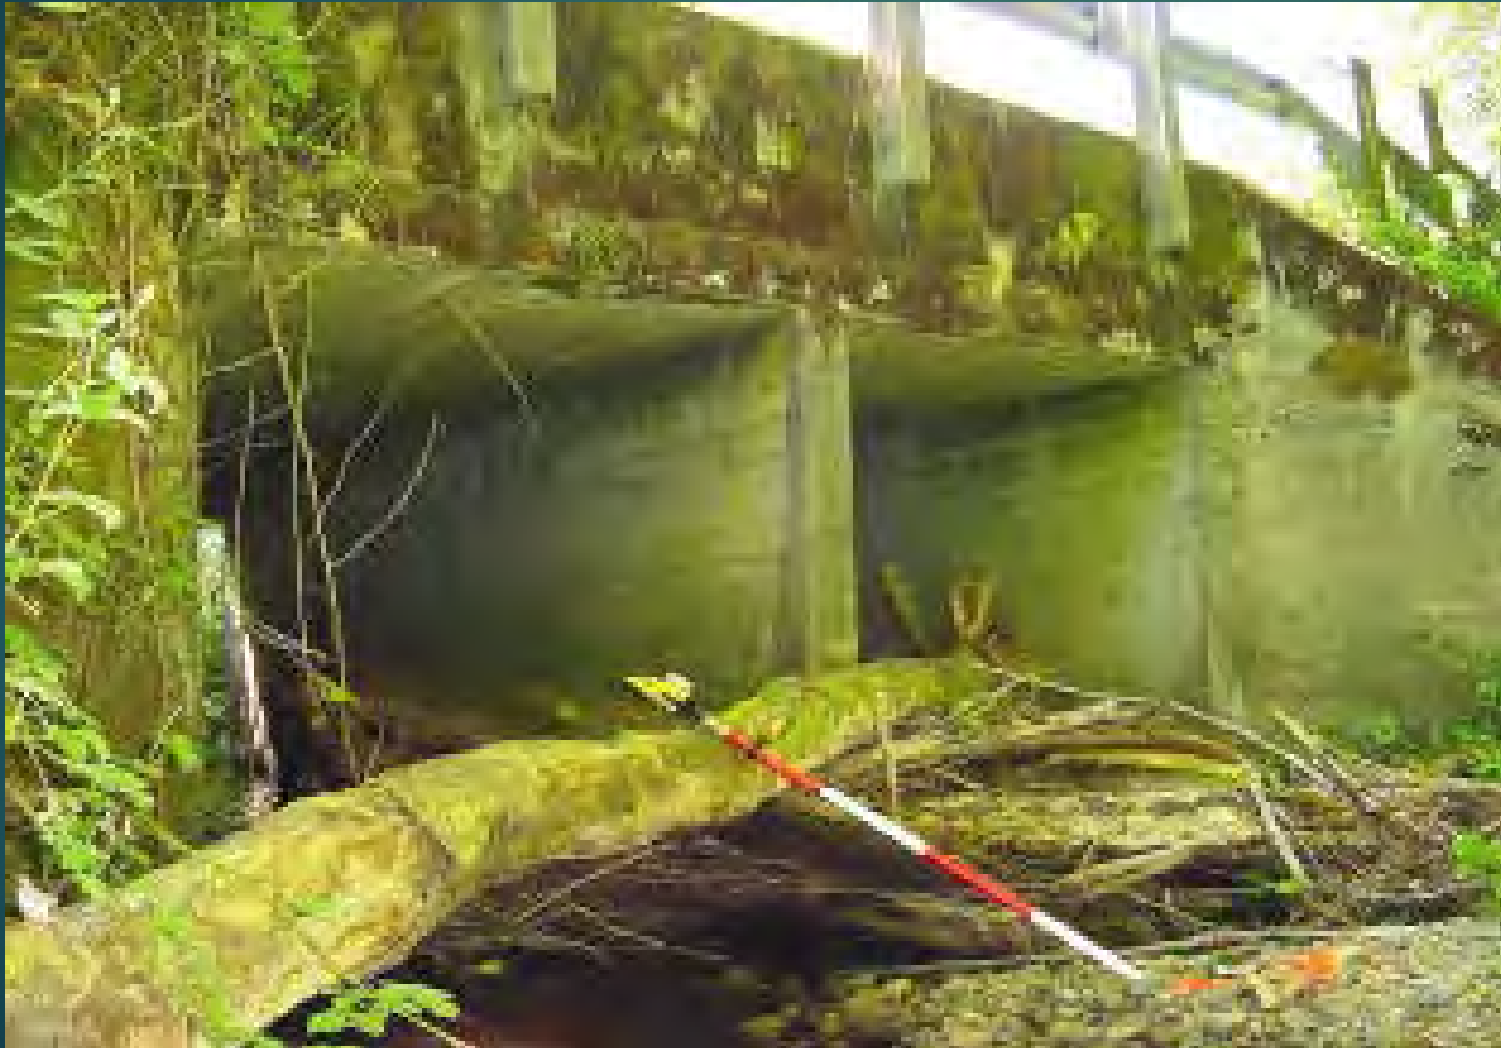
DRAINAGE DETAILS
 NO SCALE
DD-1

Replaced an 8 x 8-foot reinforced concrete double box culvert with a full span 70-foot long bridge

TYPICAL CROSS SECTION TO LINE
 STA 10+75 TO 11+67.8 LT
 STA 10+75 TO 11+50 RT

TYPICAL CROSS SECTION TO LINE
 STA 10+20 TO 10+75

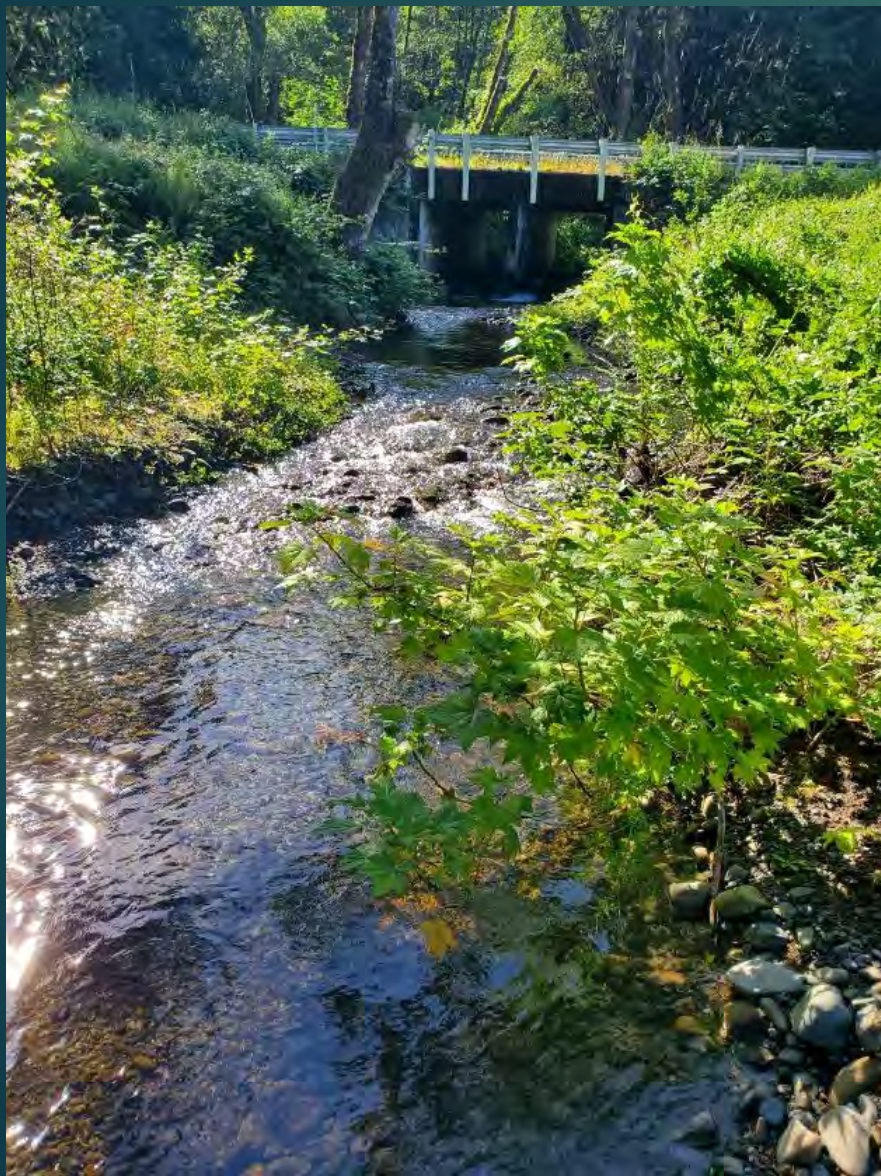
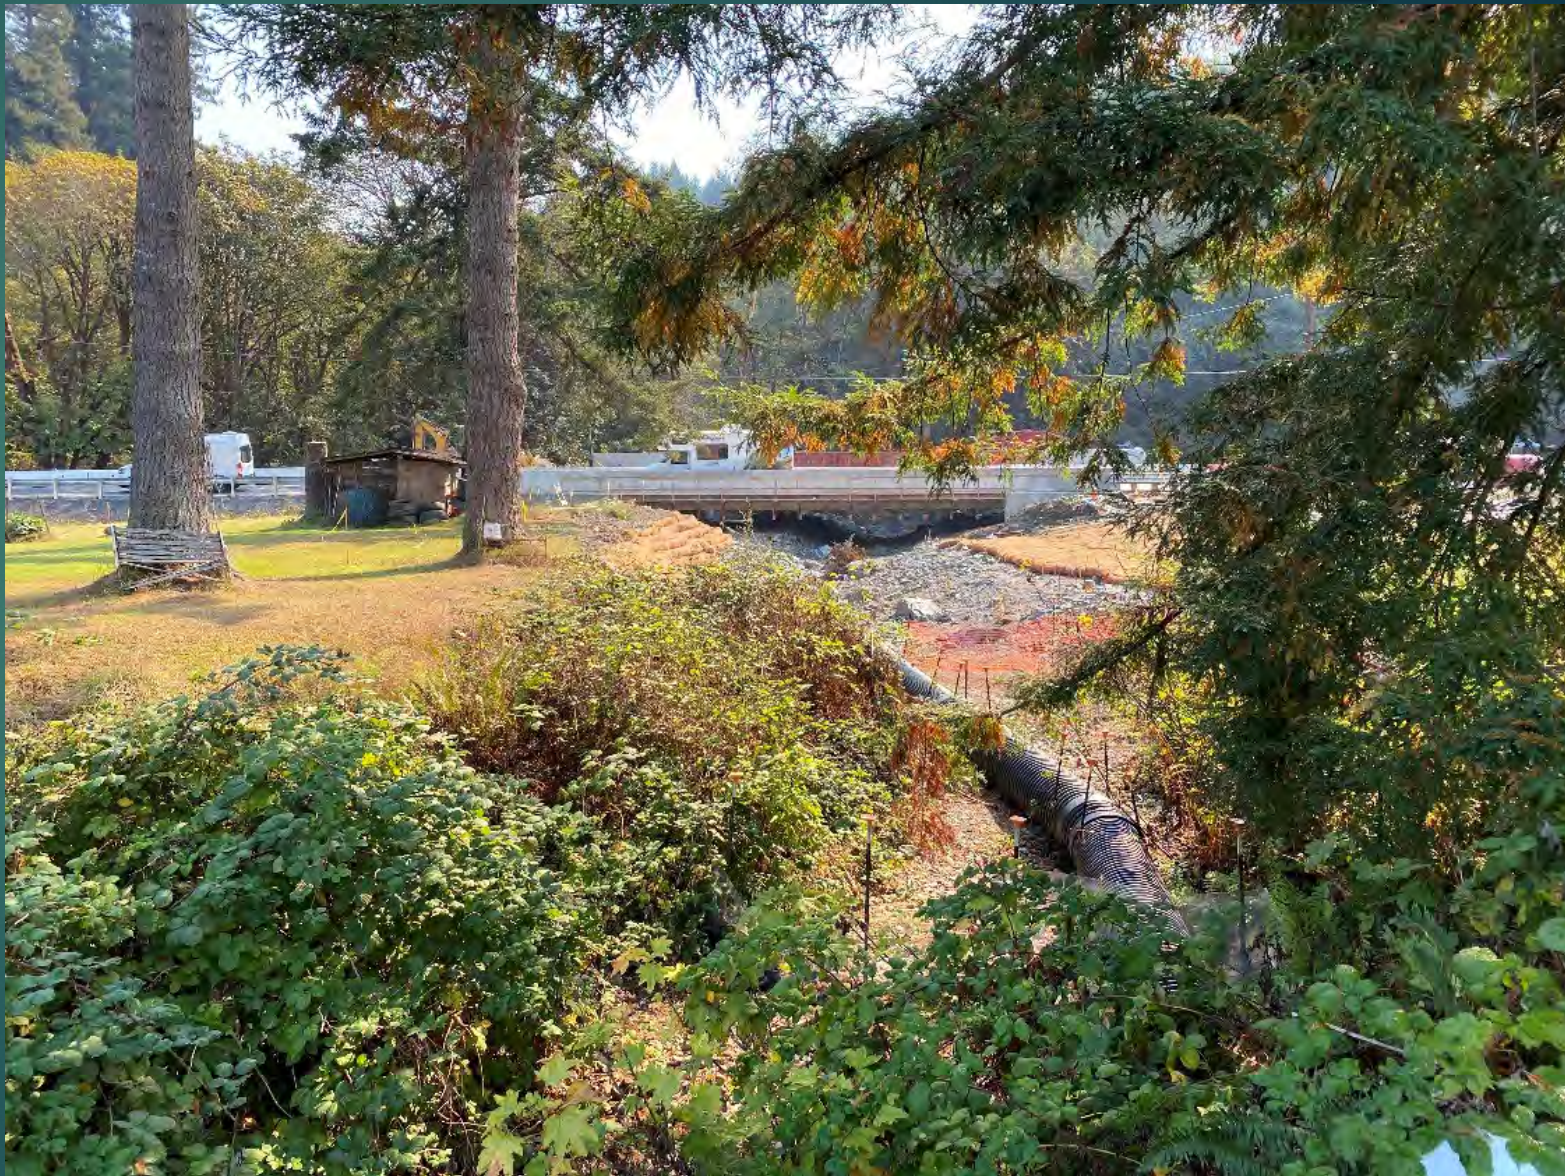
Before

After

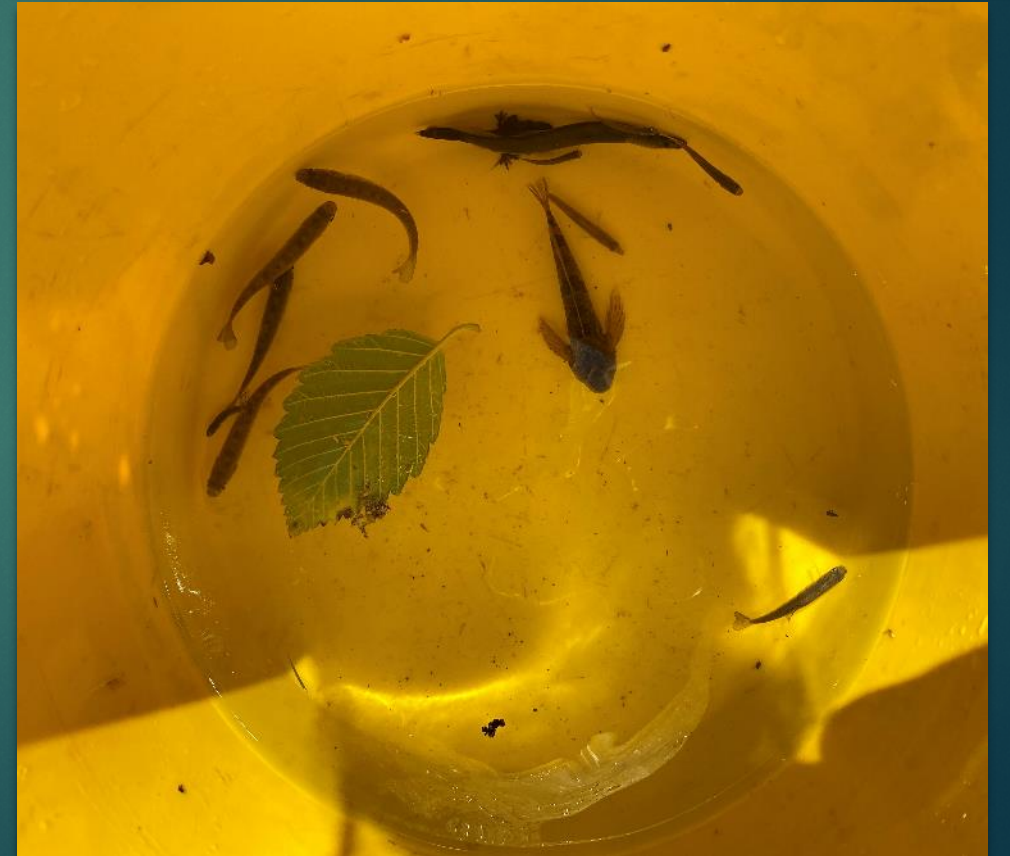
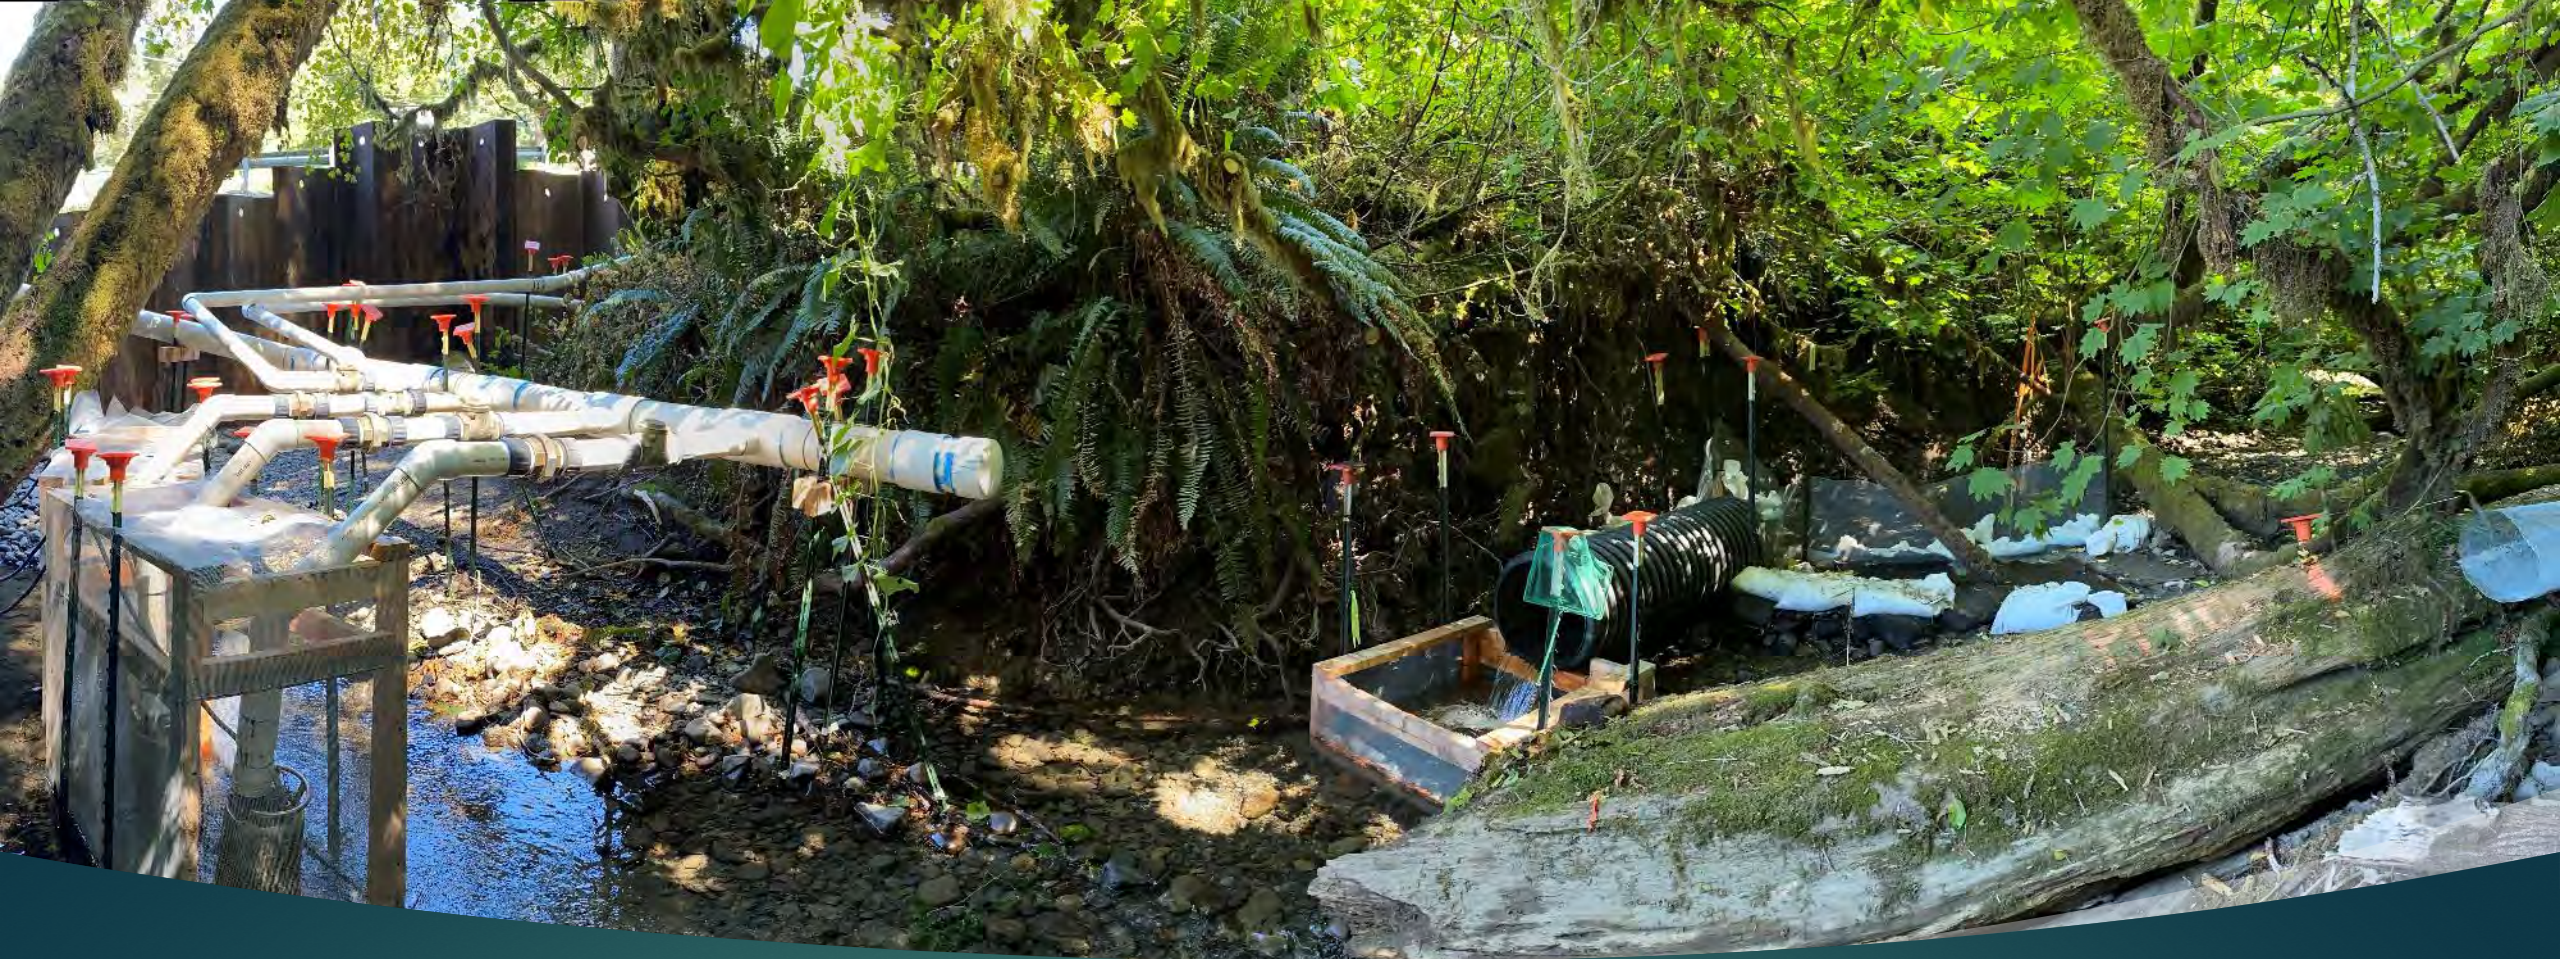
Fyke trap and Water diversion

A fyke trap was used to capture out-migrating fish so they could be moved downstream.

The contractor installed sheet piles to isolate the work area from the water, and then installed a five pump gallery to capture the surface flow

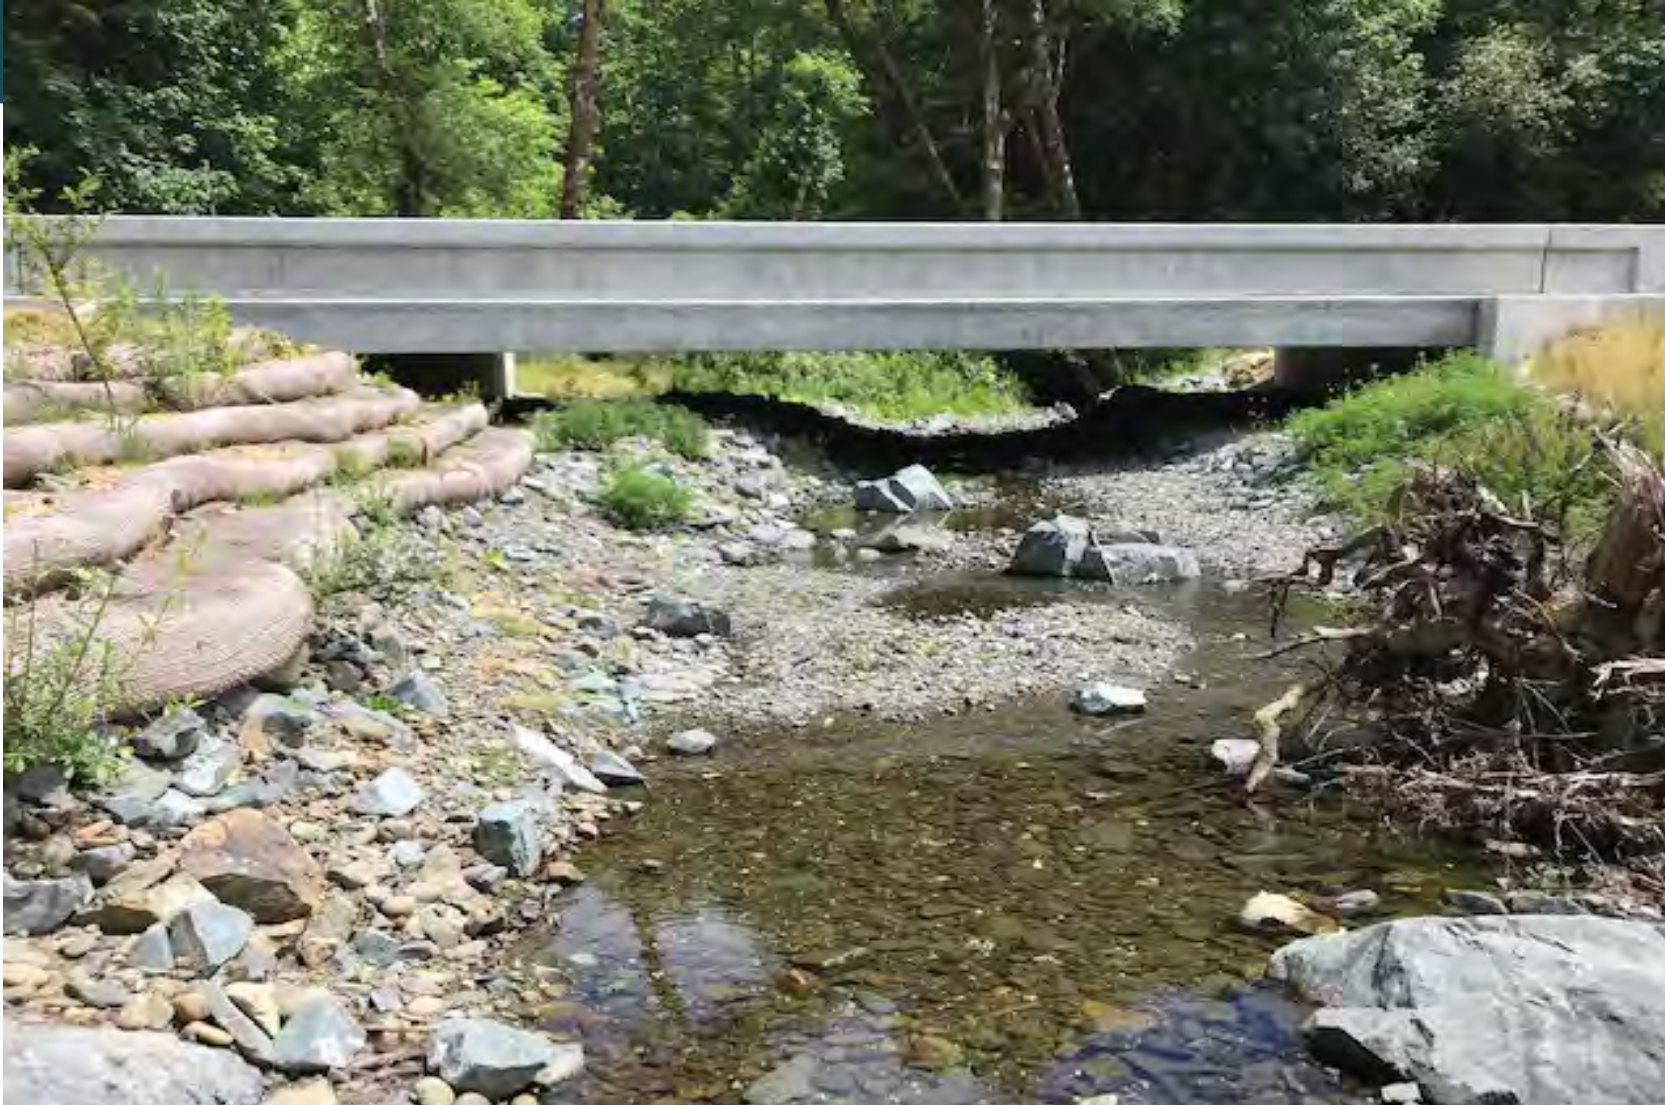
Construction 22.5' active channel width---70 foot long single span precast slab. (No piers or columns in the channel)

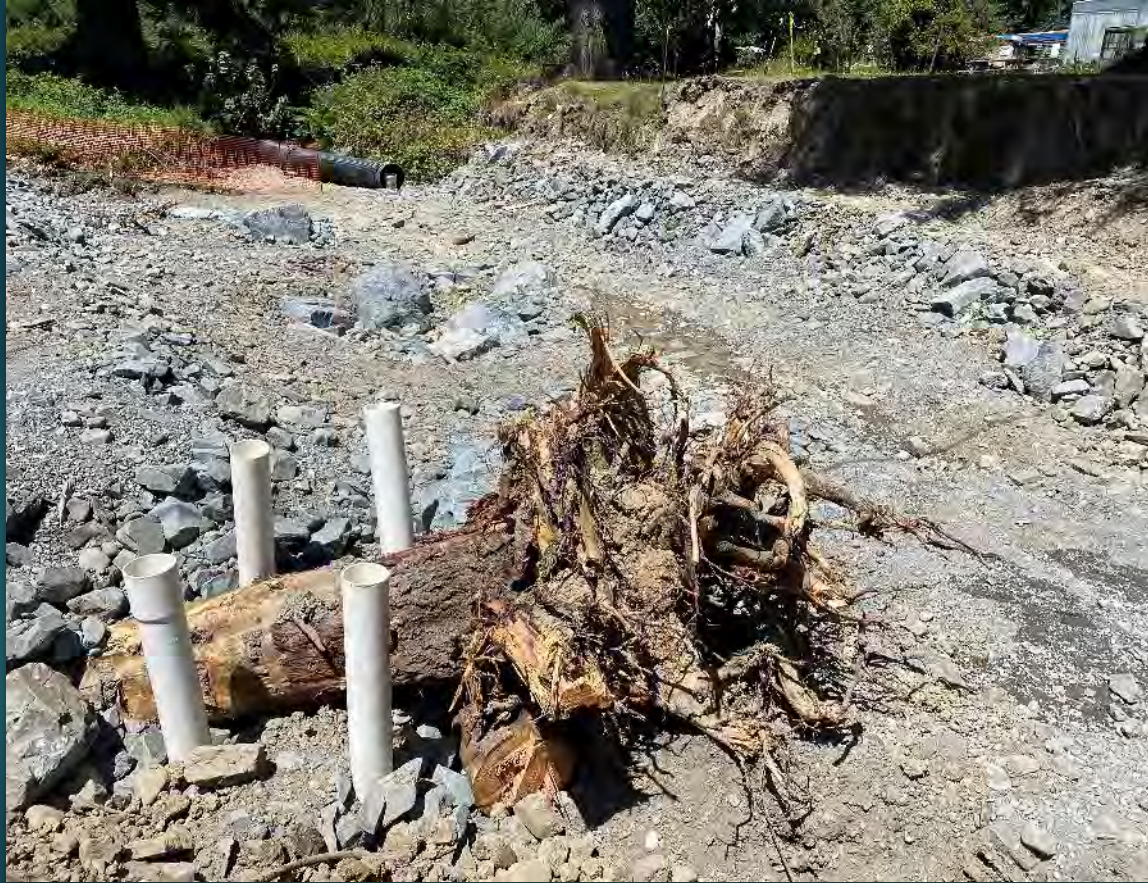
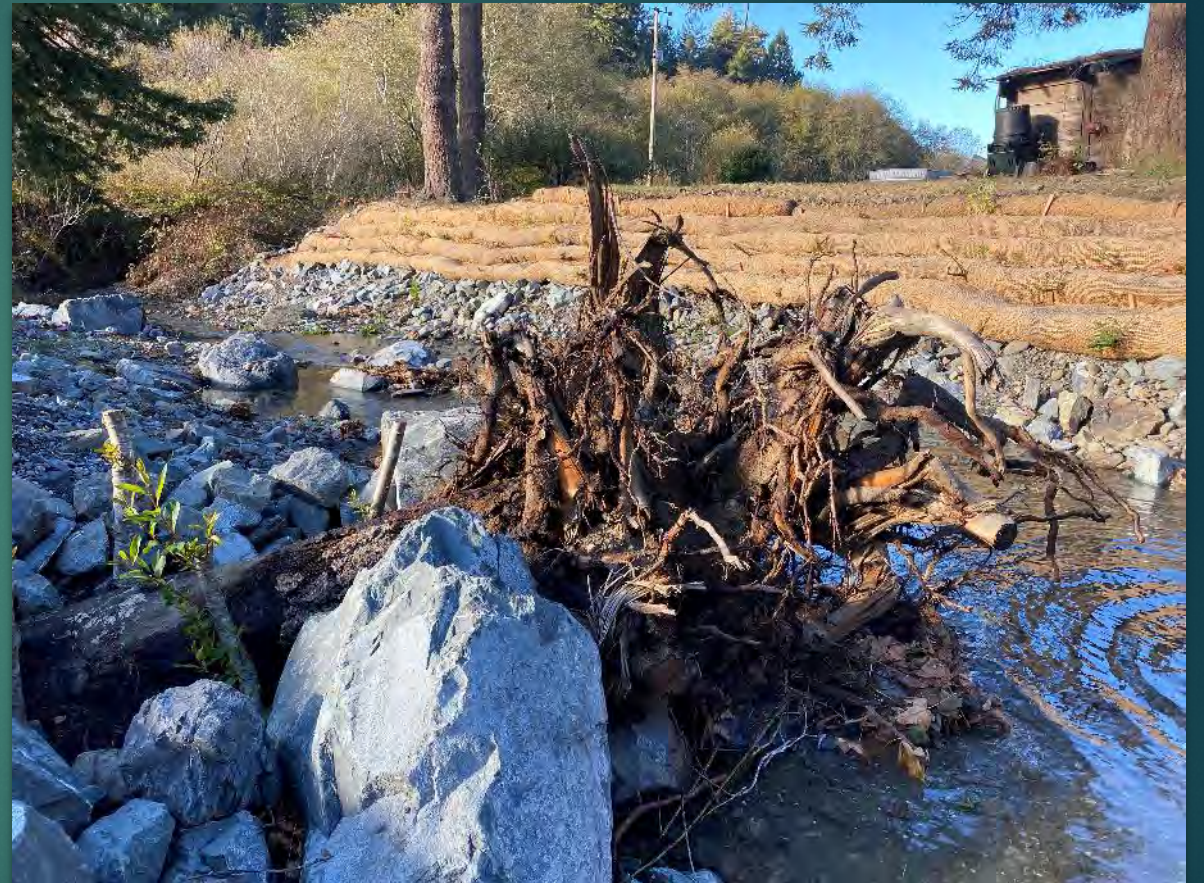
Boulder clusters were added to create channel diversity and localized scour

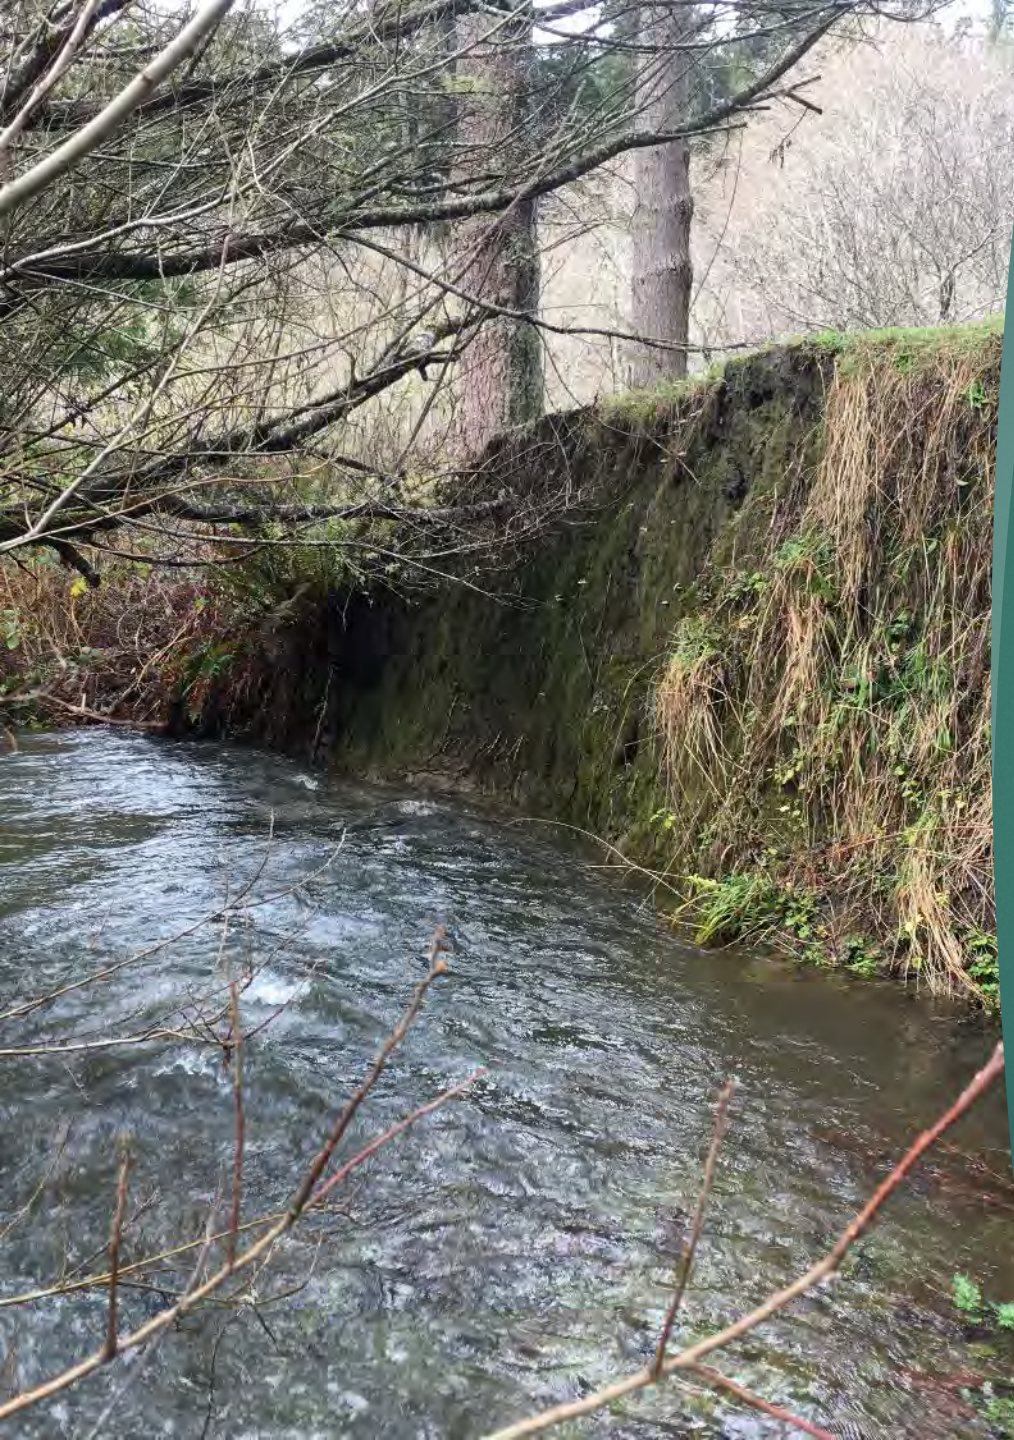
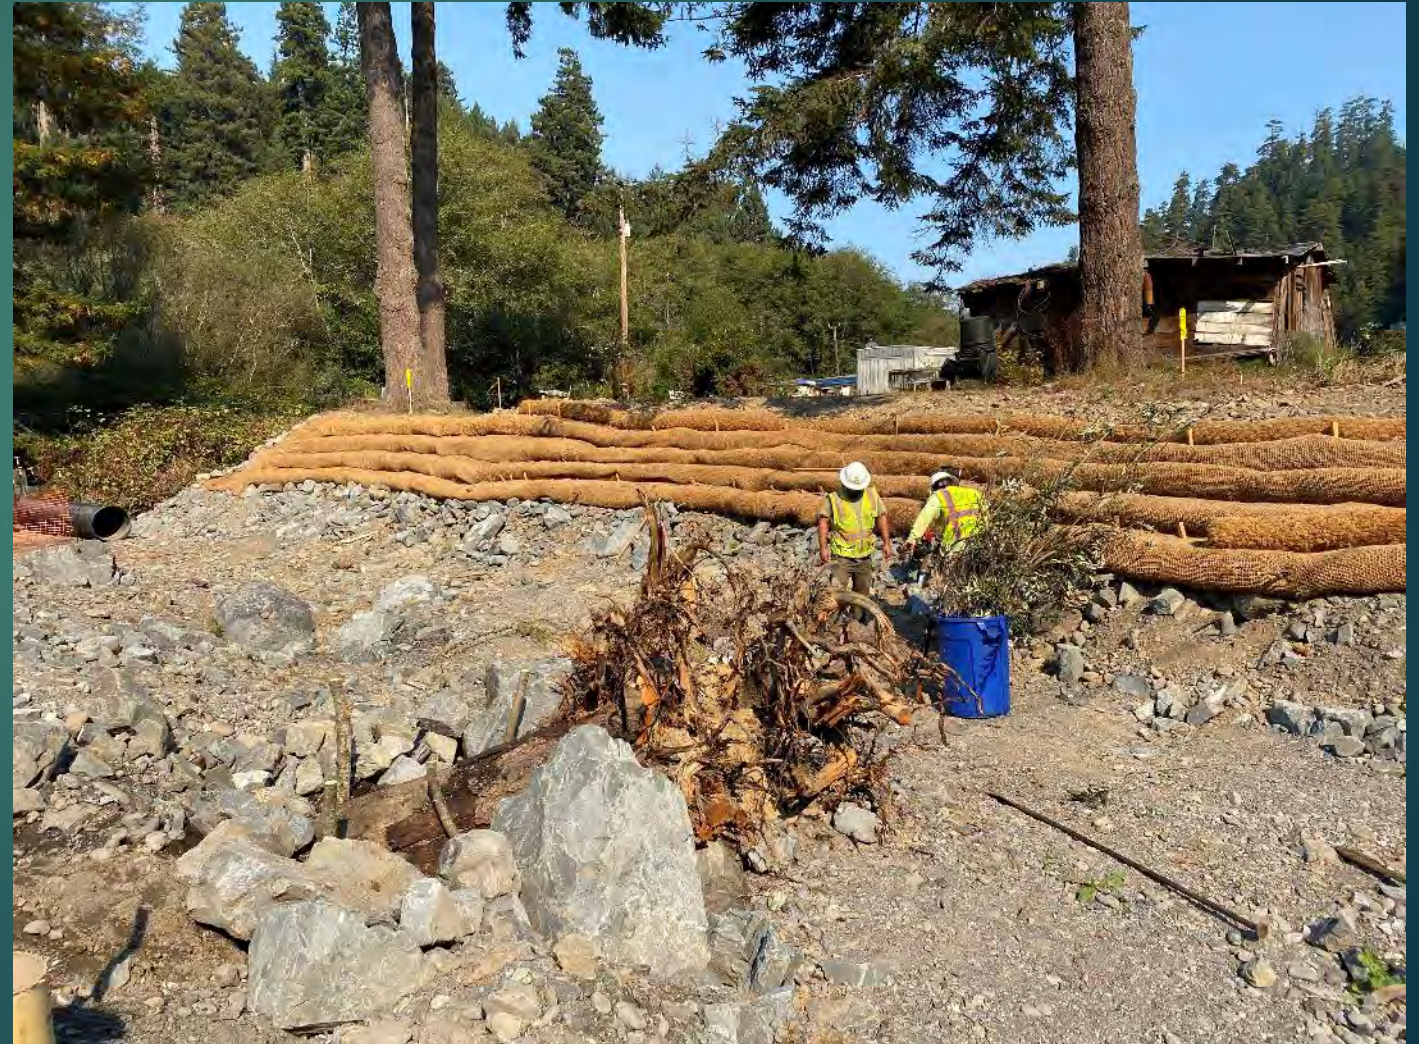
Installation of Root Wad Structures

Biostabilization of the vertical bank (downstream right bank)

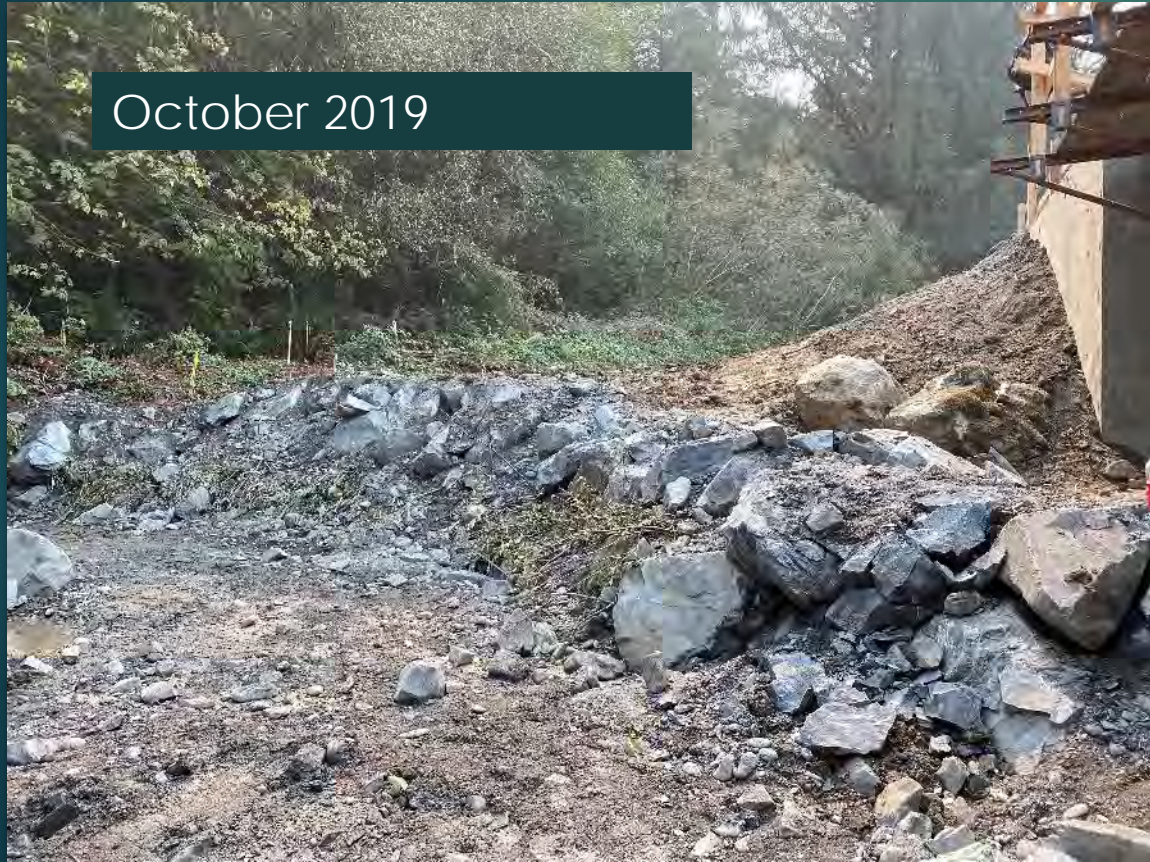
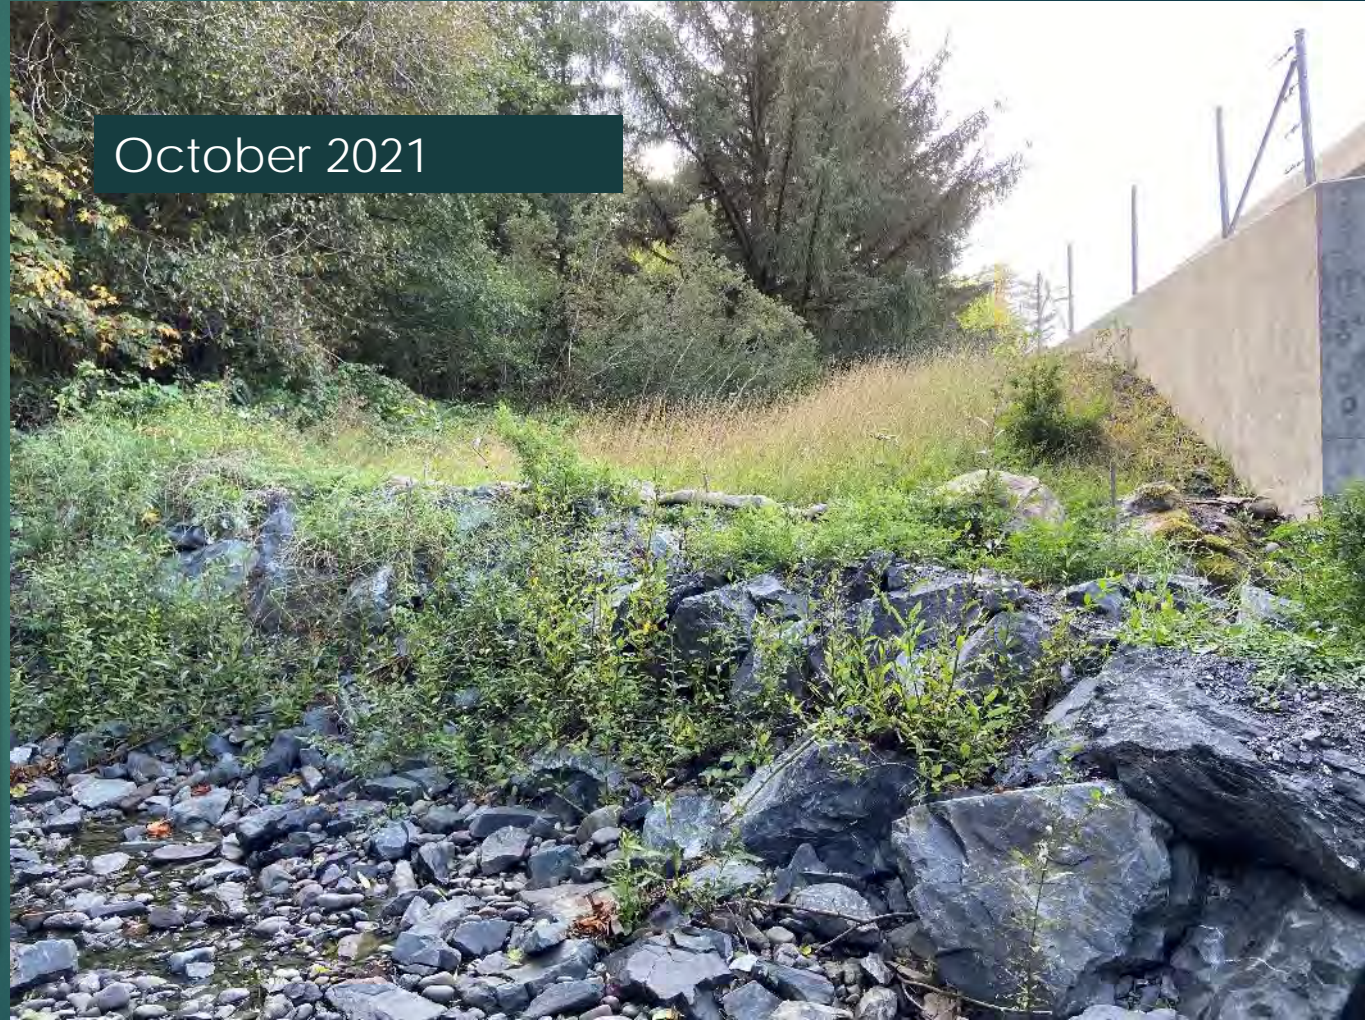
Willow Blanket (upstream left bank)

October 2019

October 2021
